## LIFE Dee River project

## Erbistock weir

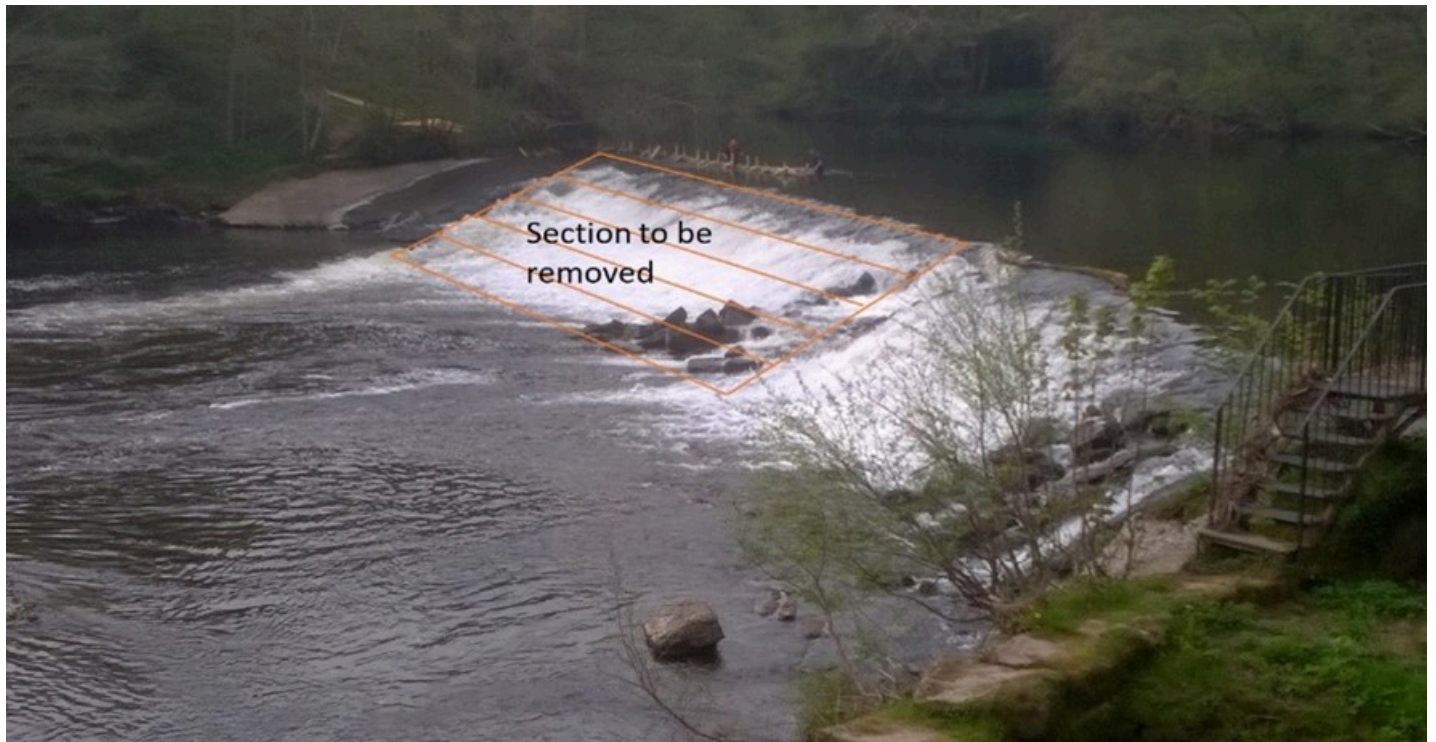
Erbistock weir is approximately 80m wide, stone built and set at an angle to the flow circa 46km from the tidal limit. A baulk fish pass was located on the right bank which is in a bad state of repair and is only suitable for a limited range of species (mainly salmonids) at certain flows. This can be seen in figure 2. Removal of the weir would open up approximately 88km of main stem river for all fish species.

There was an area of damage to the glacis of the weir, which made fish passage more challenging, due to competing attraction flows. The removal location was dictated, to a degree, by the location of this damage.

**FIGURE 2** Side view of section to be removed taken from lefthand bank till current damage to weir face.  
© LIFEDeeRiver

The proposal was to remove approximately 40m of the weir to create a new primary flow channel. This will mimic the natural width of the river in the area to imitate the natural morphology present to encourage natural processes to re-establish. All stone removed from the site was redistributed within the channel, either to provide protection for the remaining weir, or as habitat creation.

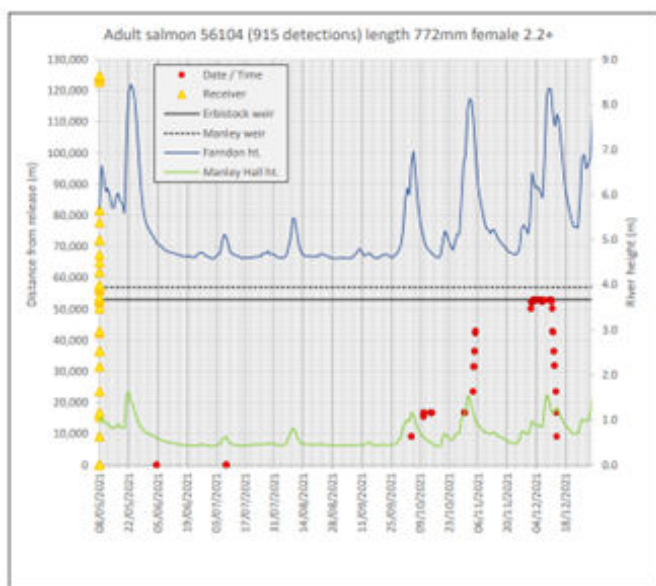
Through acoustic tracking studies, the LIFEDeeRiver project demonstrated that Erbistock weir was a partial barrier to *Salmo salar*, *Petromyzon marinus* and *Lampetra fluviatilis* (figures 4 and 5). On the graphs, the red dots indicate detections picked up on a receiver (receivers denoted as a yellow triangle on the Y axis). The solid black line indicates Erbistock weir.

**FIGURE 4** Acoustic track of adult salmon that failed to pass Erbistock weir. © LIFEDeeRiver

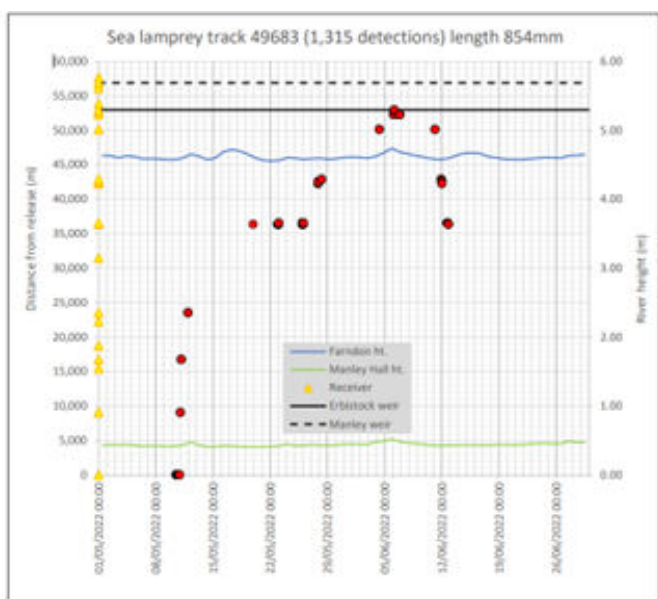
**FIGURE 5** Acoustic track of adult sea lamprey that failed to pass Erbistock weir. © LIFEDeeRiver

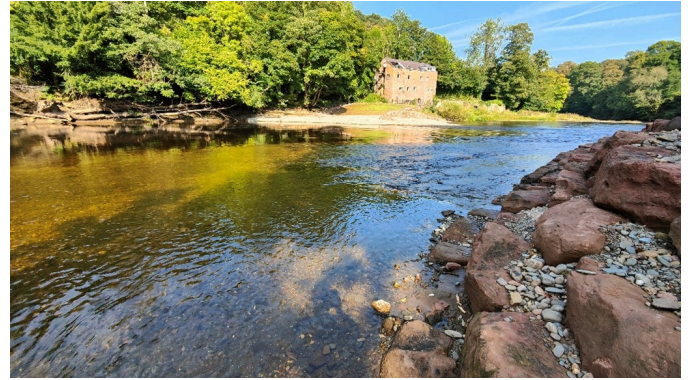
**FIGURE 8** Some of the long diagonal weir was retained to help protect the mill September 2024  
© RRC
