# Remove structures that are no longer needed

**Title:** River Uck, Buxted Park: Middle Ouse Restoration of Physical Habitats (MORPH)

**Location:** Buxted, East Sussex, England

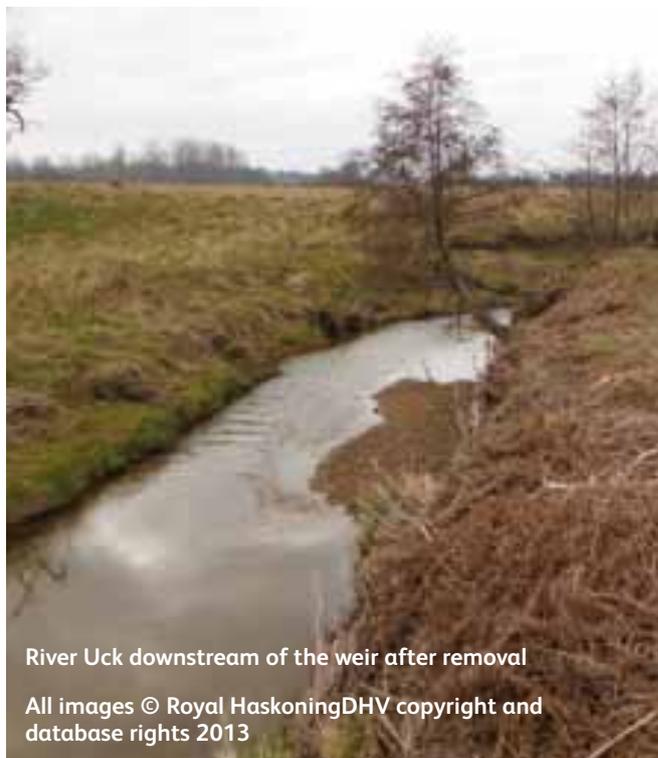
River Uck downstream of the weir after removal

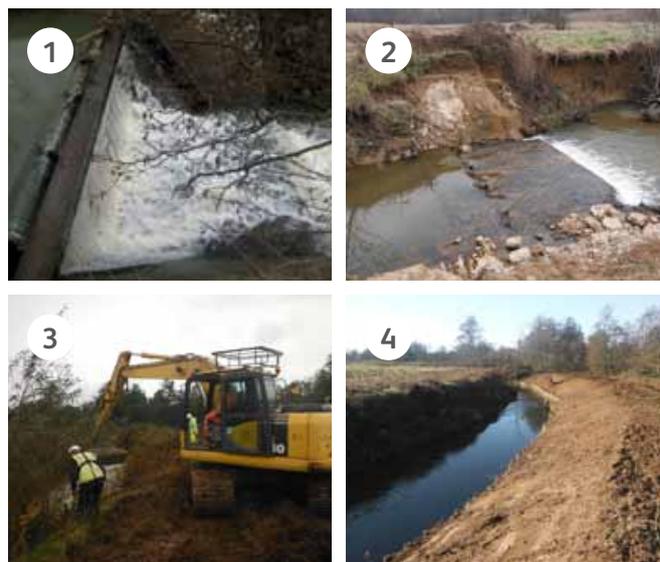
Clockwise: (1) Weir prior to works; (2) weir after wingwall / metal removal; (3) construction of gravel beds; (4) willow spilling protecting reprofiled right hand bank.

- The concrete weir was removed, including the wing walls and metal components, leaving the concrete apron. The banks were reprofiled and the weir pool was infilled using rock and gravel material;
- Kentish Ragstone gravel (sized between 20-40mm), selected to encourage barbel, chub and dace, was used for gravel seeding of key locations on the inside of meander bends throughout the reach;
- Willow spilling was installed to protect footpaths and ornamental fishing lakes where essential;
- Bank reprofiling was undertaken in high-risk areas at the downstream end of the reach.
