River restorations in River Keravanjoki, Hyvinkää, Finland

Restoration in brook Longinoja, Helsinki, Finland

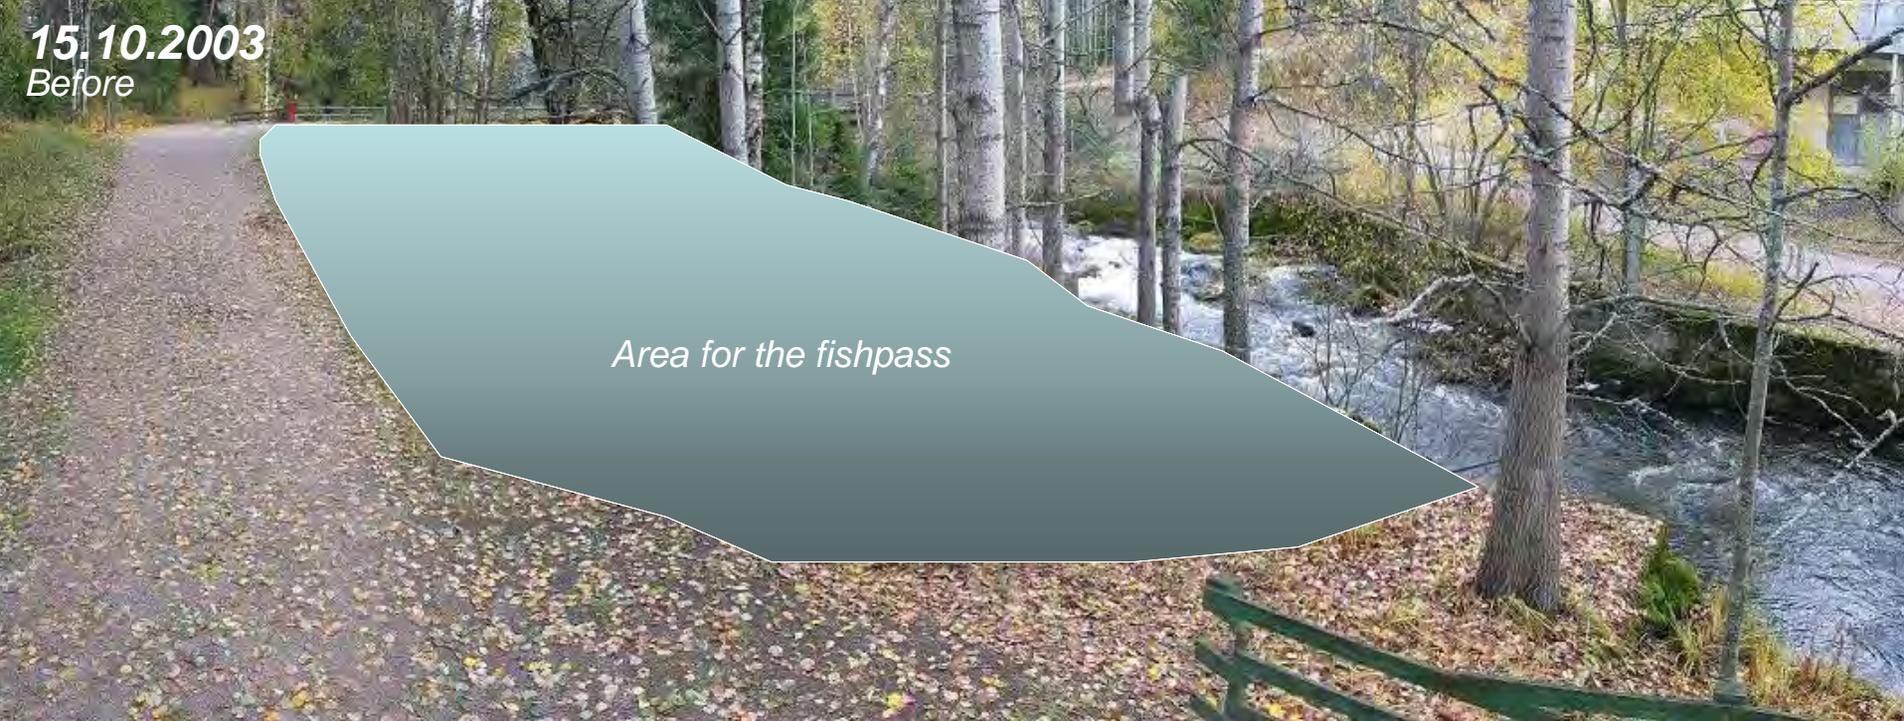
15.10.2003
Before

Area for the fishpass

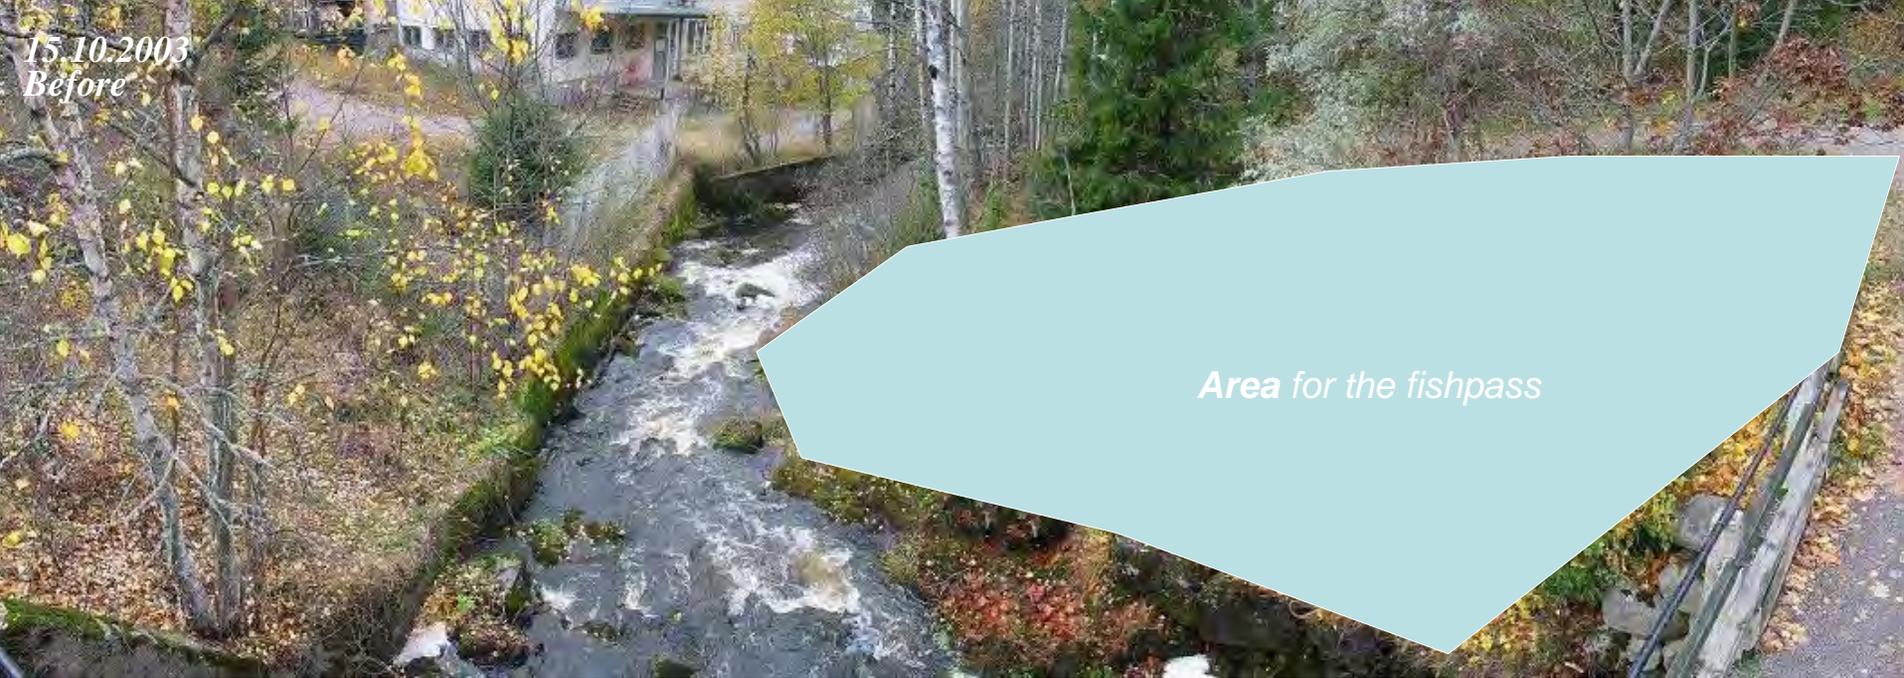
15.10.2003
Before

Area for the fishpass

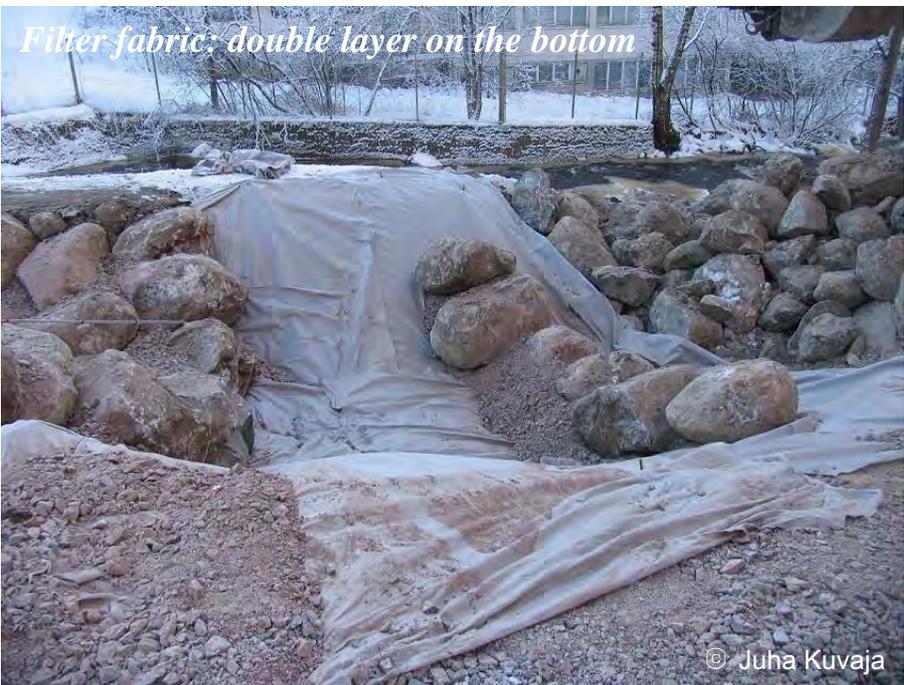
Filter fabric: double layer on the bottom

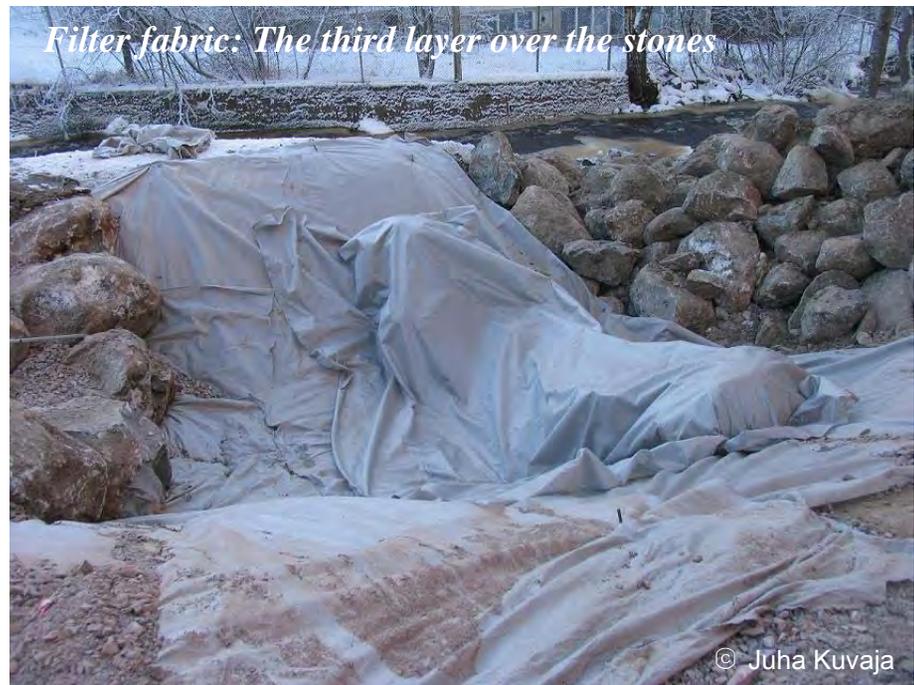
Filter fabric: The third layer over the stones

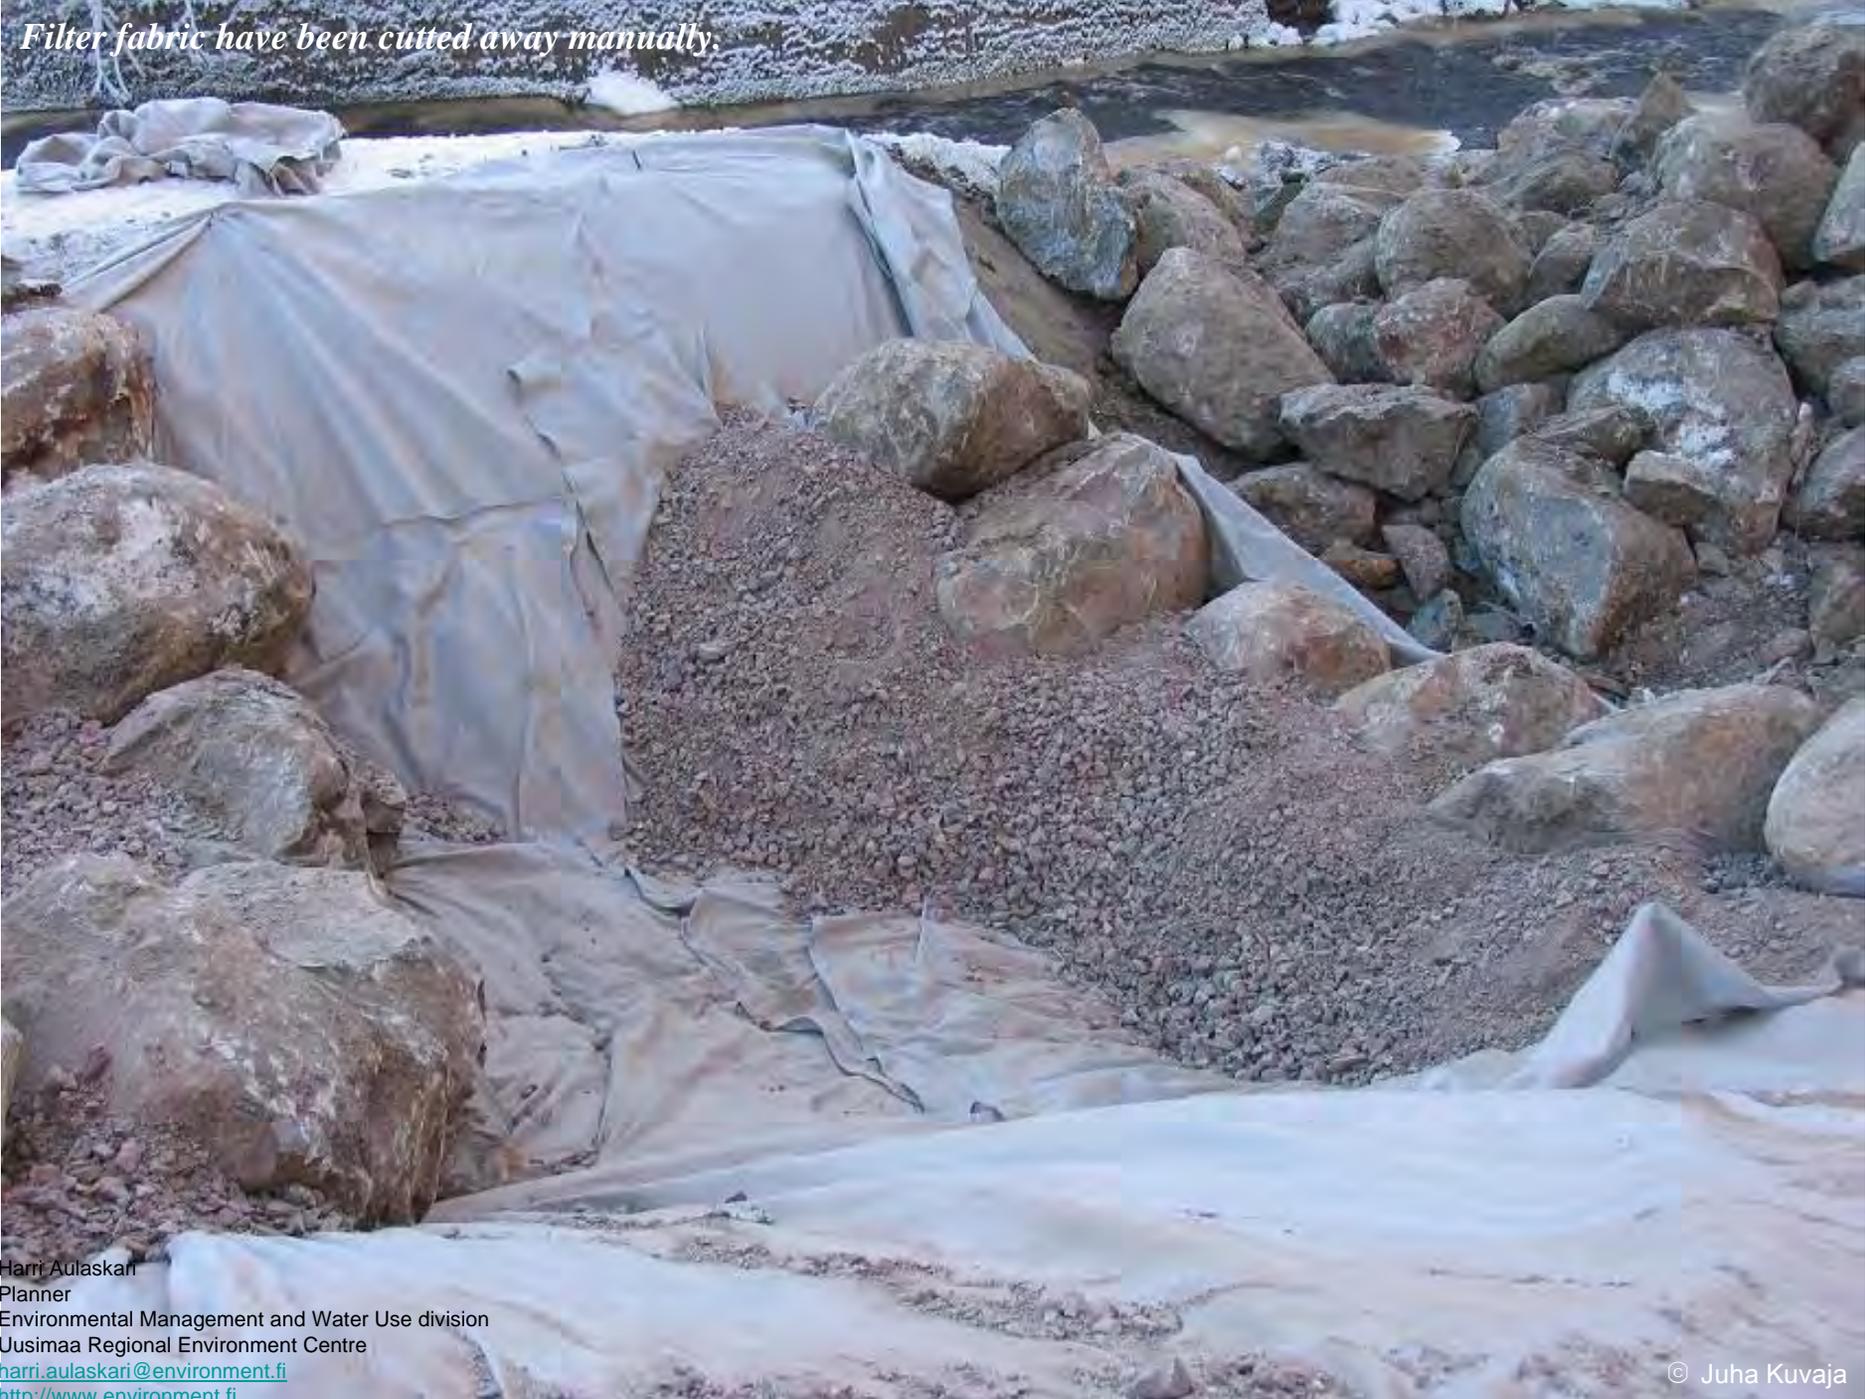
Filter fabric have been cutted away manually,
