Removing a weir and renaturalising the Iton River on the Plis industrial site in Hondouville

Reopening side channels along the Saône in Jassans-Riottier

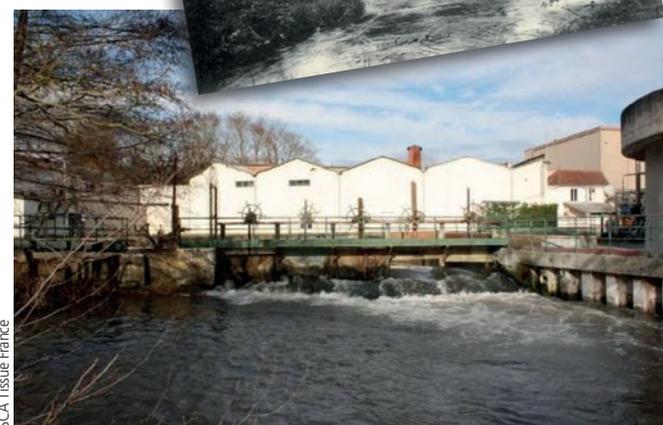
The Plis weir in 2014.

The outdated Plis weir measured 1.1 metres high with the gates closed and 0.8 metre with the gates open. It caused numerous malfunctions in the river, including a break in sediment transport, an obstacle to the passage of trout and eels, degraded water quality, a more uniform flow pattern and siltation of habitats (an impounded reach extending 600 metres).

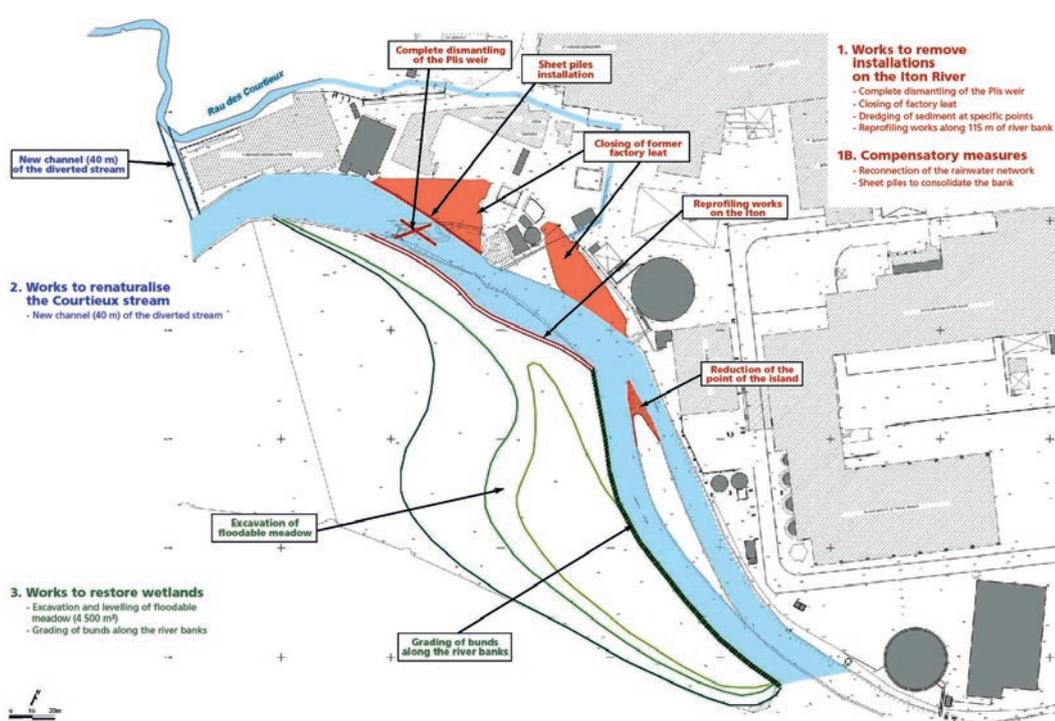
Overview of the selected project. [Egis Eau, 2013]

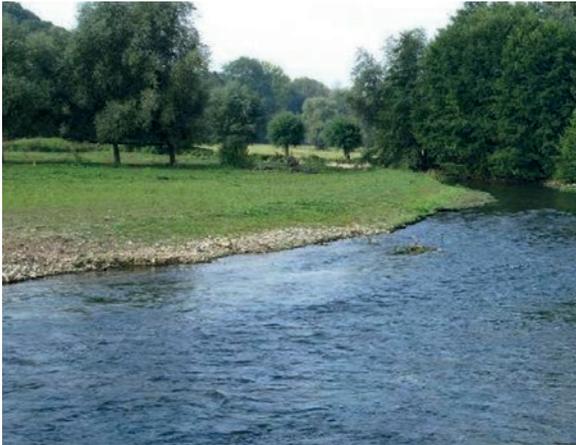
The meadow after restoration of the wetland (2014).

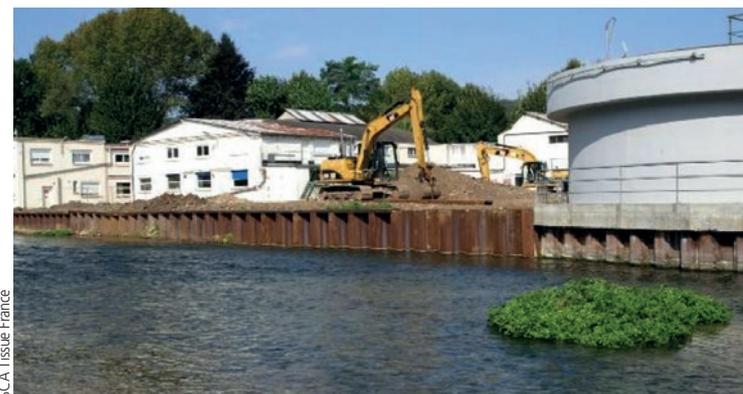
Filling in the factory leat following the removal of the Plis weir (2014).

The factory channel was filled in with the landfill from the meadow. The banks along the industrial site were reinforced with sheet piles to protect the buildings. The outlet of the wastewater-treatment plant, originally in the factory channel, was extended to the Iton.

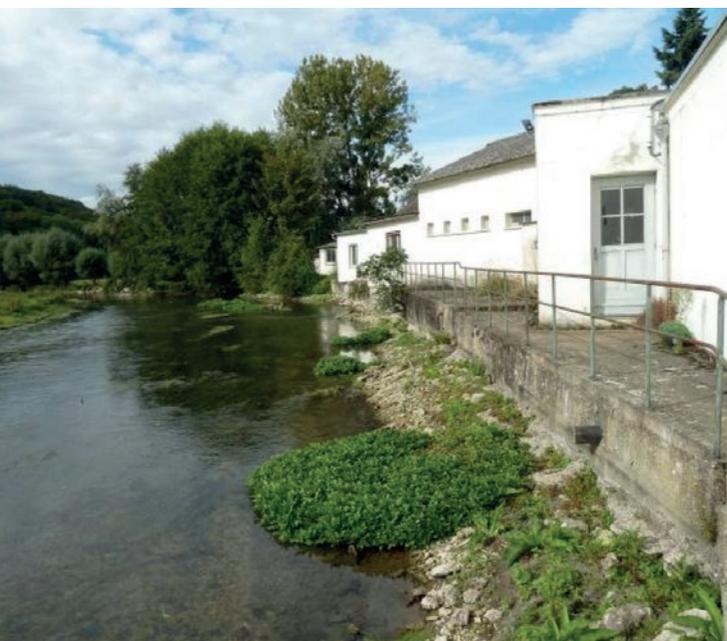
Filling in the factory leat following the removal of the Plis weir (2014).

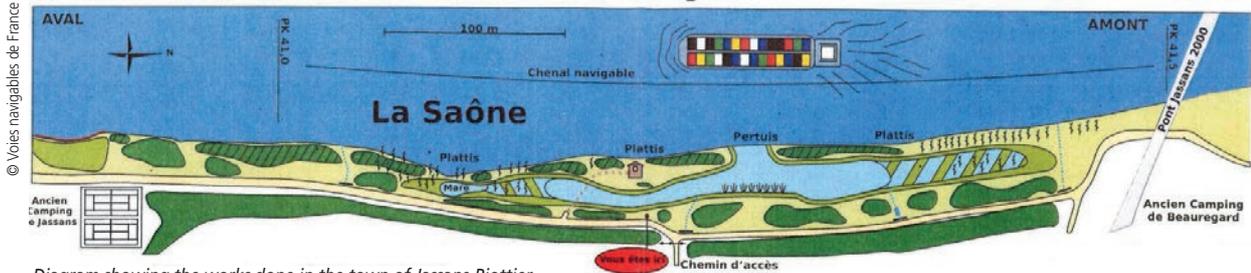
Diagram showing the works done in the town of Jassans-Riottier.

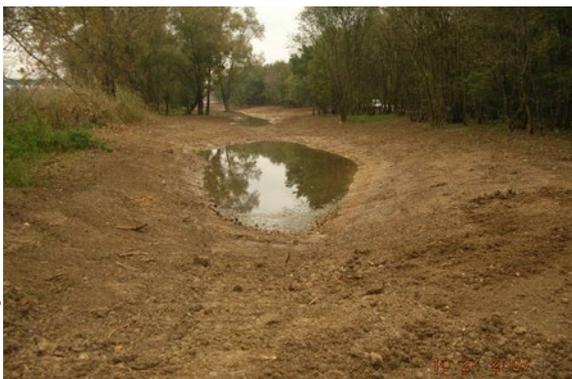
Earthwork to restore a side channel and ponds. October 2007.

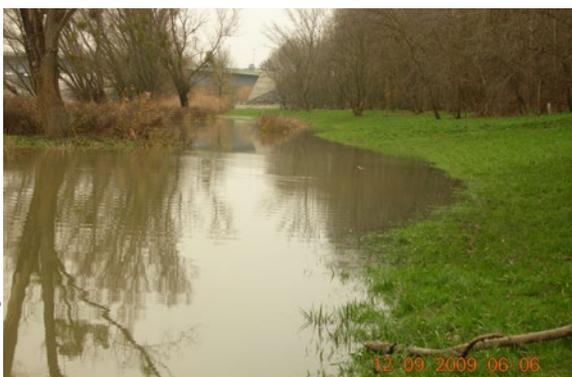
Flooding of the restored side channel. December 2009.

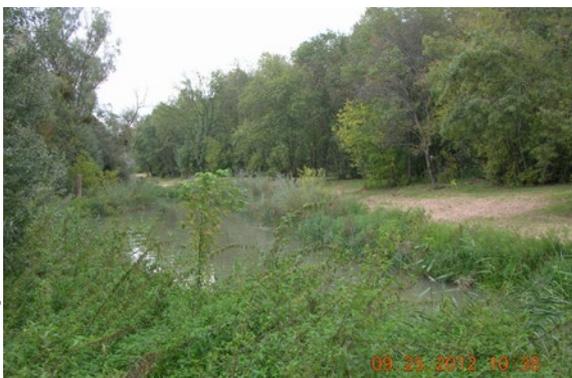
The vegetation in the restored side channel had developed well 4.5 years after the works. September 2012.

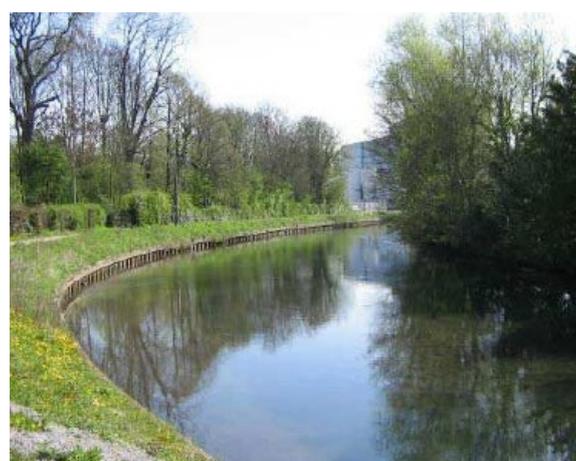
Banks protected by sheet piles prior to the restoration works. Autumn 2010.

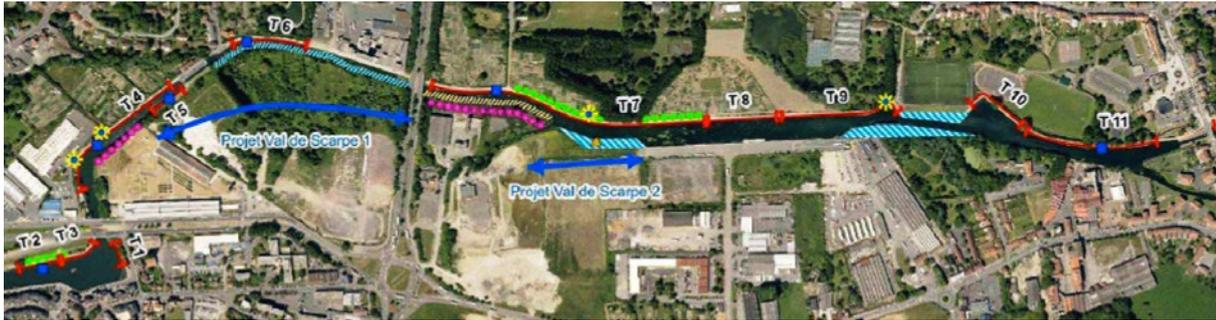
Creation of stagnant and semi-stagnant lagoons along the Scarpe. Summer 2010.

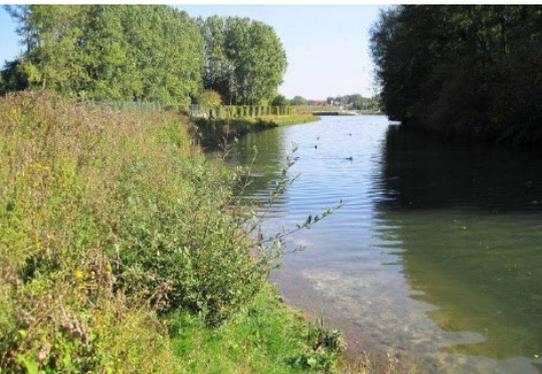
Banks regraded and planted. Autumn 2012.

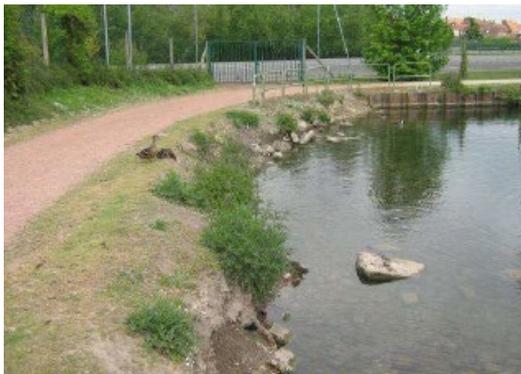
Erosion and damage near the turn-around point on the Scarpe. Autumn 2010.

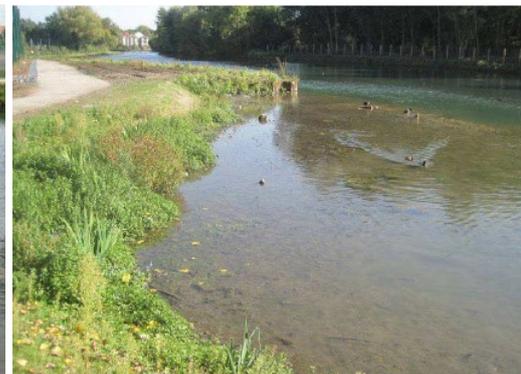
Regrading and creation of a reed bed by closing the turn-around point. Autumn 2012.

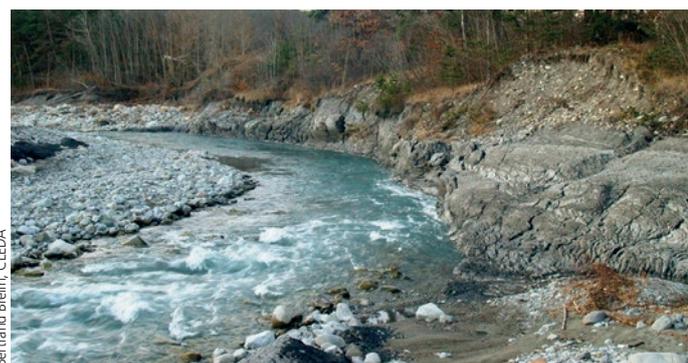
Bed scouring of the Drac into the clay, loss of riparian vegetation and a landslide, in November 2011.

A study carried out in 2000 signalled a problem of incision in the bed of the Drac (clay substratum) upstream of the town of Saint-Bonnet-en-Champsaur, caused by massive extractions of gravel since the 1960s and that ended only in 2012.

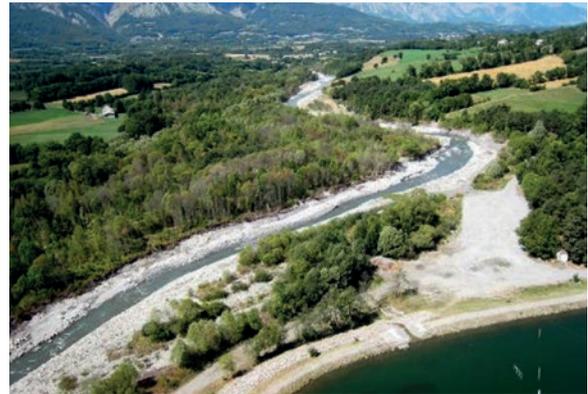
The Drac with the scoured bed next to the Champsaur Lake in August 2009.

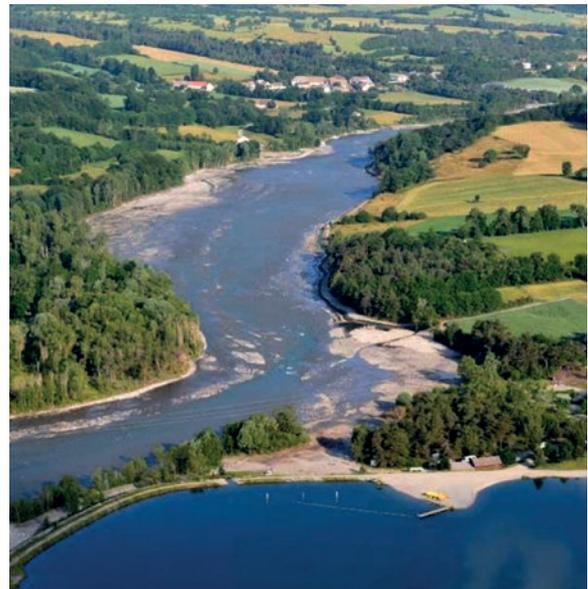
The restored Drac next to the Champsaur Lake in June 2014.

The second phase consisted of a vast operation to reload the bed with 450,000 m³ of alluvium removed from the former terraces of the Drac and from zones of sediment accumulation along other rivers in the river basin.

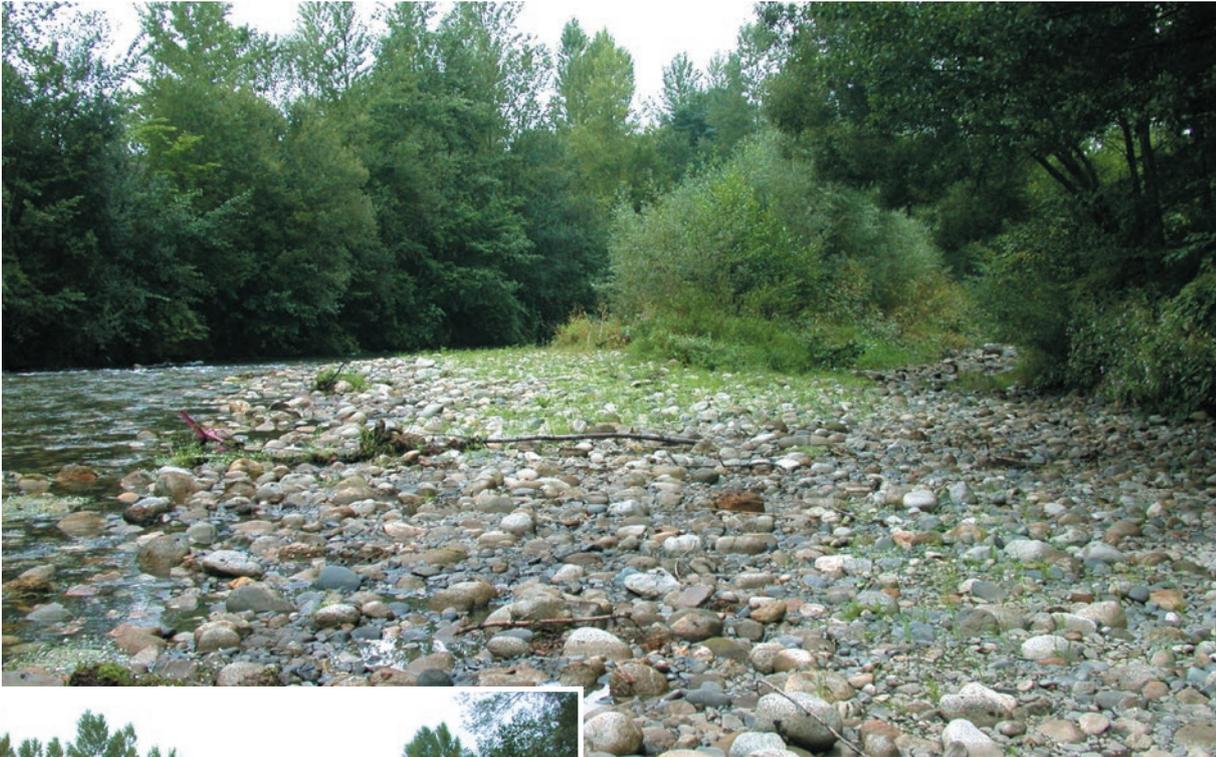
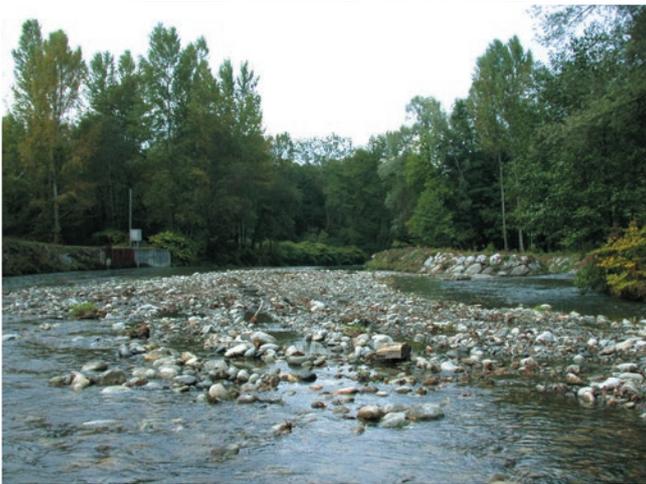
An alluvial bar on the upper Adour before (above) and after (opposite) the works.

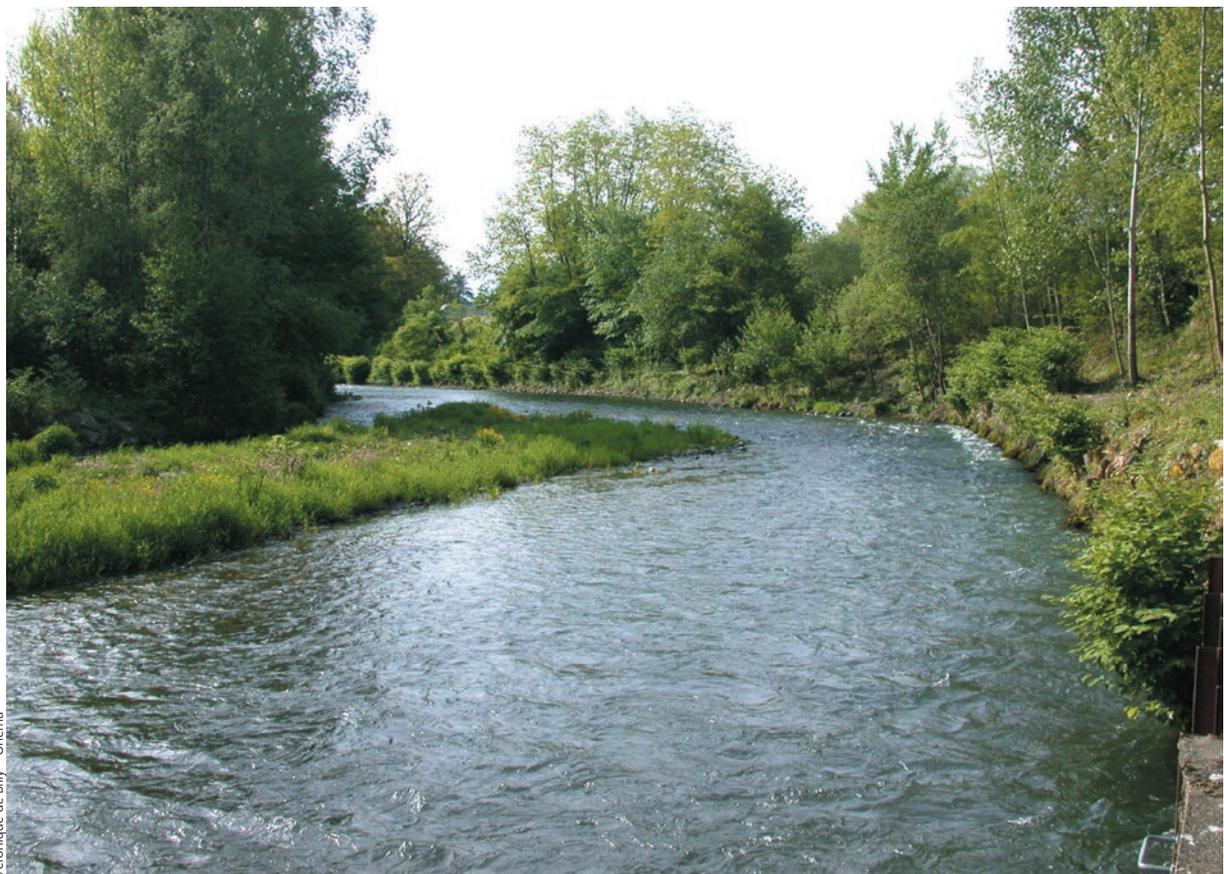
The upper Adour with a treated left bank

A track parallel to the banks, at least ten metres from the river in the riparian vegetation and open only to maintenance personnel and local land owners, was created to facilitate maintenance and provide access to the river in the event urgent action is required during a flood. Vegetation is cut on a very selective basis in order to preserve the habitats of the animals that depend on the aquatic environments. Management of accumulated debris and jams is kept to a minimum. An assessment now determines whether debris and jams constitute an effective obstacle to the flow of water and only the "risky" situations are managed by removing any vegetation and raking the sediment to a depth of 80 cm.

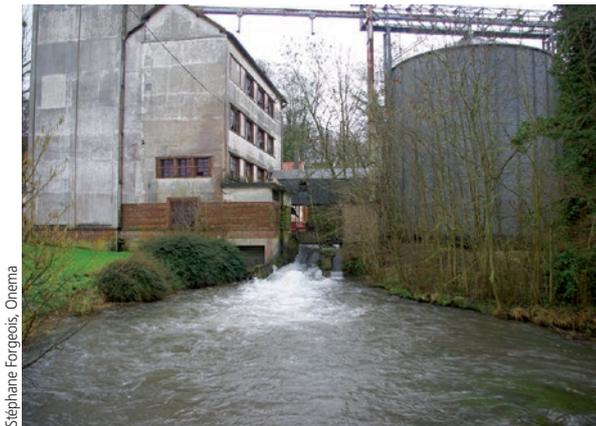
The Sénarpont weir, a total barrier for fish, in 2012 prior to the works.

As of the year 2000, the weir of the mill in Sénarpont [ROE 38669], 1.9 metres high with an impounded reach extending approximately 800 metres, represented the historic limit to colonisation of the Bresle by long-distance, migratory salmonids. The mill dates back to the Middle Ages and is made up of a leat, a bypass located in the middle of the leat, an outlet used to flood the underlying meadows and the main system component, a weir equipped with a large gate at the end of the leat.

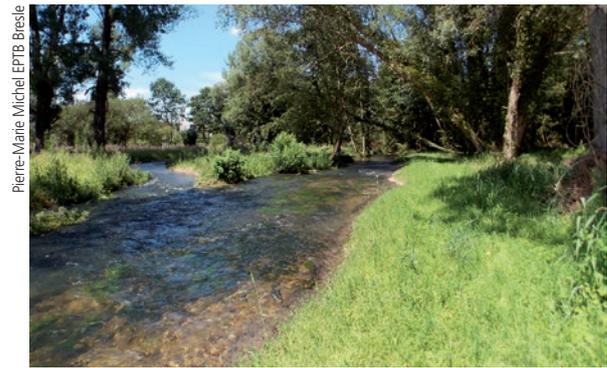
The new channel in the talweg in 2014.

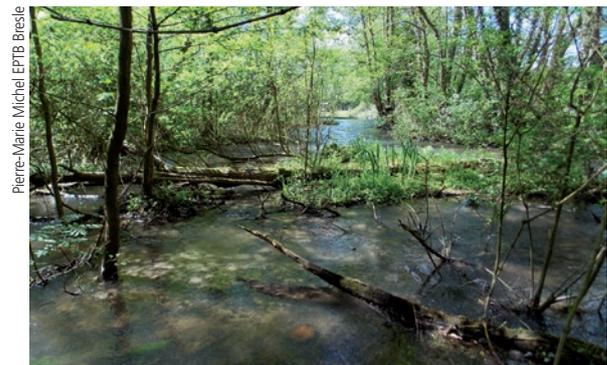
The diverse, intermediate zone in 2014, following the works.

The former impounded reach was replaced by a series of diversified flows in multiple channels in the valley bottom. Fine sediment was removed to reveal the coarse substrate that is now renewed naturally thanks to the restoration of the morphodynamic process.
