European **River Restoration** Conference Featuring the IRF Riverprize

Celebrating Successes and Addressing Challenges 5th edition | 11-13 September 2013 | Vienna

# **BANK EROSION CONTROL AS PART OF A REHABILITATION STRATEGY AT THE RIVER BASIN LEVEL**

António Pinto\* (PhD Student FEUP) Portugal, antonio.pinto@fe.up.pt), Pedro Teiga\* (PhD, Portugal), Rodrigo Maia\* (Associate Professor FEUP, Portugal), Nuno Bravo\*\* (ARH CENTRO Director, Portugal)

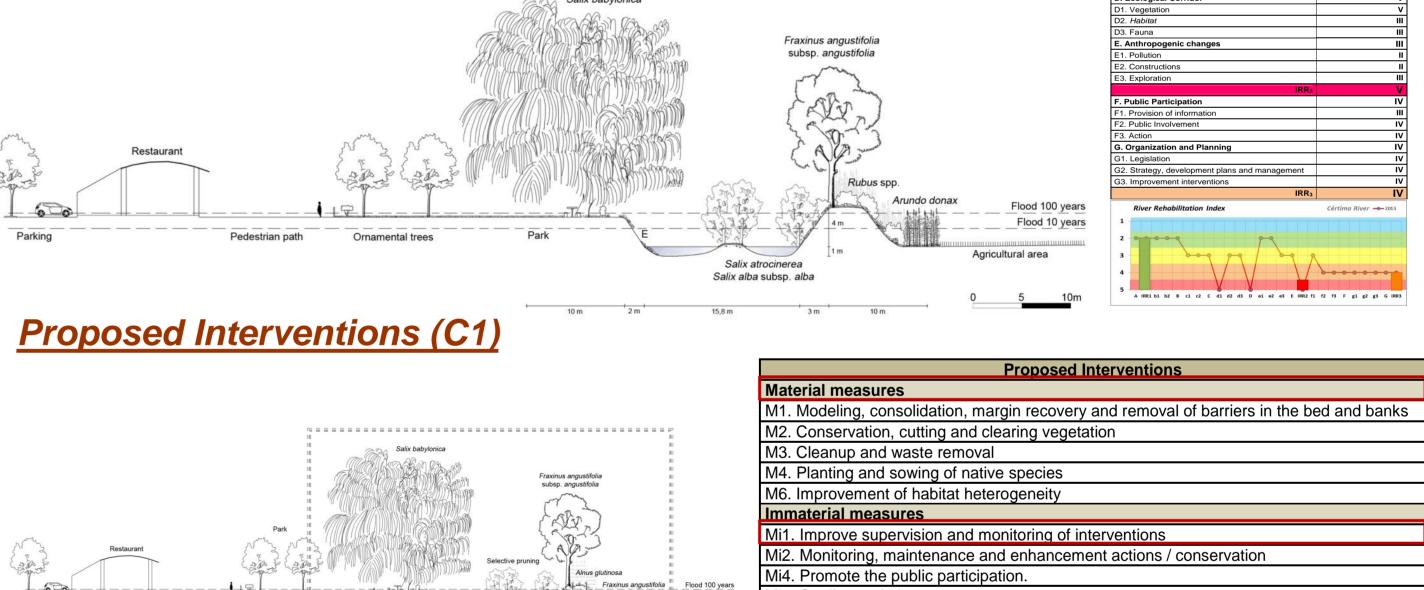
The exemplifying illustrations presented do show and enable to compare the present situation and the envisaged post-intervention state on the referred study section (C1). A set of recommendations and guidelines on the level of monitoring and maintenance to observe are also specified.

The application of the methodology to control bank erosion is exemplified on a stretch of Cértima River (Vouga River Basin), over which a survey of the main problems, pressures and needs associated with bank erosion was performed. As a result of that characterization and of the developed methodology, proposals of interventions to control bank erosion, namely stabilization techniques, could be defined, as exemplified for a river section at Mogofores Bridge (C1). The corresponding study area is occupied, on the left bank (LB) by a leisure and recreation park, and on the right bank (RB) by agricultural land, that justifying the use of different stabilization techniques: cribwall (LB) and live riprap (RB). As an example, a scheme "type" of cribwall, including a set of technical, operational specifications and inherent costs need to implement that solution, is presented.

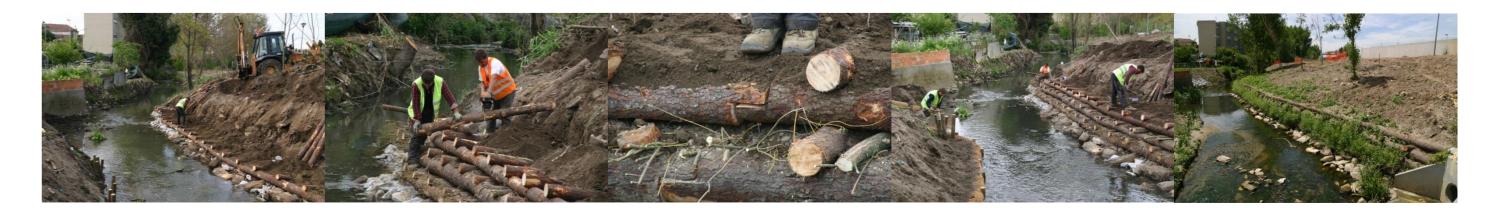
#### Intervention (example):

e distribution of live stakes in the structure must be asymmetric, avoiding linear and regular
