# Improve channel geomorphology to create habitat

Title: Bonesgate Stream Restoration Sscheme Location: Bonesgate Stream, West Ewell, Surrey, England Cost of technique: ££ Overall scheme cost: ££££ Dates: 2008

Overview of Bonesgate Stream restoration

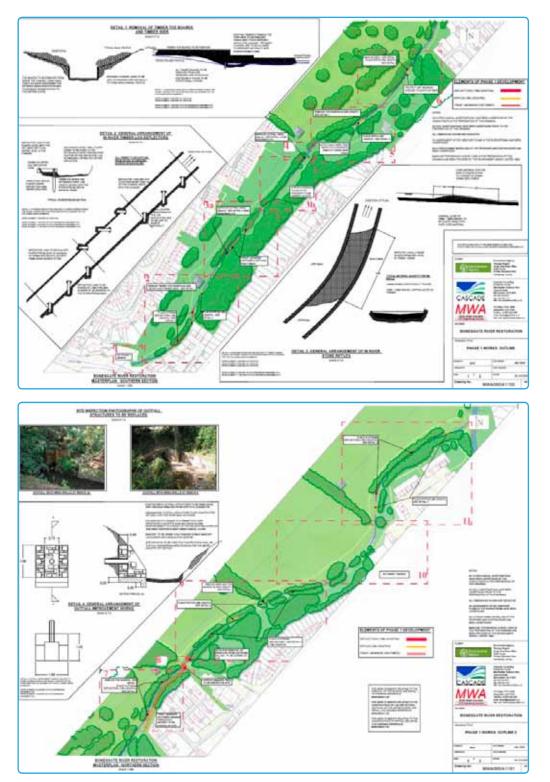
Details of restoration plan for Bonesgate Stream

Approximately 0.8 km of the Bonesgate Stream at the downstream end was restored by the Environment Agency in 2008. The aim of the project was to recreate some of the historical course of the river, identified from the 1859 historical mapping. The following construction took place:

- The weirs were removed. This involved either in situ crushing, leaving some parts in the stream, or complete removal from the stream.
- Meanders were reinstated along one section of the stream two stage channel for these sections.
- The toe-boards were removed (entirely in some sections, but in others, sections remain in situ).
- Two different designs for log flow deflectors were installed in four locations in sets of threes, made from the conifer trees removed from part of the bank small deflectors and large 'box' deflectors.
- Gravel riffles were constructed.

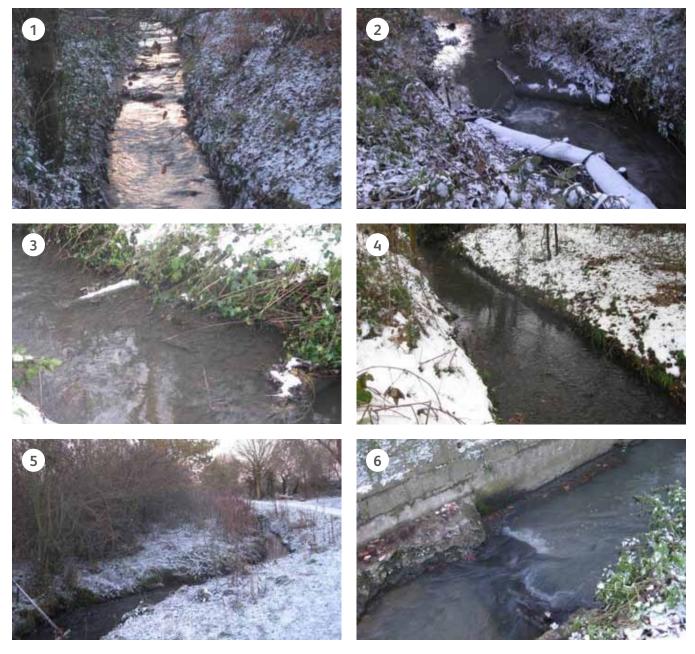
(1) Reach where toe-boarding has been removed; (2) pine-box deflectors backfilled with gravel; (3) small flow deflectors; (4) artificial riffle in a straightened section of the channel; (5) remeandering of previously straightened channel; (6) former location of weir with concrete base and banks retained.

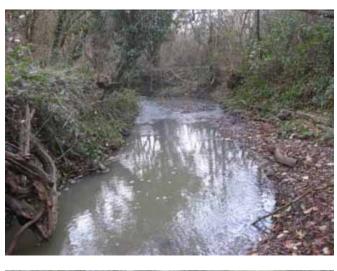
Improved channel conditions resulting from mitigation measures outlined above.

- Toe board removal has increased flow and geomorphological variability at the channel margins, resulting in undercutting a short distance up and downstream.
- Deflectors have locally increased flow diversity and resulted in localised erosion and bank retreat (the small deflectors have achieved this to a greater extent than the larger ones, which are above normal low flow levels).
- The new riffles locally increase flow diversity, changing slow, uniform glide flows into swift, shallow riffle flows, although they remain as static features and have not yet dynamically joined up with the wider river system.
- Remeandering has locally increased sinuosity and flow diversity.
- The removal of weirs has increased upstream flow diversity, and also bed scour and bank adjustment where hard bank protection has also been removed
