Use green engineering techniques instead of hard bank protection

Title: Coir roll revetment at Bedlam Bridge

Location: Bedlam Bridge, March, Cambridgeshire, England

Technique: Coir roll revetment installation; bank re-profiling

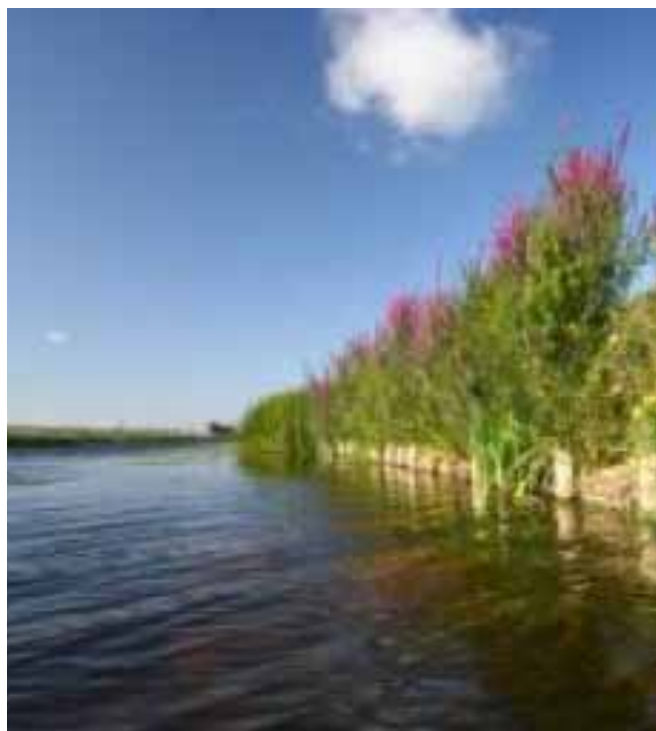
An eroded and undercut bank exposing bare earth at the water margin was restored using coir rolls pre-established with native water plants to create a naturally regenerating revetment and to restore water vole habitat.

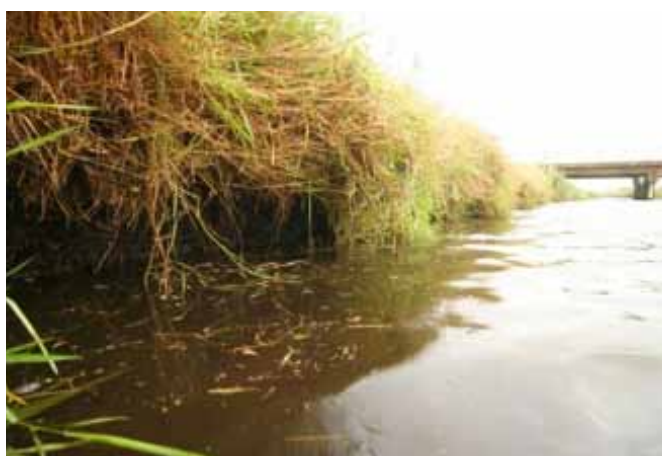
Undercutting erosion caused by wave erosion and discharge from adjacent pumping station outfall

The main issues at the site include erosion from an adjacent pumping station outfall created undercutting of the bank at the waterline and additional wave erosion from boat wash, in places up to 1m back from the original

margin. The erosion also prevented water voles from establishing their burrows and entry points to the channel due to the undercut and the absence of any marginal shelves. In addition, the undercutting erosion led to bank slippages.

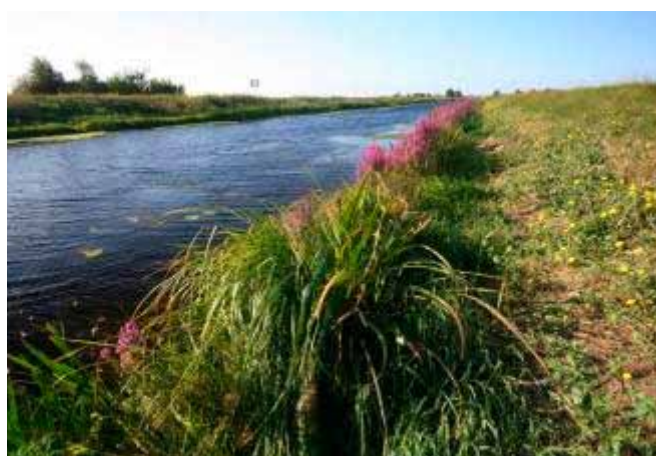
September 2009, seven months after installation, lesser pond sedge and purple loosestrife have developed strongly.

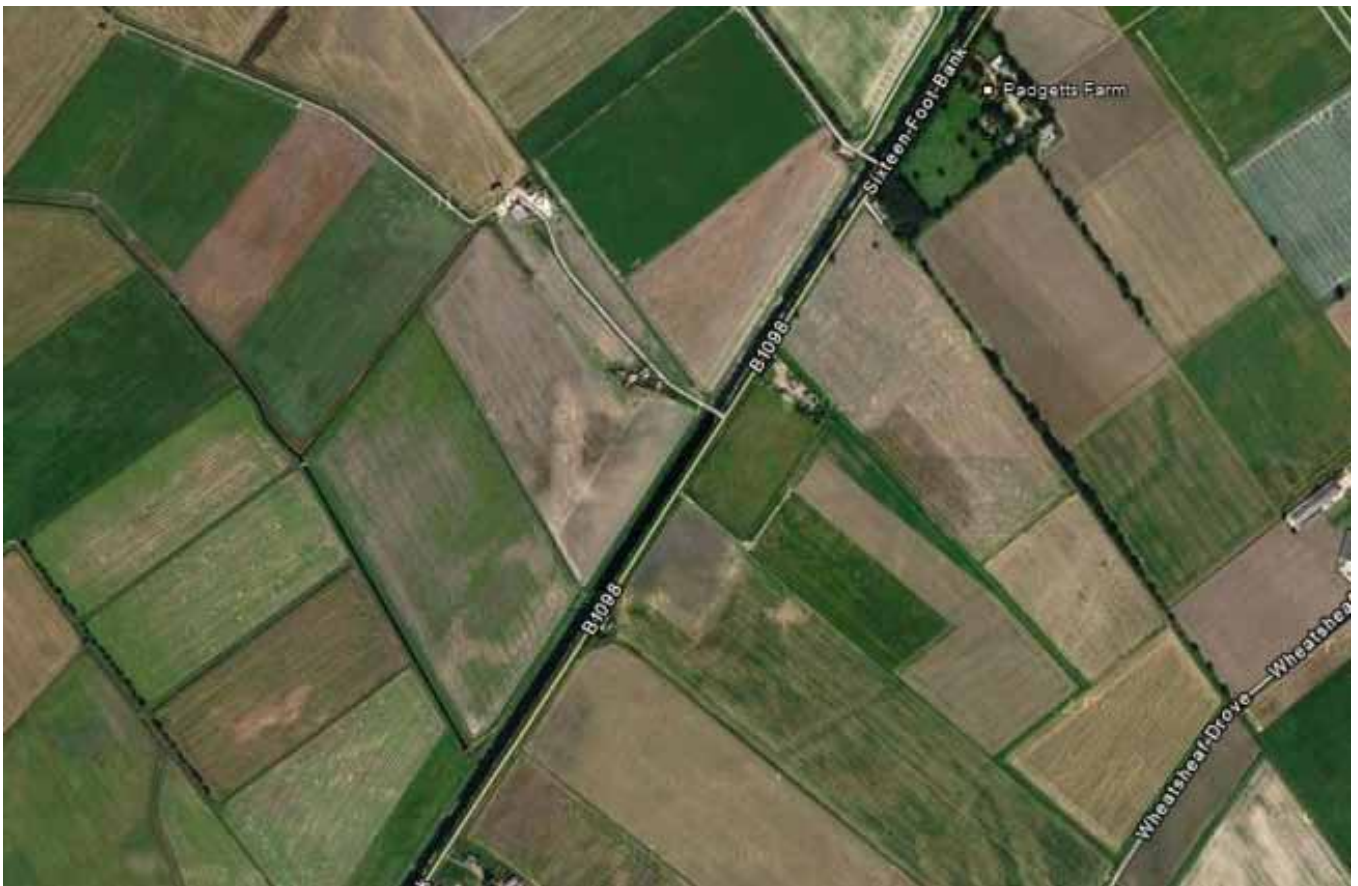
Aerial view of approximate area of works
© Mid Level IDB copyright and database rights 2013

- The undercut bank toe was pulled back approximately 1.5 m to create a ledge for the coir rolls to be laid on just above winter water level, which is about 0.25 m below summer water level (1 and 2). The rolls are half submerged during the summer growing period;
- The coir rolls were initially positioned on the ledge and secured with timber stakes approximately 1.5 m in length pushed in on either side with an excavator bucket. (3) The second inner row of posts were not required at future sites as it was found that they could be pinned against the bank with a single row of posts on the drain side. Future work was adapted to follow this second methodology;
- The coir rolls were held in a wide mesh and pre-established with a mix of native emergent plants (4).

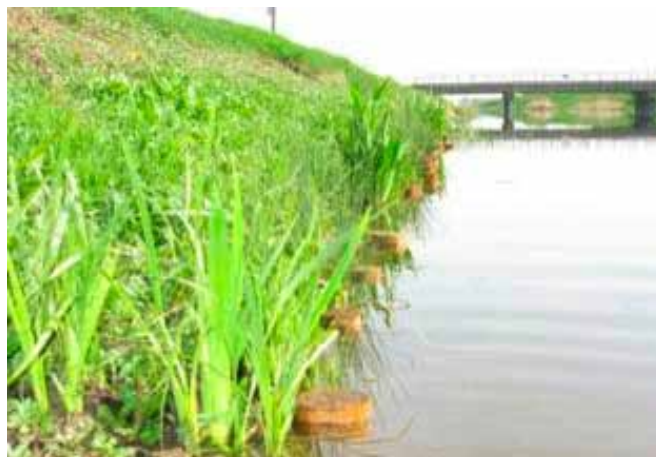
April 2009, three months after installation, yellow flag is the first plant to develop. Summer water level is now nearly covering the coir rolls.

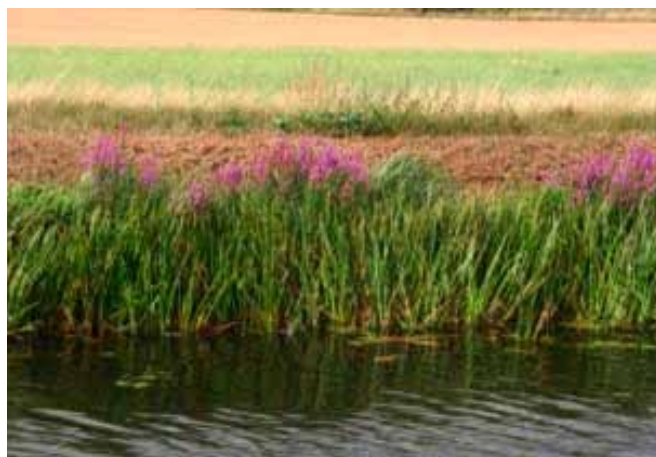
August 2011, new vegetation, branched bur-reed, has become established in front of the coir rolls ensuring the revetment process are naturally regenerating.
