Title: Cottenham Lode bank repairs

Location: Rampton, Cambridgeshire, England

Technique: Bank reprofiling

Dates: April 2013

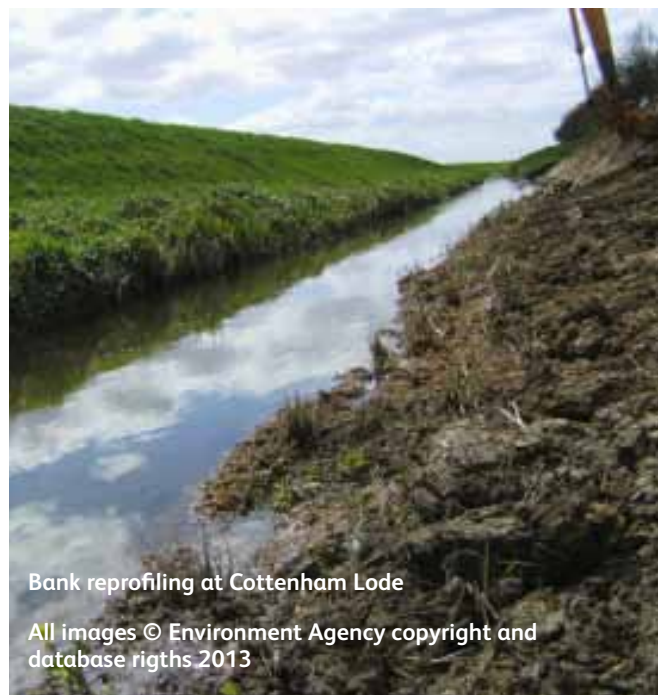
Bank reprofiling at Cottenham Lode

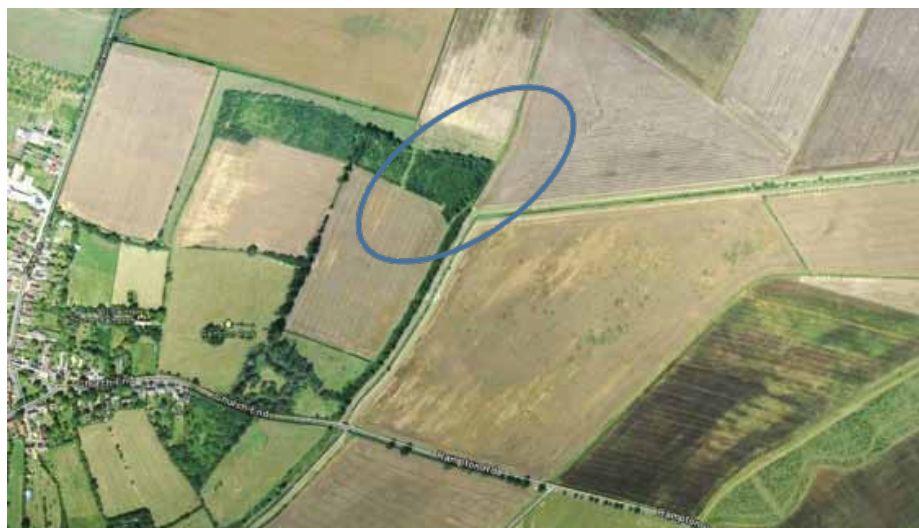
Overview of straightened and impounded project site

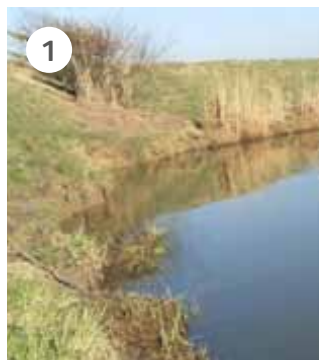
The left bank in the Cottenham Lode was failing the required asset condition. The Environment Agency's Asset Performance and Operations team were therefore tasked with identifying suitable measures to reinstate the bank (approximately 60 m in length) to its correct asset condition to provide adequate flood protection.

1) Failing bank at Cottenham, before scheme implementation
2) Installation of "soft" bank protection

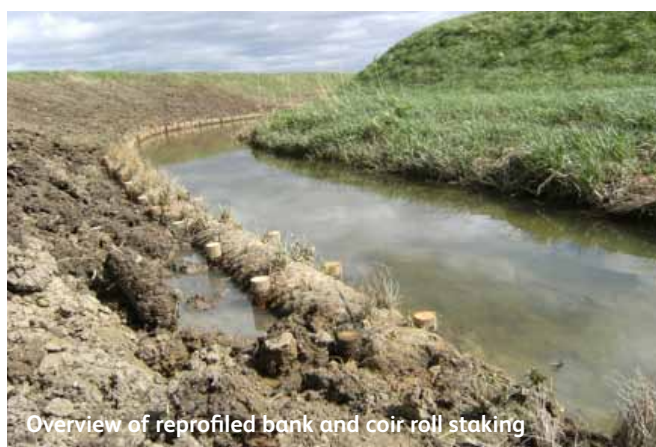
Overview of reprofiled bank and coir roll staking

- Reprofilng of river banks.
- Creation of a new berm along the left bank.
- Use of soft engineering techniques, namely a combination of pre-established coir rolls and matting.
- Installation of piping to allow water voles to gain access to burrow entrance.
