# AGGREGATES EXPLOITATION IN MATI RIVER, A HUMAN PRESSURE WITH CONSEQUENCES ON THE BED'S MORPHOLOGY, ASSESSMENT OF CHANGES.

Adrian Dhimitri<sup>1</sup>, Raimonda Londo<sup>1</sup>, Vladimir Kola<sup>1</sup>

<sup>1</sup>Geological Survey of Albania, Department of Hydrogeology, [dhimitriadrian@yahoo.com](mailto:dhimitriadrian@yahoo.com)

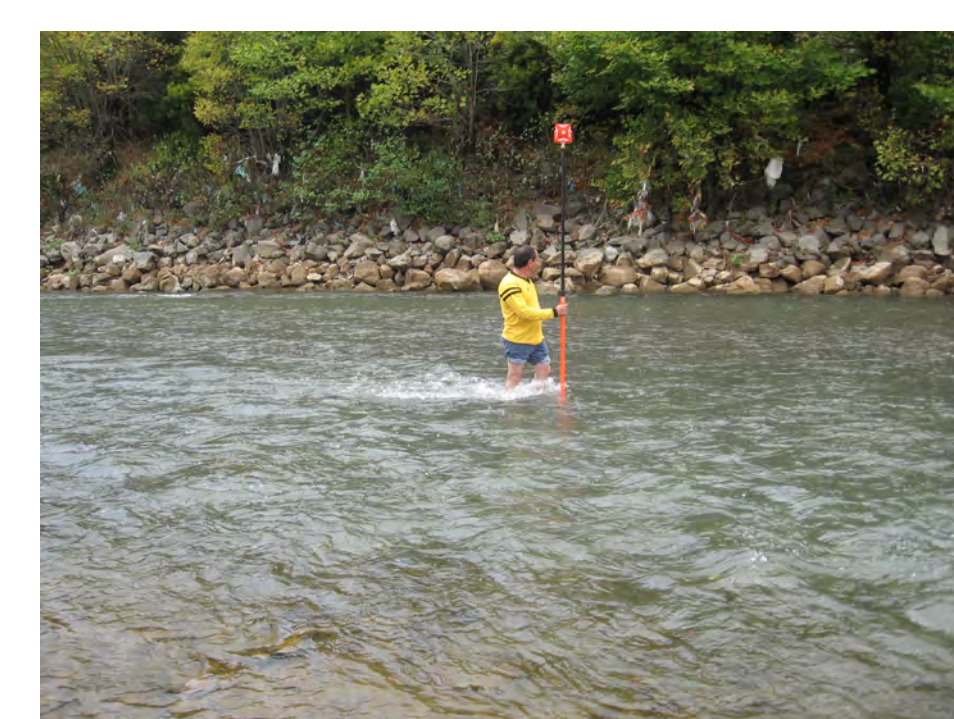
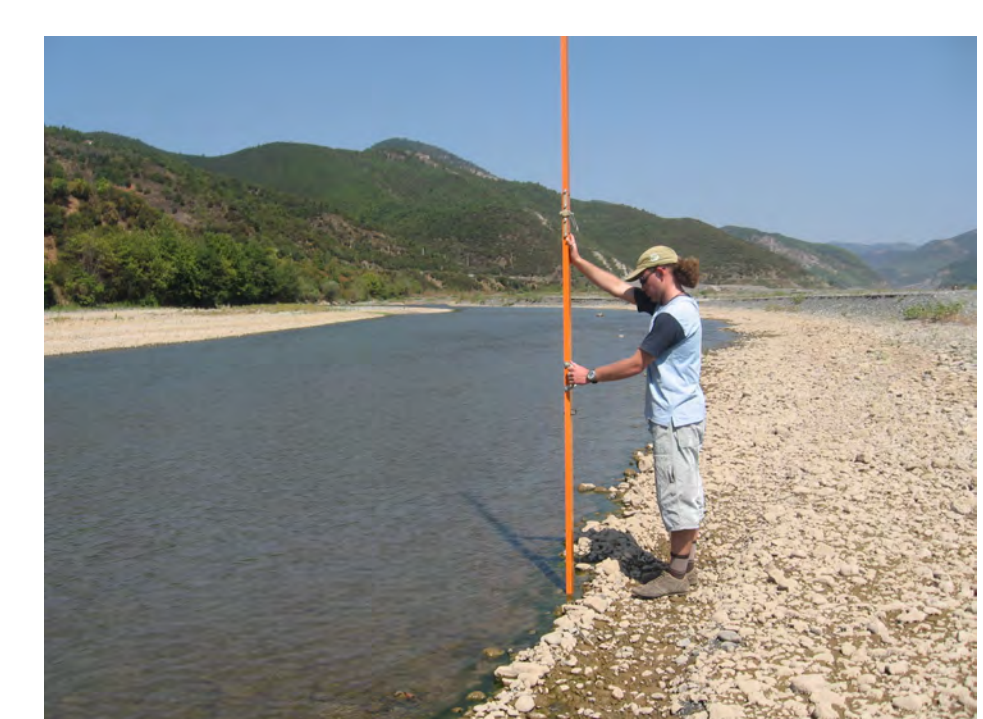
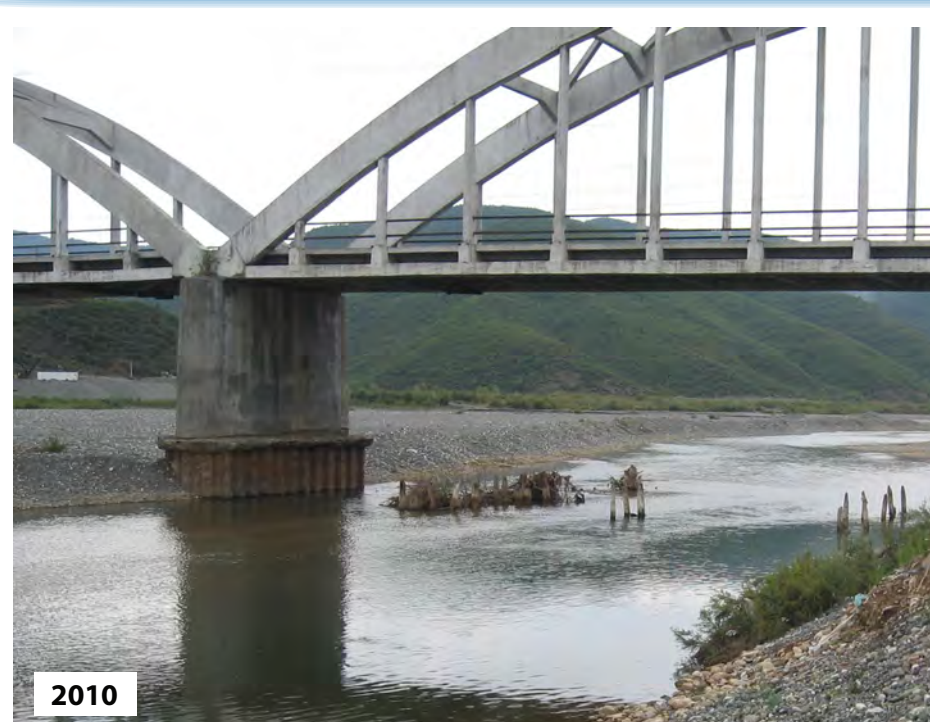
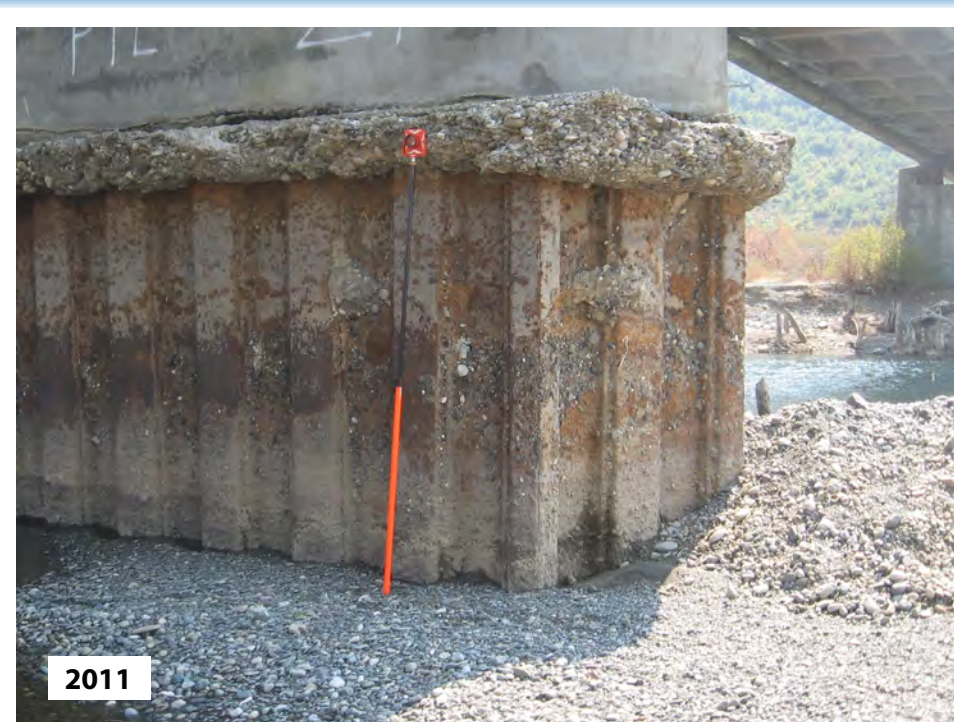
Views from Zogu Bridge section

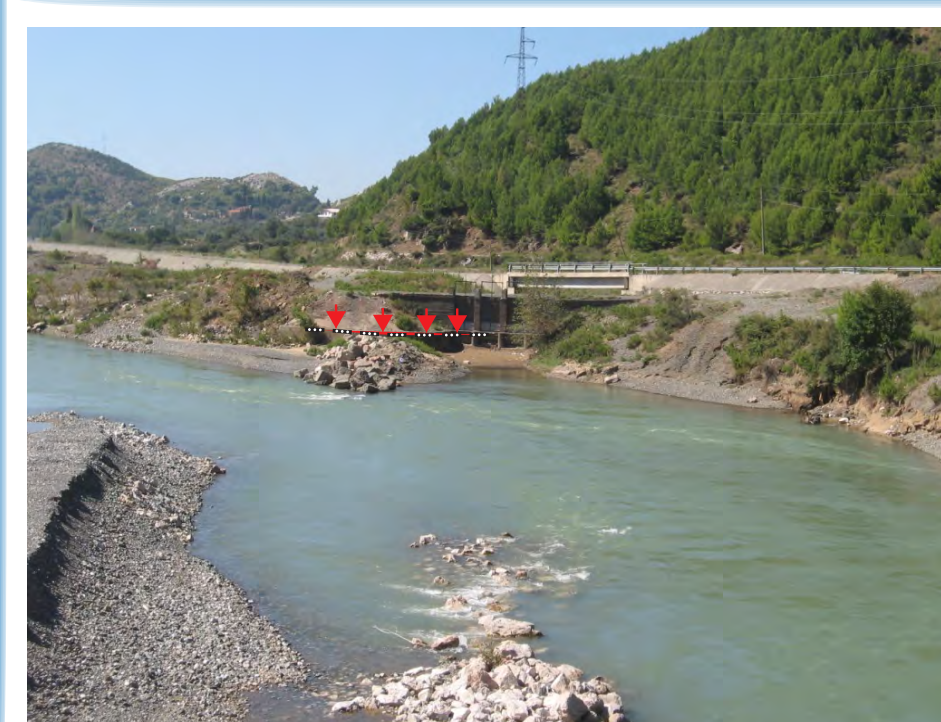
Irrigation Infrastructure on Mati river out of work
