# **The River Restoration Work at the River Petersbach**

## **A small sized River in the Urban Area of Vienna; Austria**

Gerda Holzapfel, Hans Peter Rauch, Gernot Pfannhauser, Philipp Weihs

Institute of Soil Bioengineering and Landscape Construction and Institute of Meteorology,  
University of Natural Resources and Life Science, 1190 Vienna, Austria

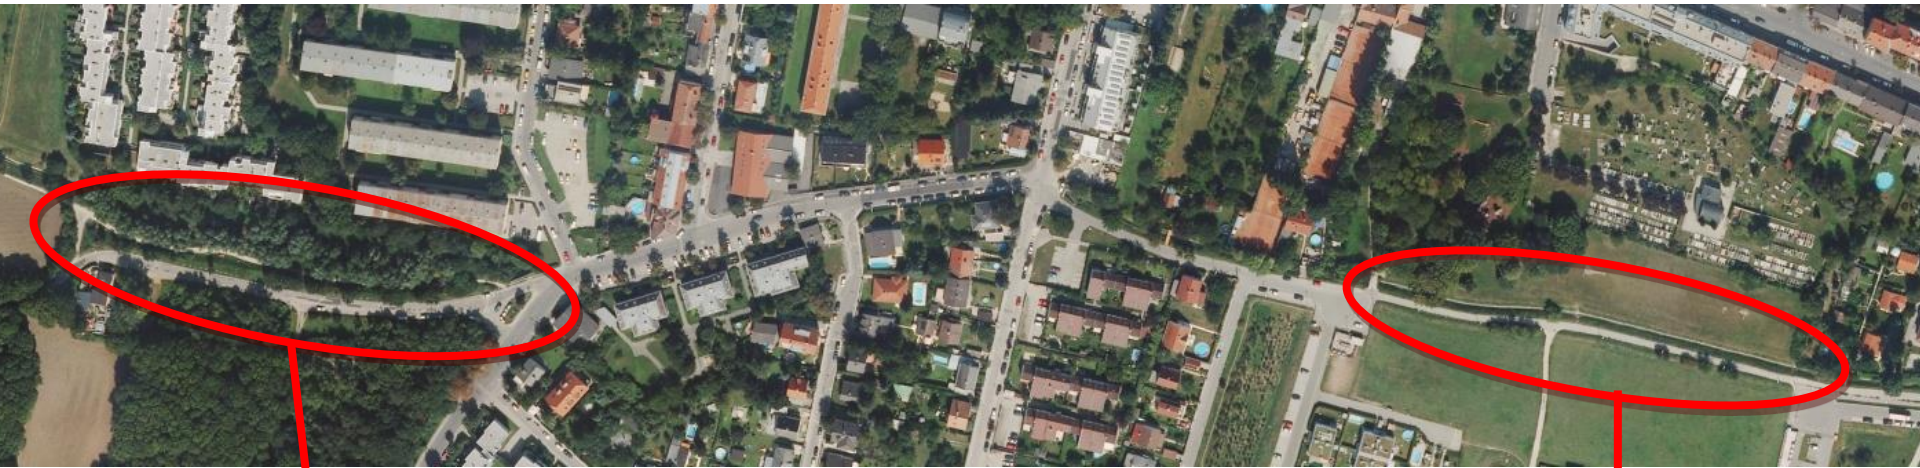
**AREA 1 (2001/2002)**  
**179 m**

**AREA 2 (2012)**  
**189 m**

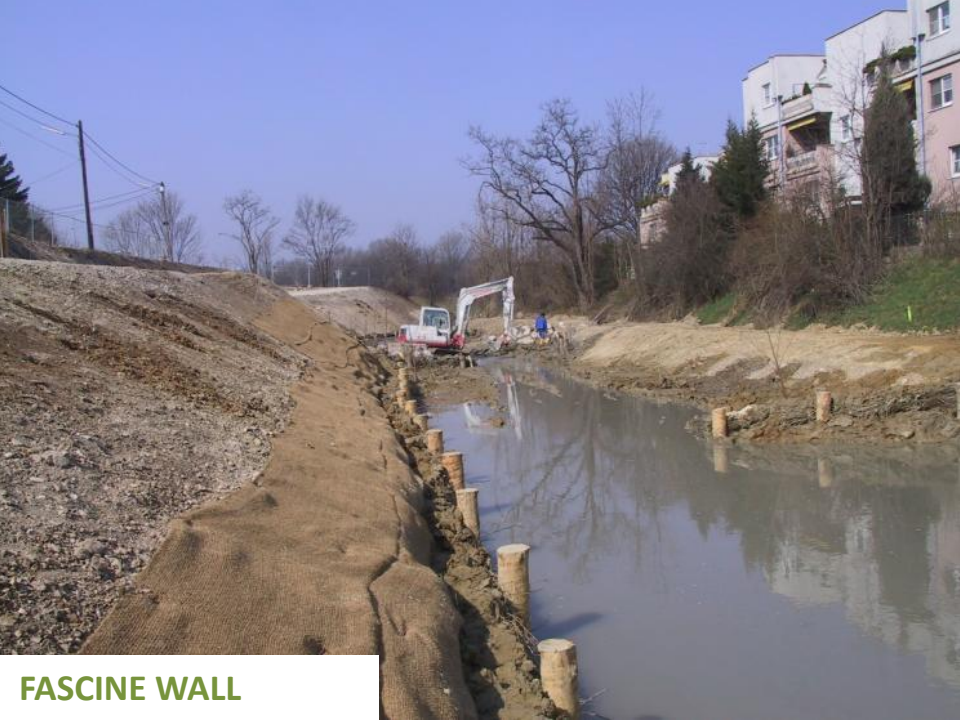
FASCINE WALL

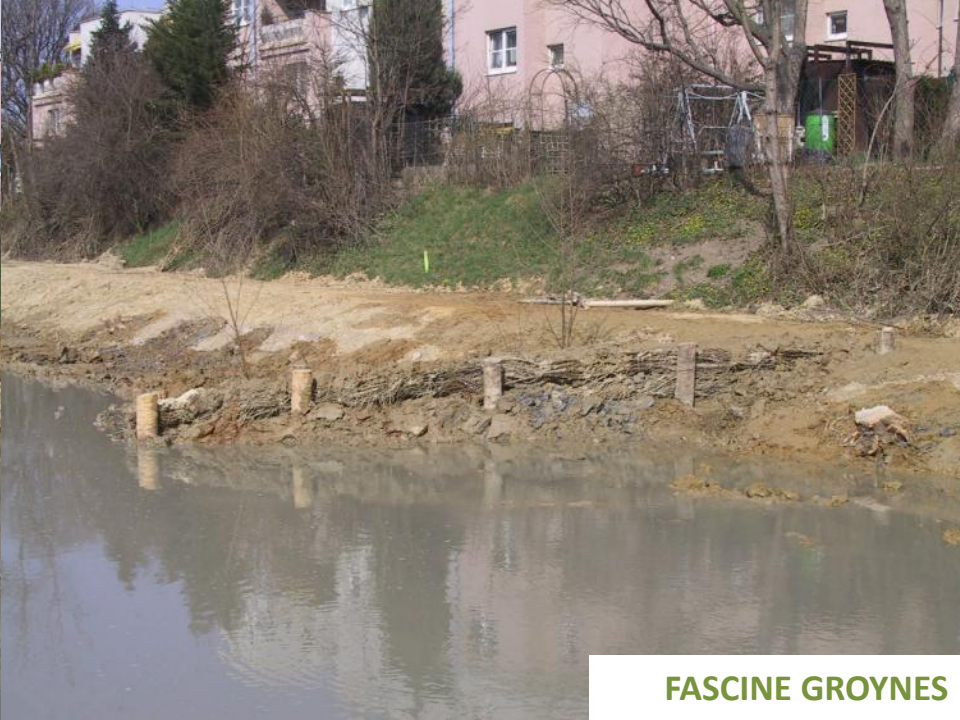
FASCINE GROYNES

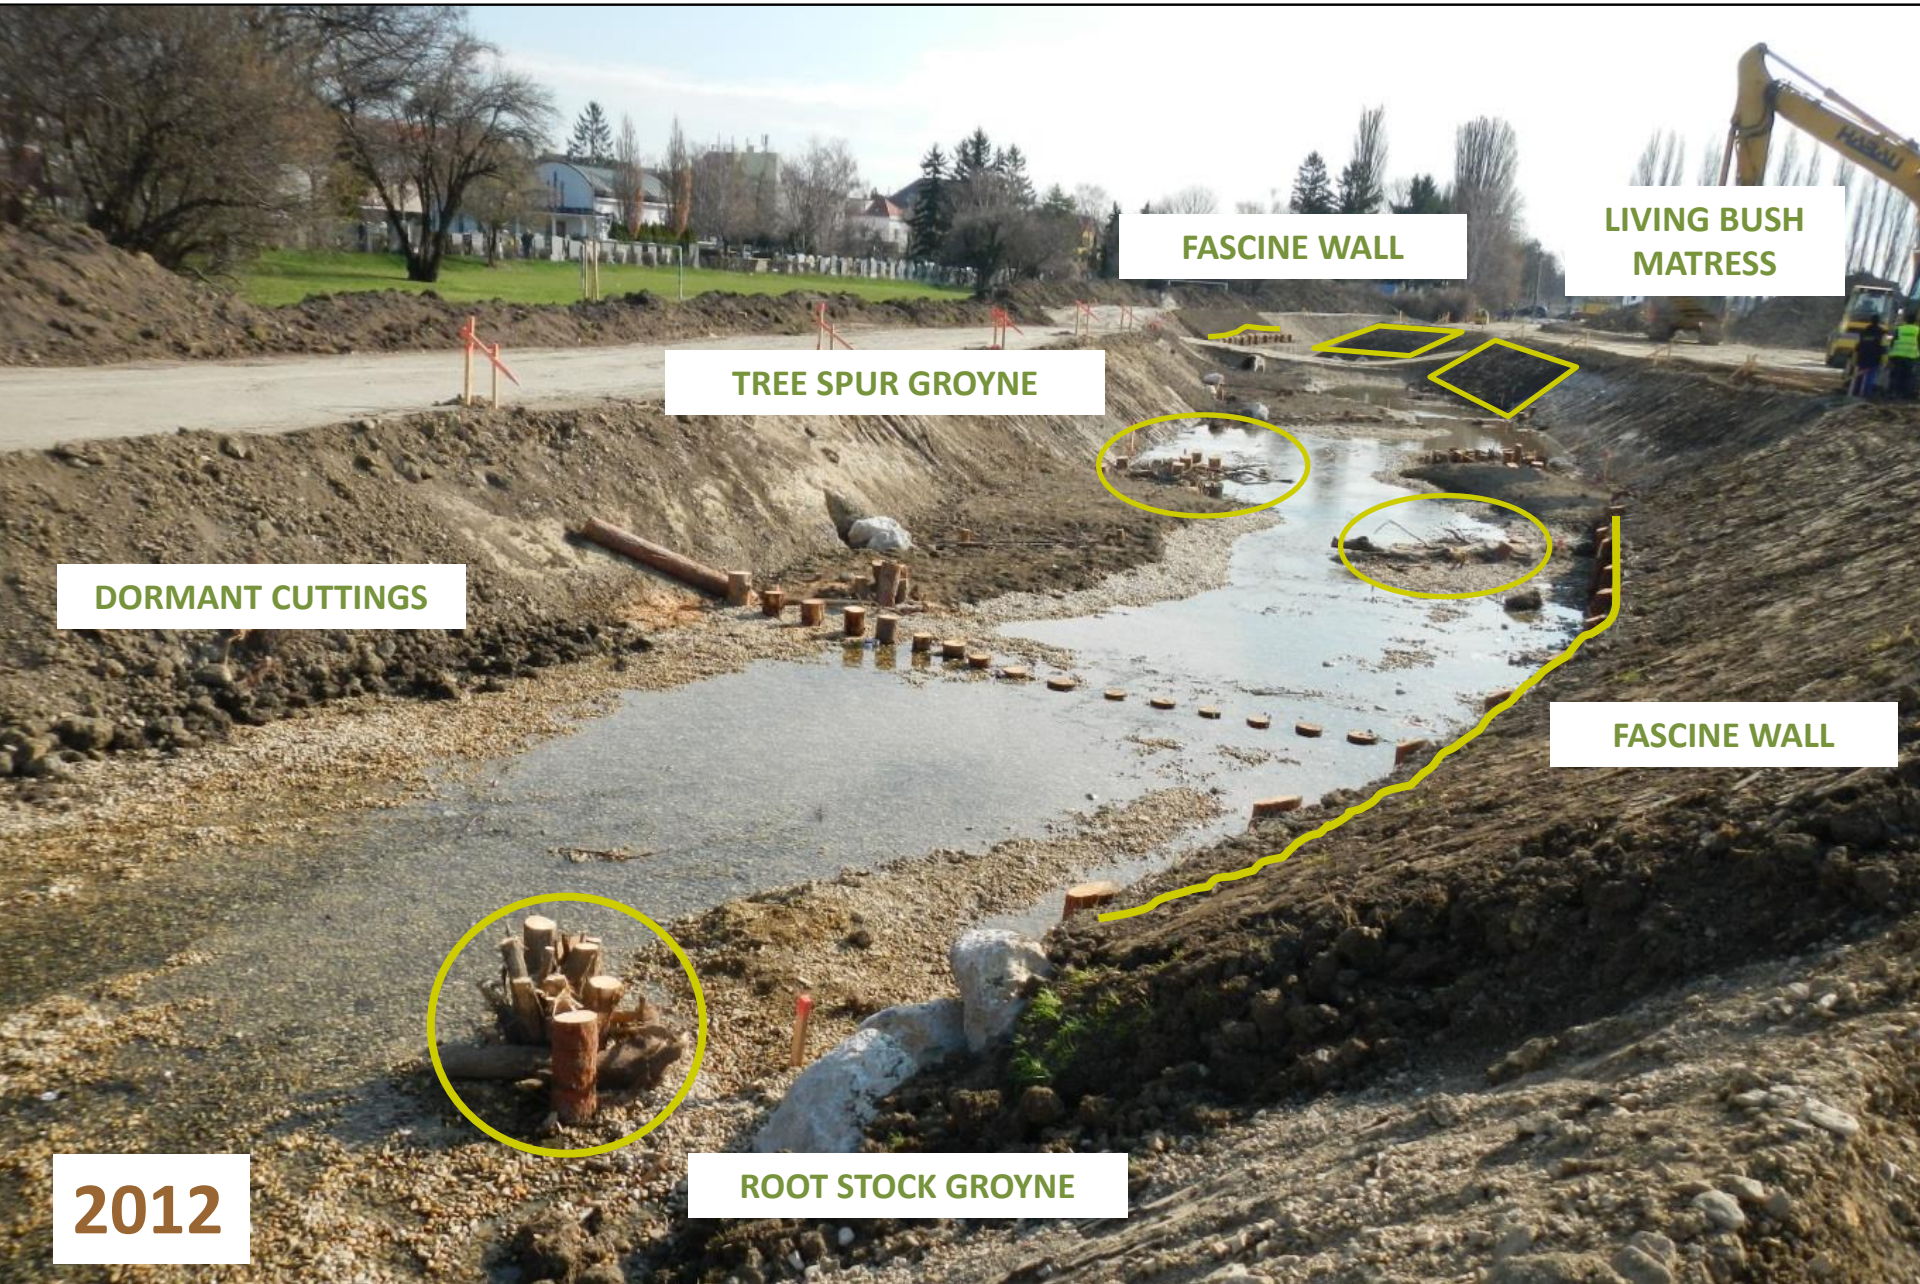
FASCINE WALL

LIVING BUSH  
MATRESS

TREE SPUR GROYPE

DORMANT CUTTINGS

ROOT STOCK GROYPE

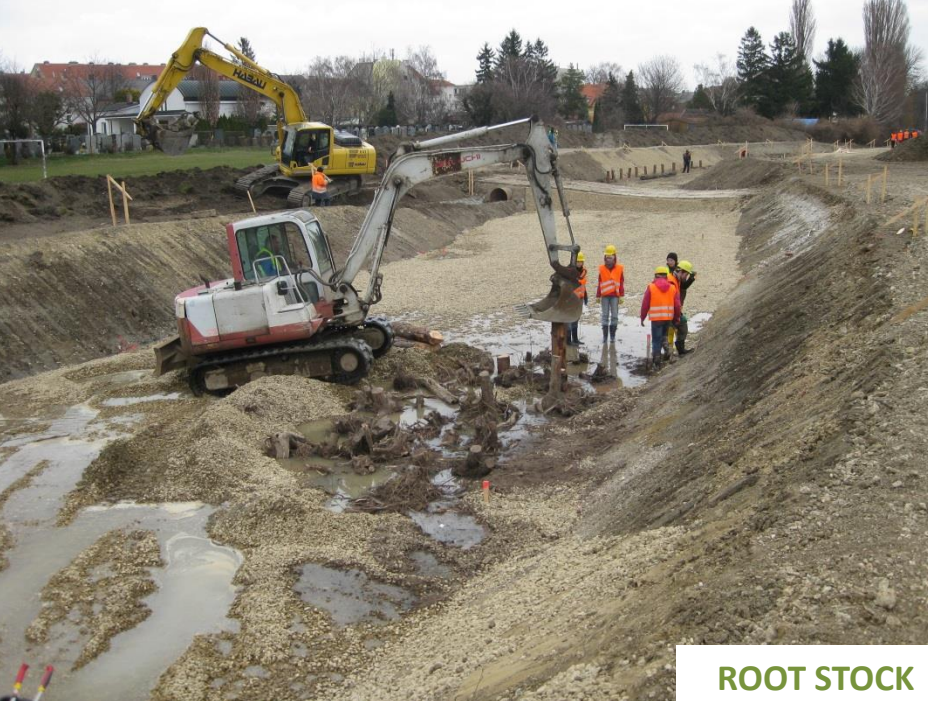
ROOT STOCK

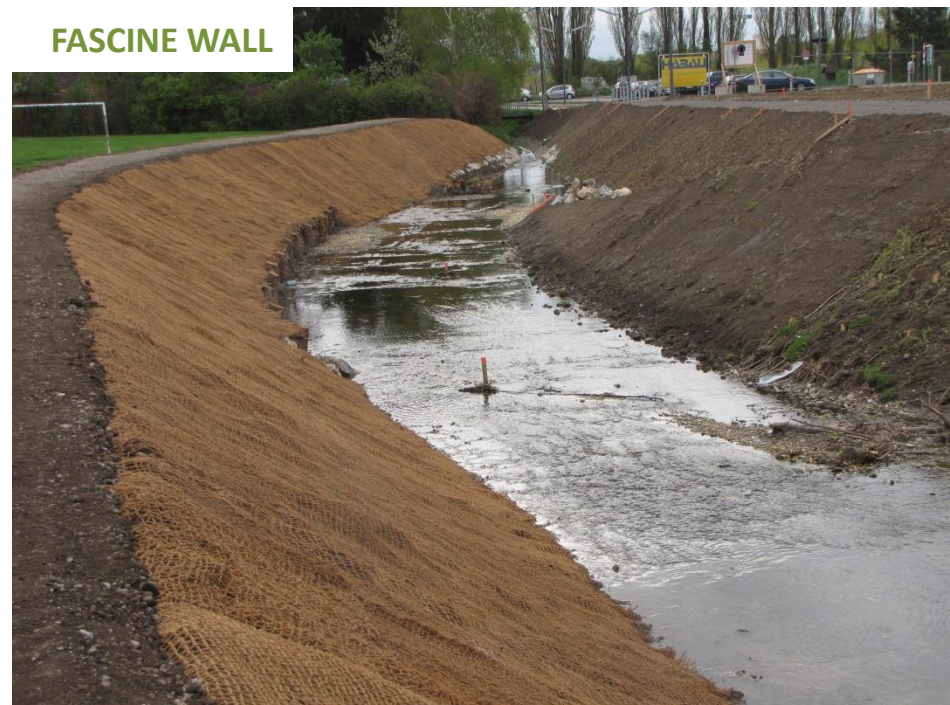
FASCINE WALL

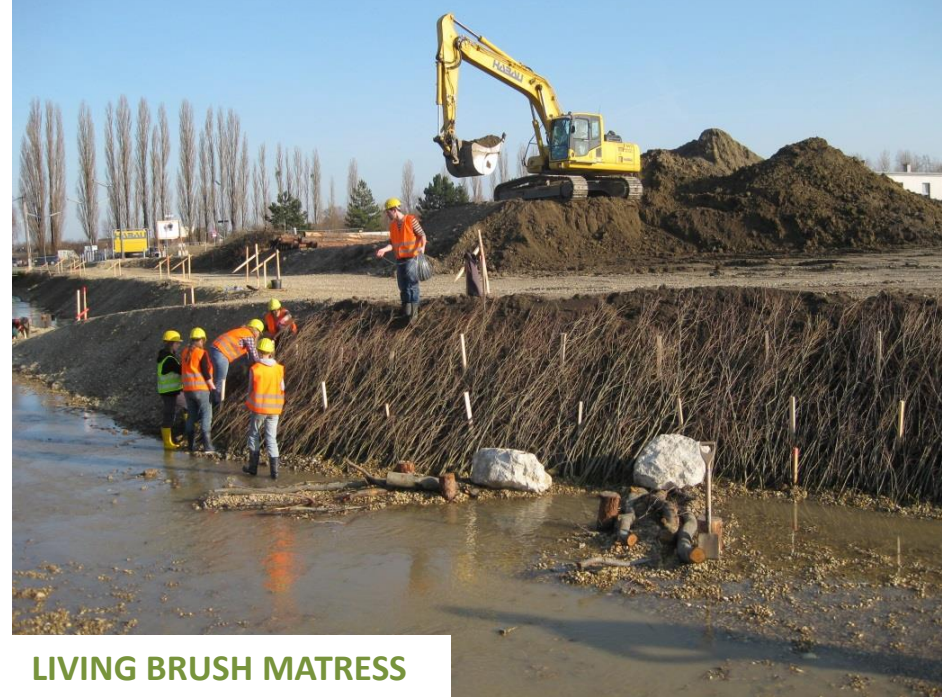
LIVING BRUSH MATRESS

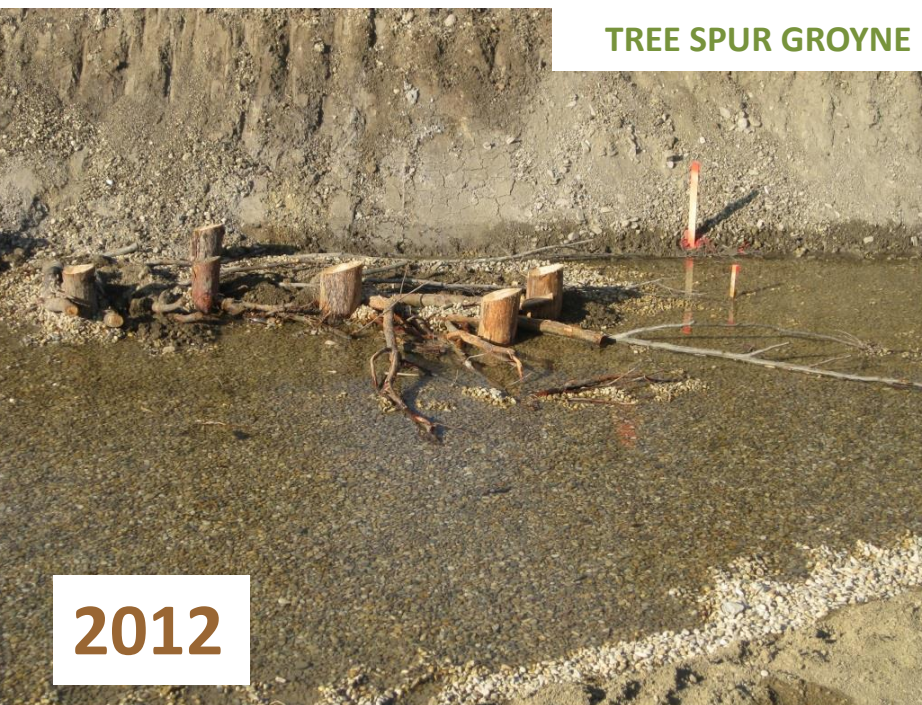
TREE SPUR GROYPE

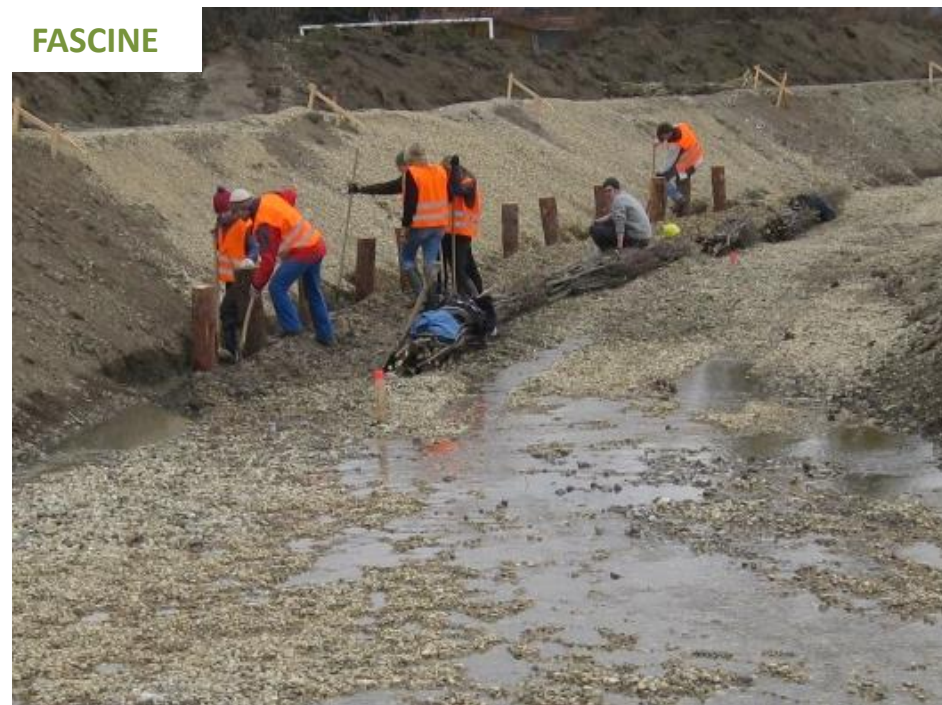
FASCINE

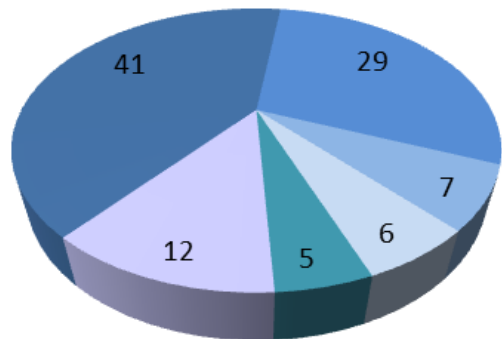
- Salix alba
- Alnus glutinosa
- Robinia pseudoacacia
- Populus nigra
- Acer campestre
- Other

- tree layer 1
- tree layer 2
- shrub layer

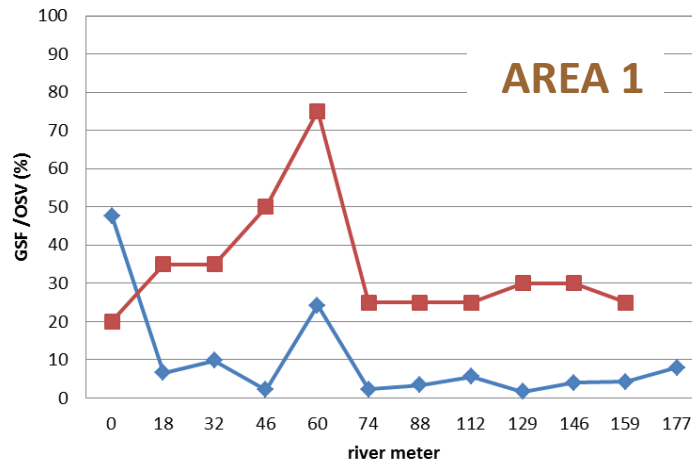
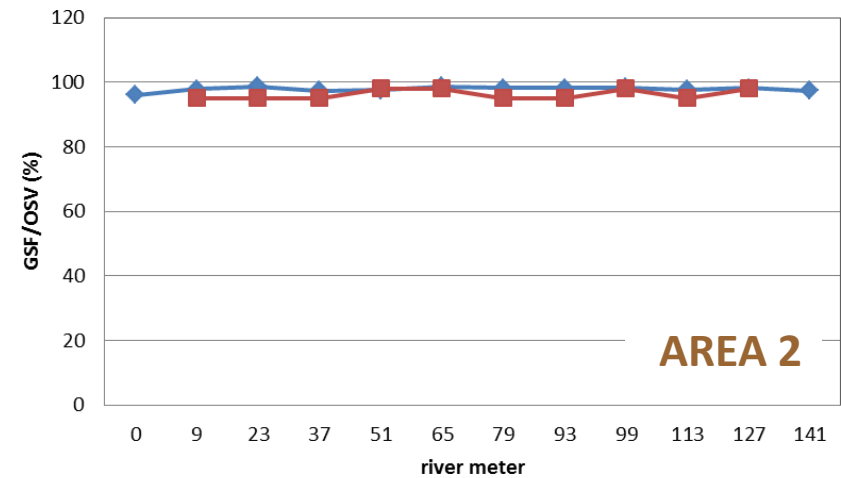
# Global Site Factor /Open Sky View

◆ Global Site Factor  
■ Open Sky View

AREA 1	AREA 2
Ø HEIGHT (m)	10	3-4
Ø CROWN DIAMETER (m)	4	
Ø BHD cm	16	2,8
COUNT SHOOTS/STEMS	366	1235
COUNT SPECIES	19	2
SHOOTS/STEMS per METER	2	6,5
Ø GSF (%)	10	98

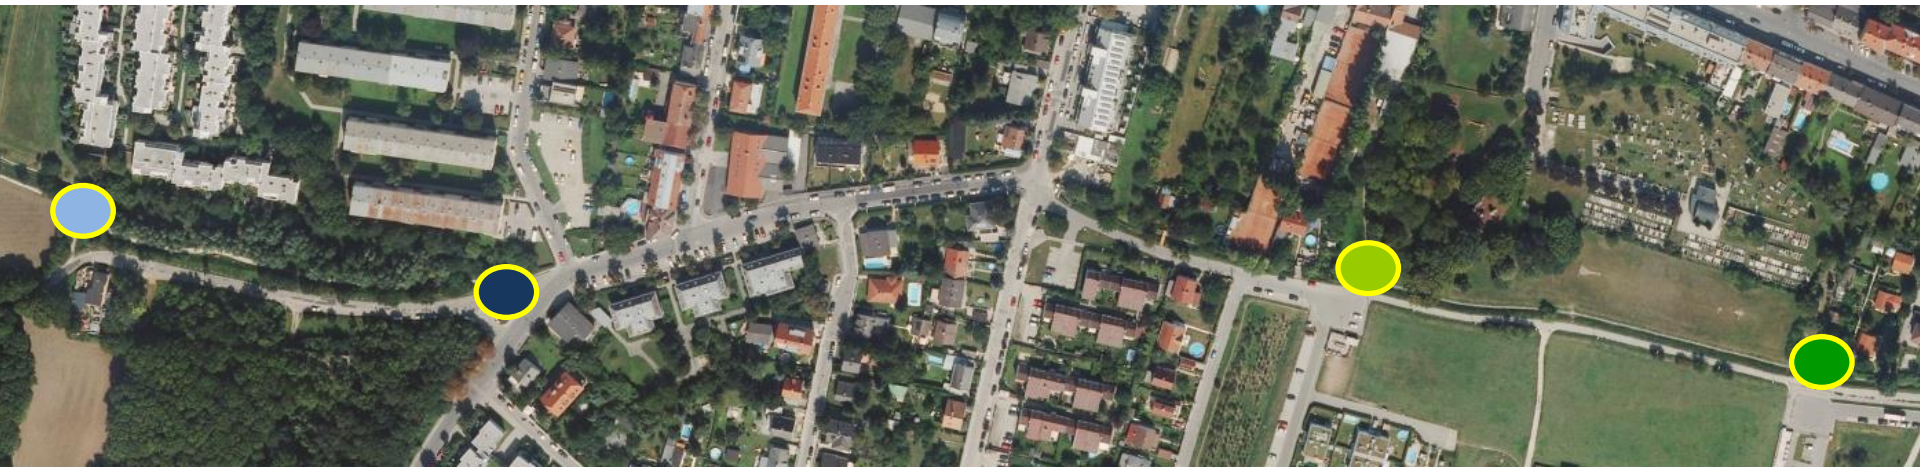
28.7.2013

AT	35,7
A1S	26,2
A1E	24,8
A2S	24,8
A2E	32,9

°C

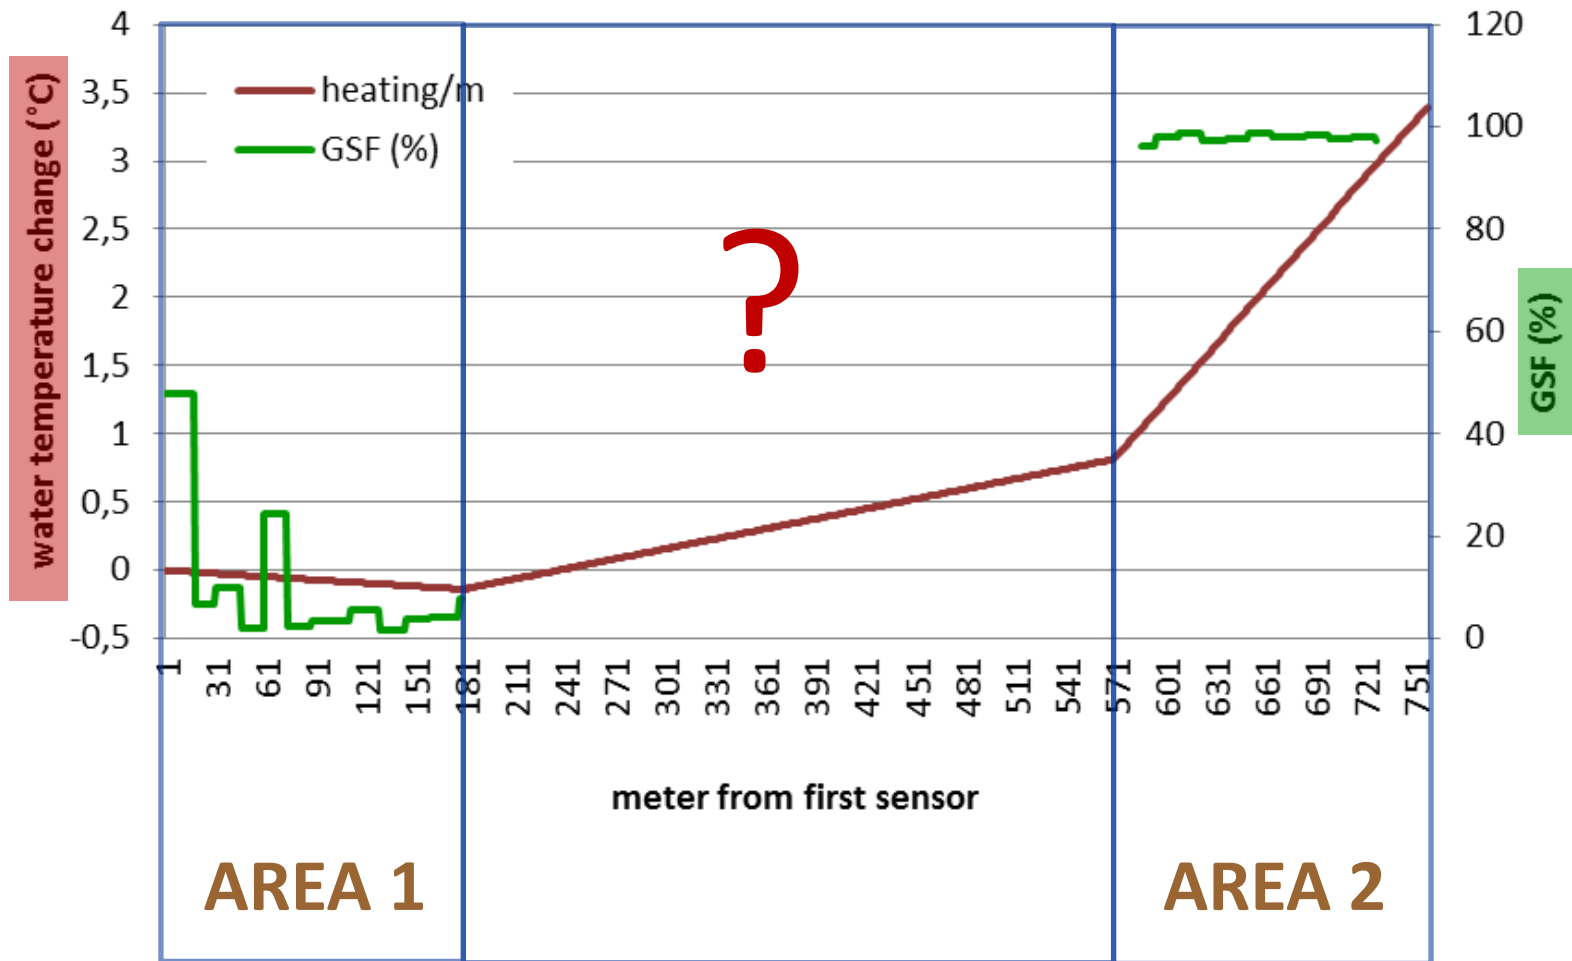
# WATER TEMPERATURE

(18.7.2013-8.8.2013)

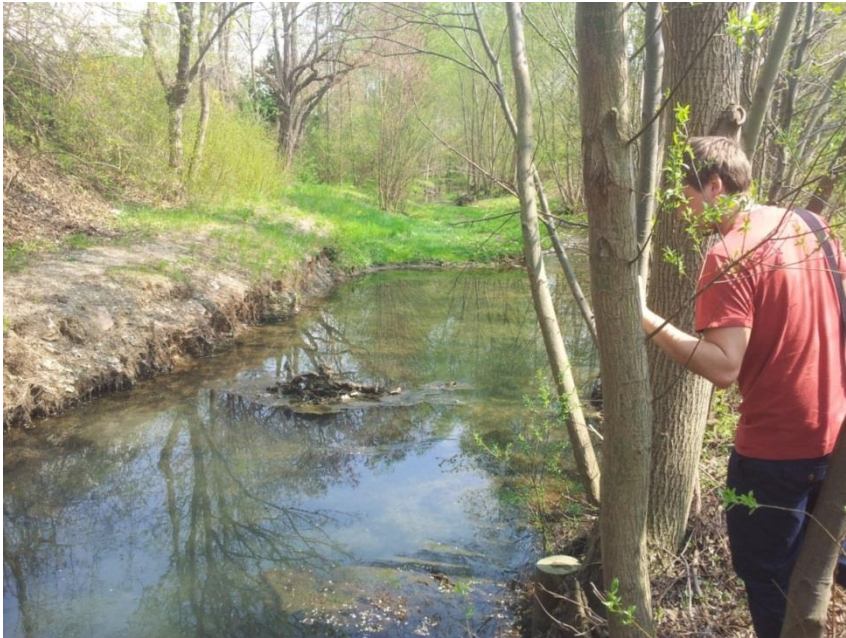
Shaded area 1 – no/few algae

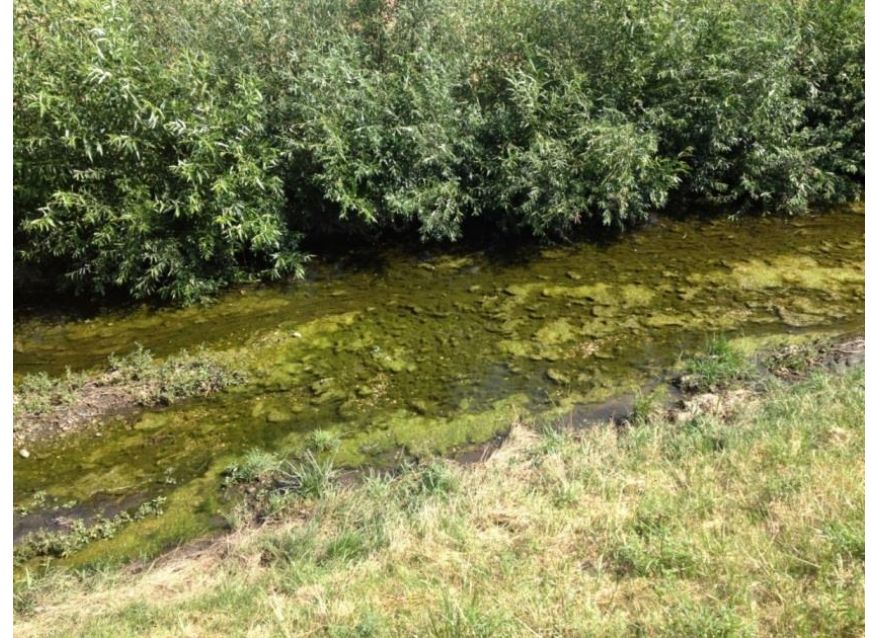
Unshaded area 2 – algae
