Demonstrated use of the RESTORE / ECRR RiverWiki

28.11.2014

Finnish Environment Institute SYKE /ECRR

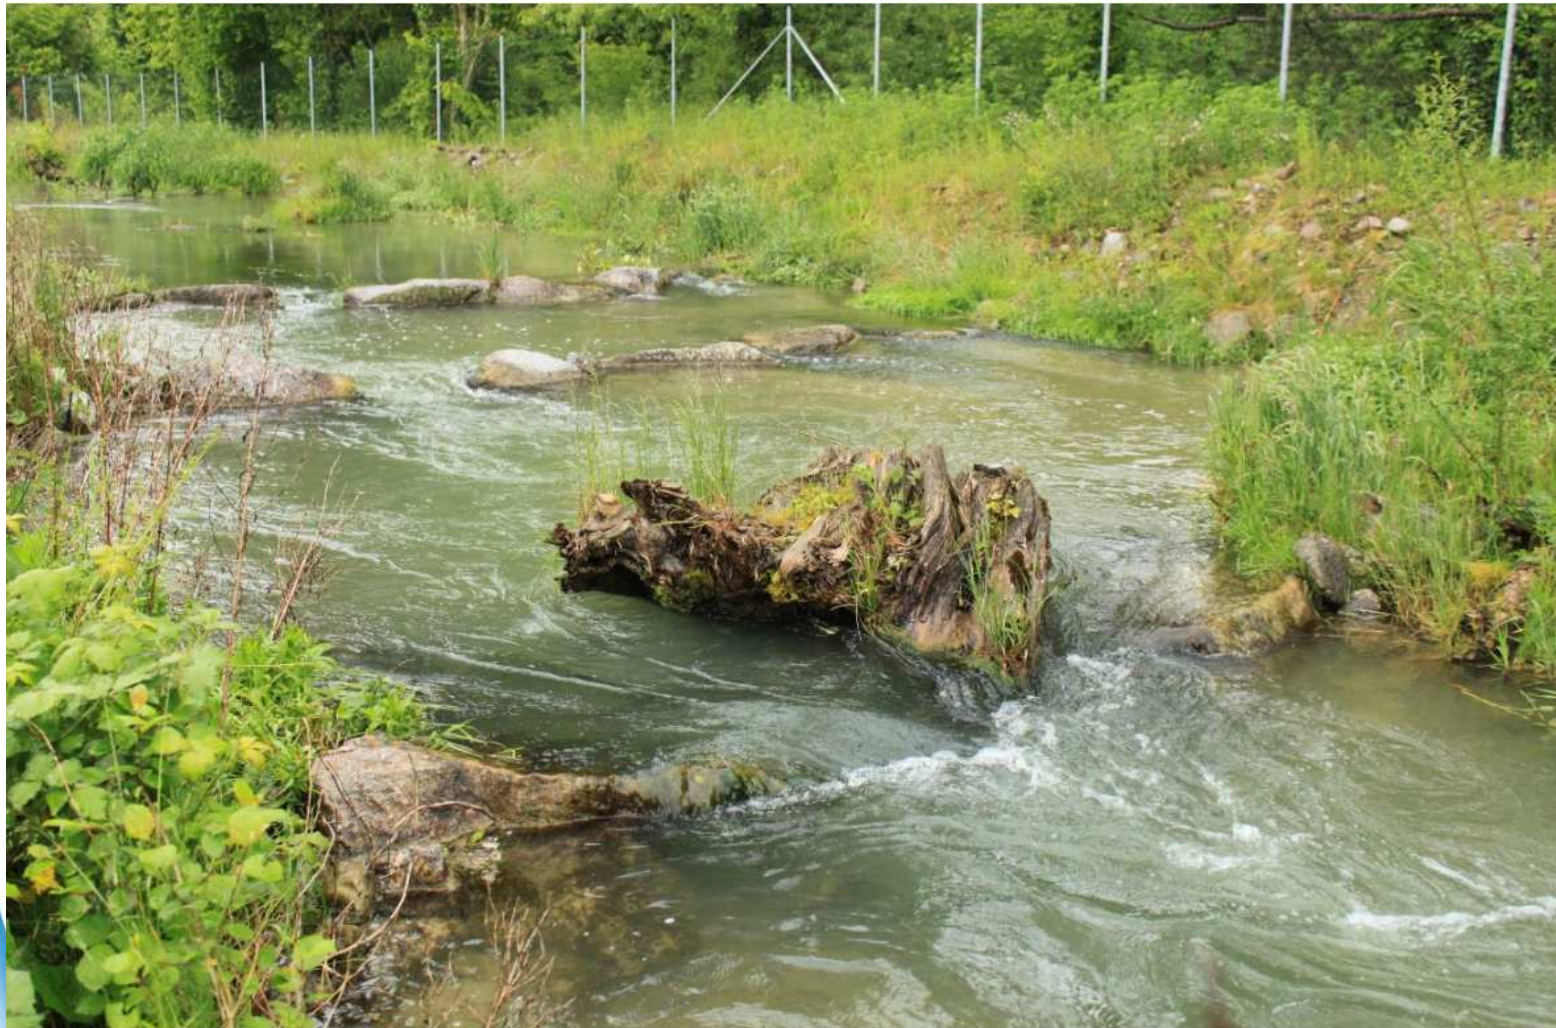
Photos of new approaches: Habitats in connection with the fish pass

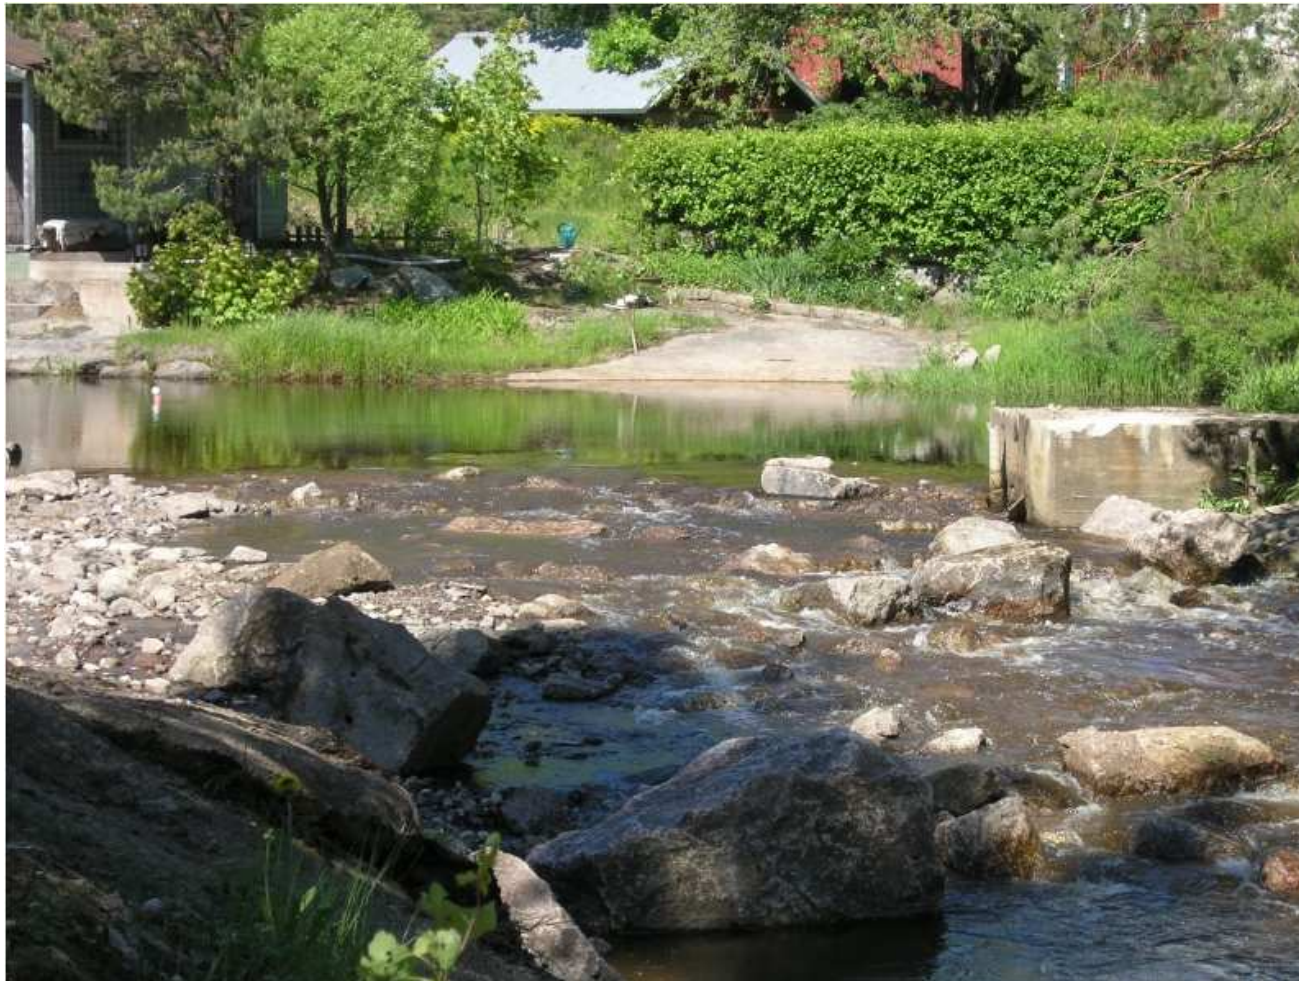
After: Accesable for Sea trout from Russia, new habitats
