# Building Stakeholder Engagement For Informed River Restoration and Catchment Management

Ruairí Ó Conchúir, MulkearLIFE / Inland Fisheries Ireland

ERRC Conference, Vienna, Austria  
29<sup>th</sup> October 2014

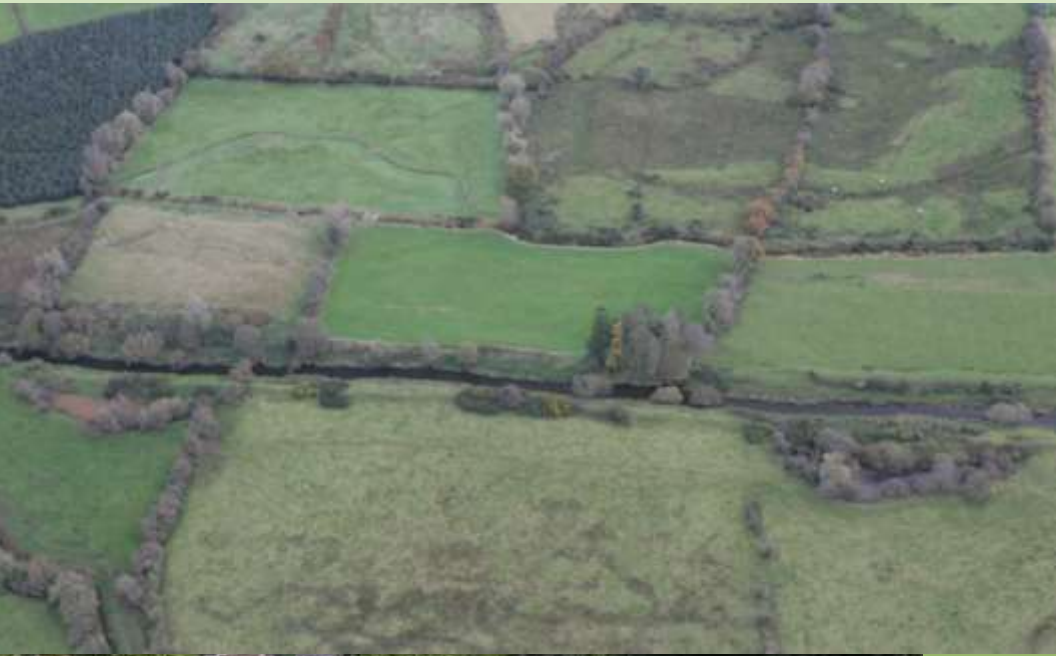
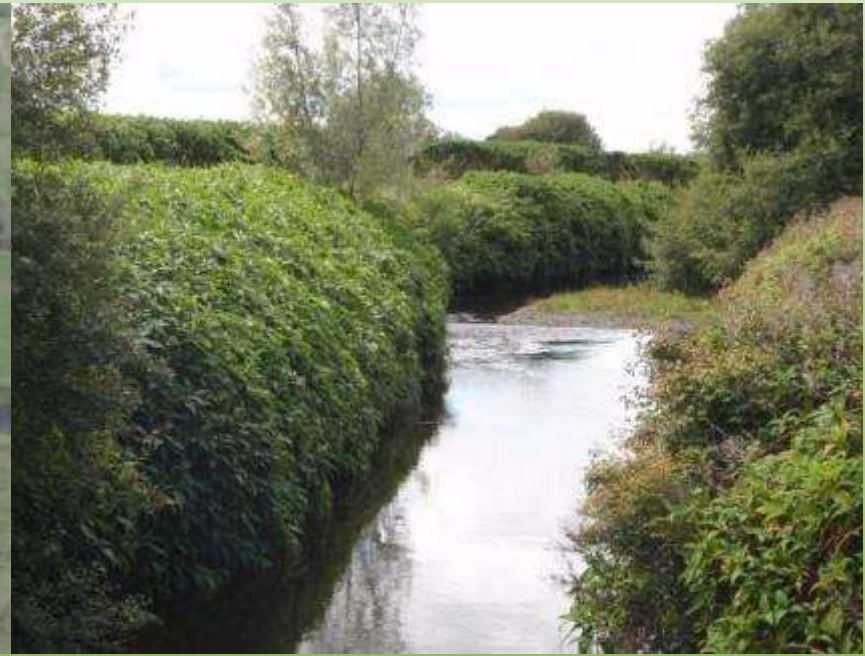
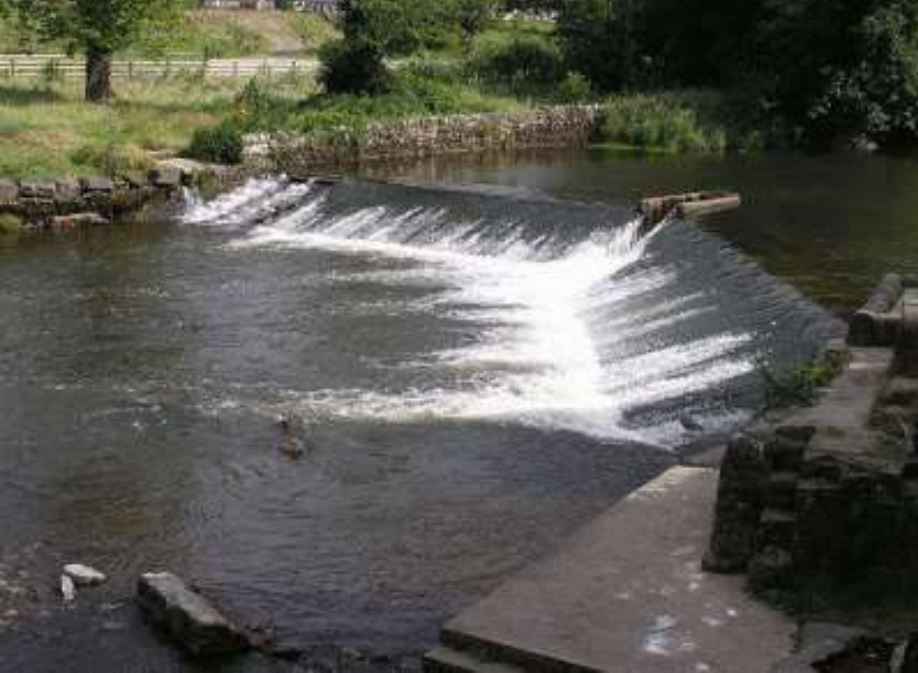
# Main Threats MulkearLIFE is Addressing

- **Long History of Land Drainage**
  - 1874 Mulkear Drainage District
  - 1942 OPW Scheme
  - 1997 OPW scheme
- **Invasive Species**
- **Barriers to Migration**
- **Water Quality Concerns**

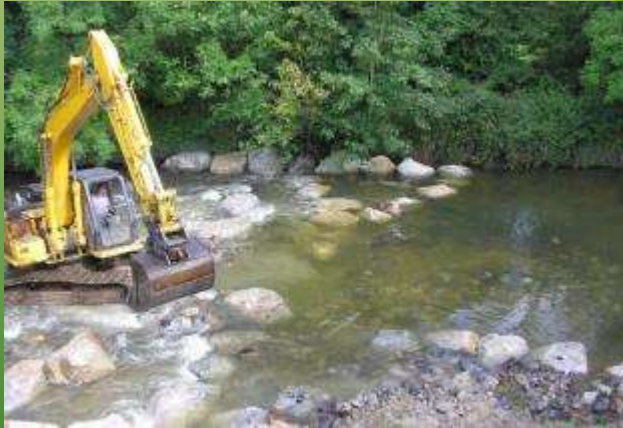
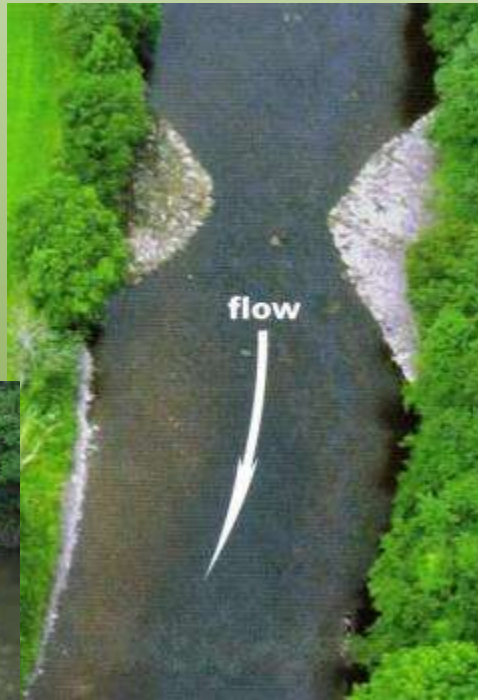
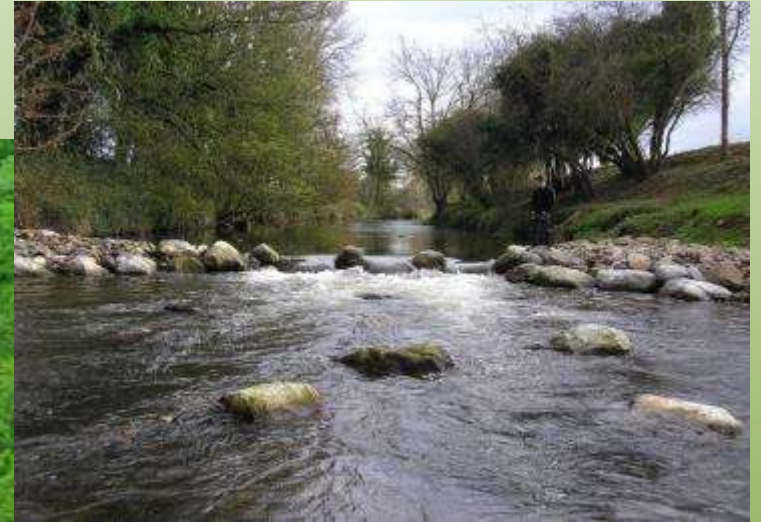
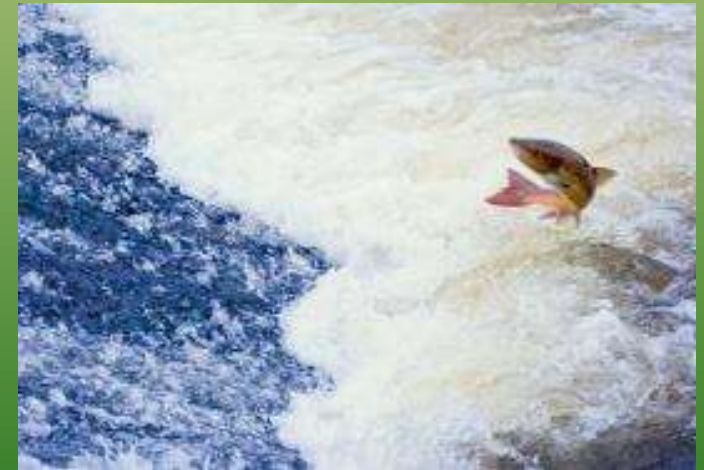
# River restoration for Salmon - Mulkear River

- Benefit: Salmon, Sea Lamprey and Otters

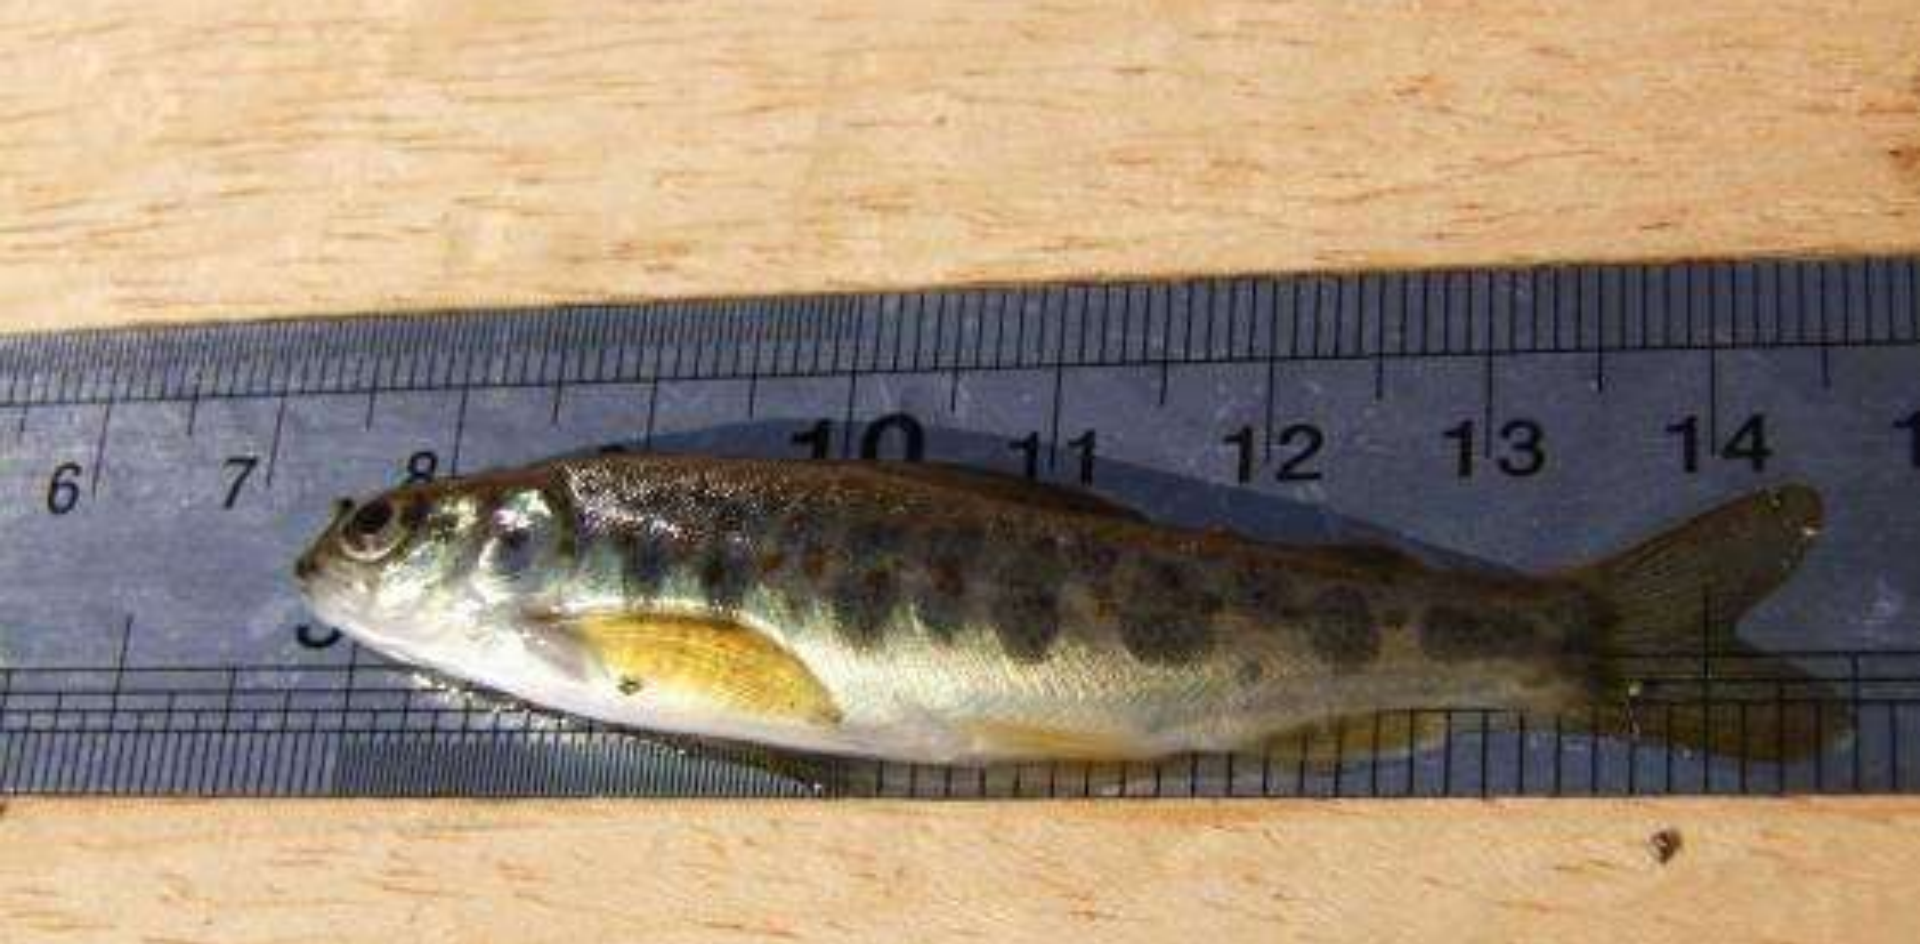
**Rubble Mat Construction is primarily designed to improve habitat for salmonids**

- Average salmon parr density has tripled

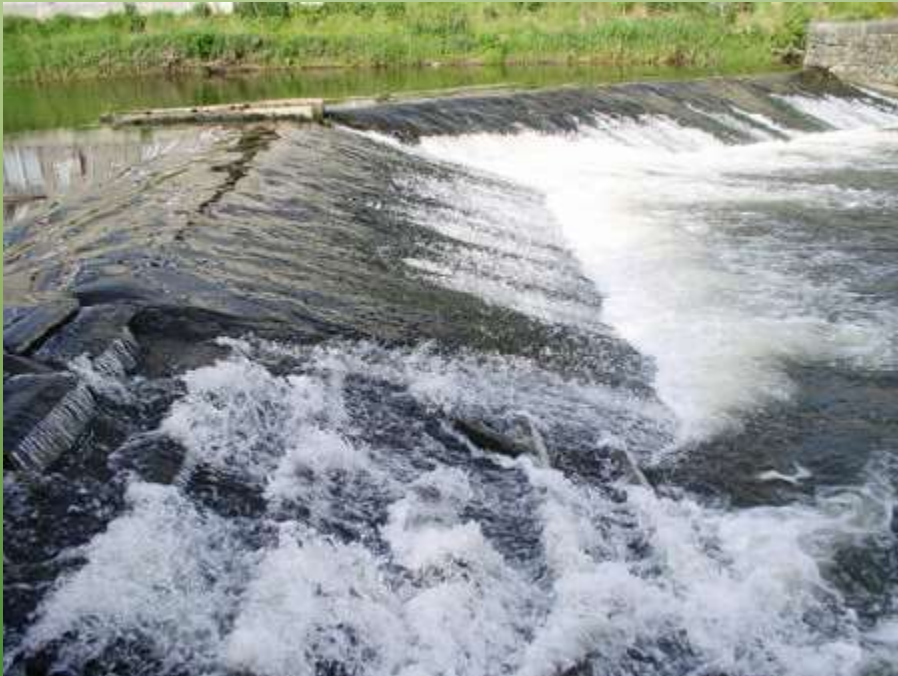
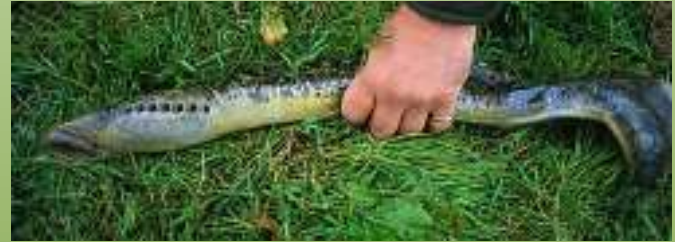
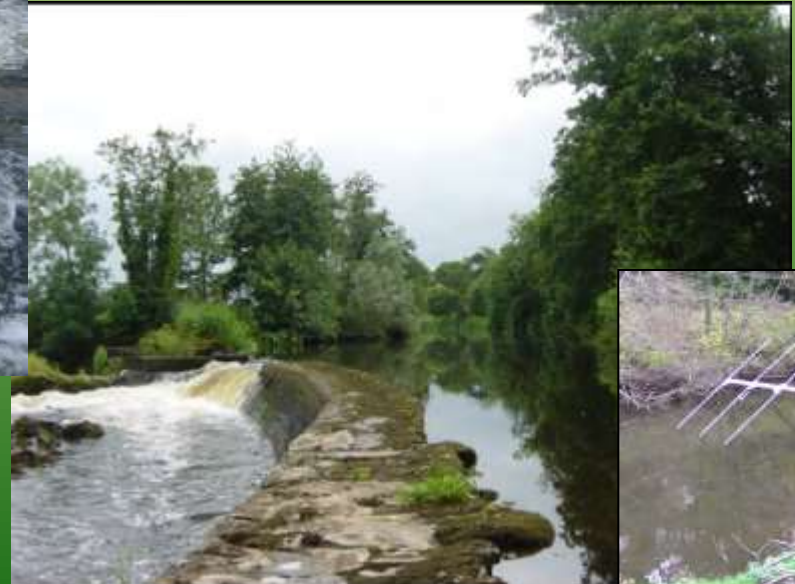
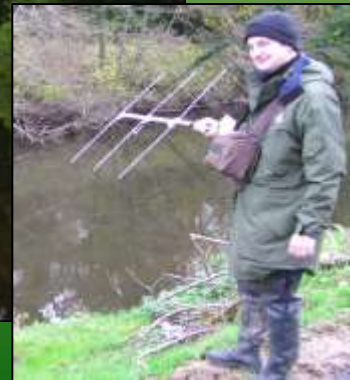
# Work Focus - Sea Lamprey Passage

- Easement of Sea Lamprey passage over weirs

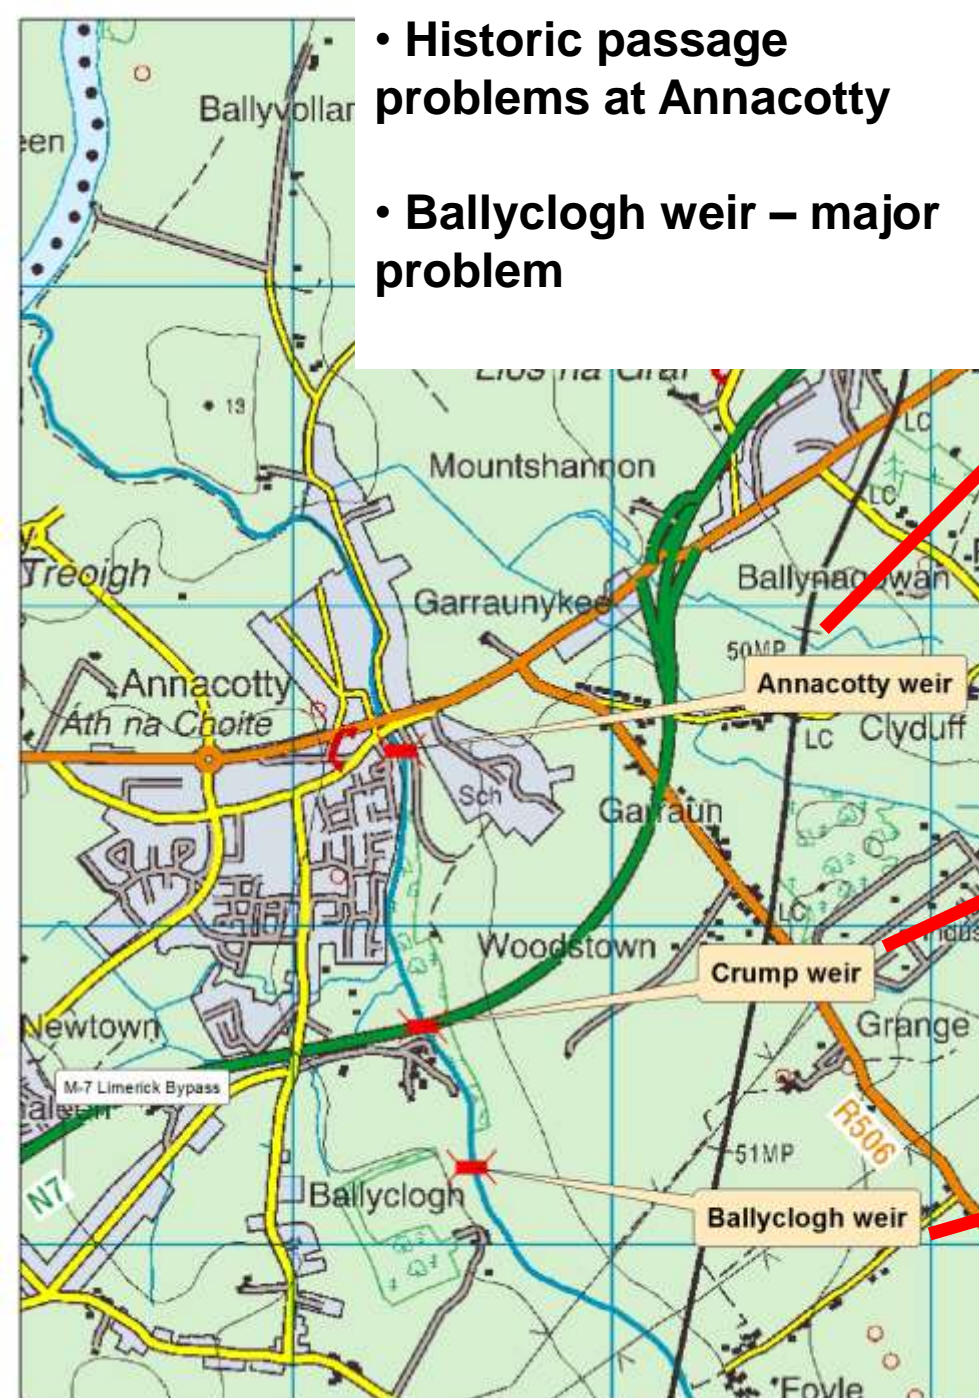
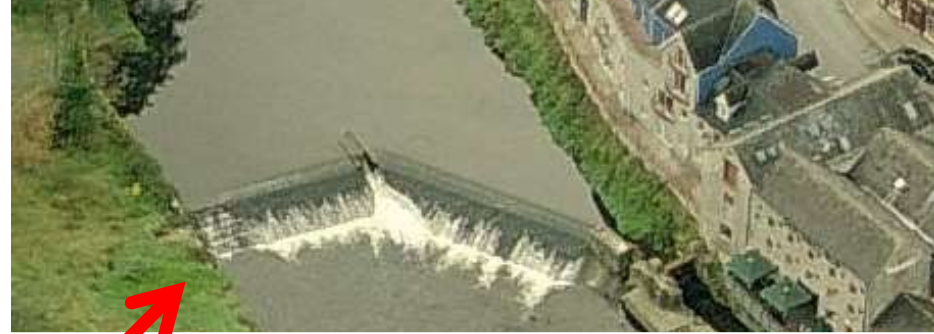
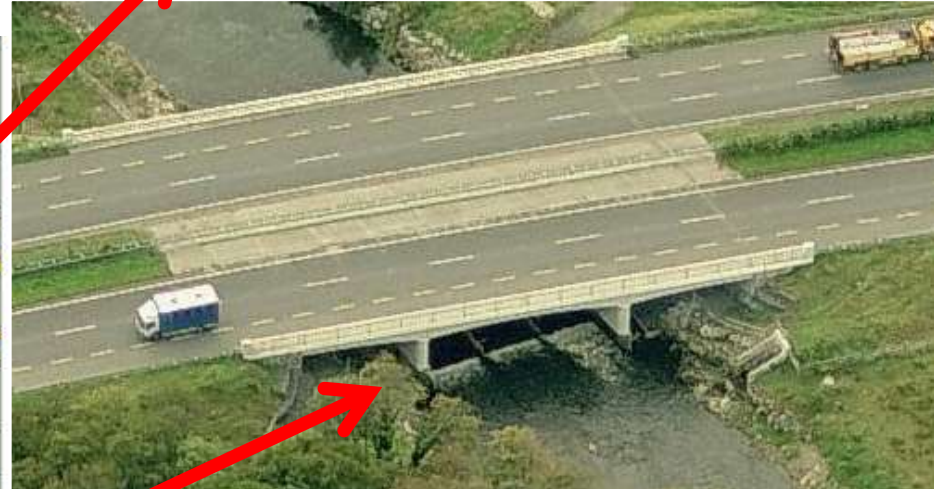
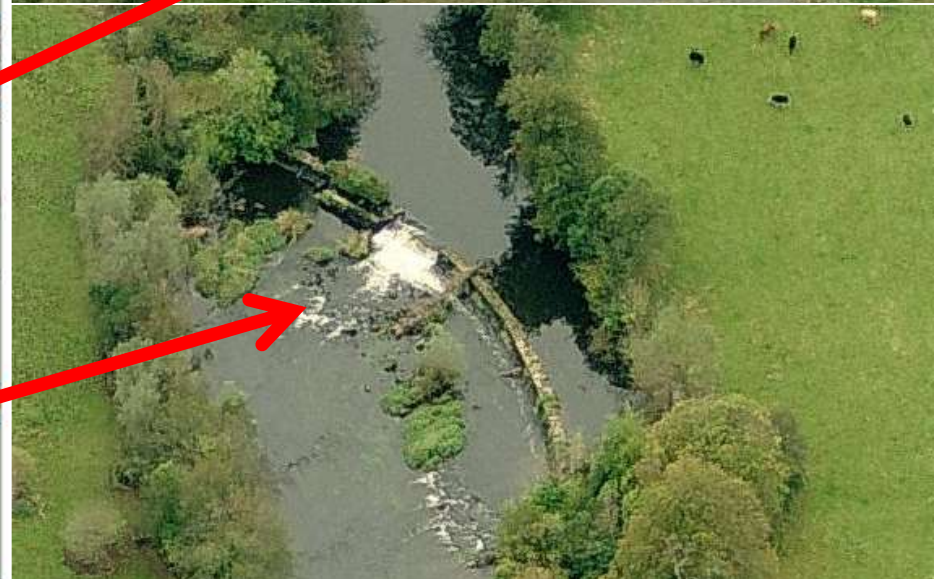
- Historic passage problems at Annacotty
- Ballyclogh weir – major problem

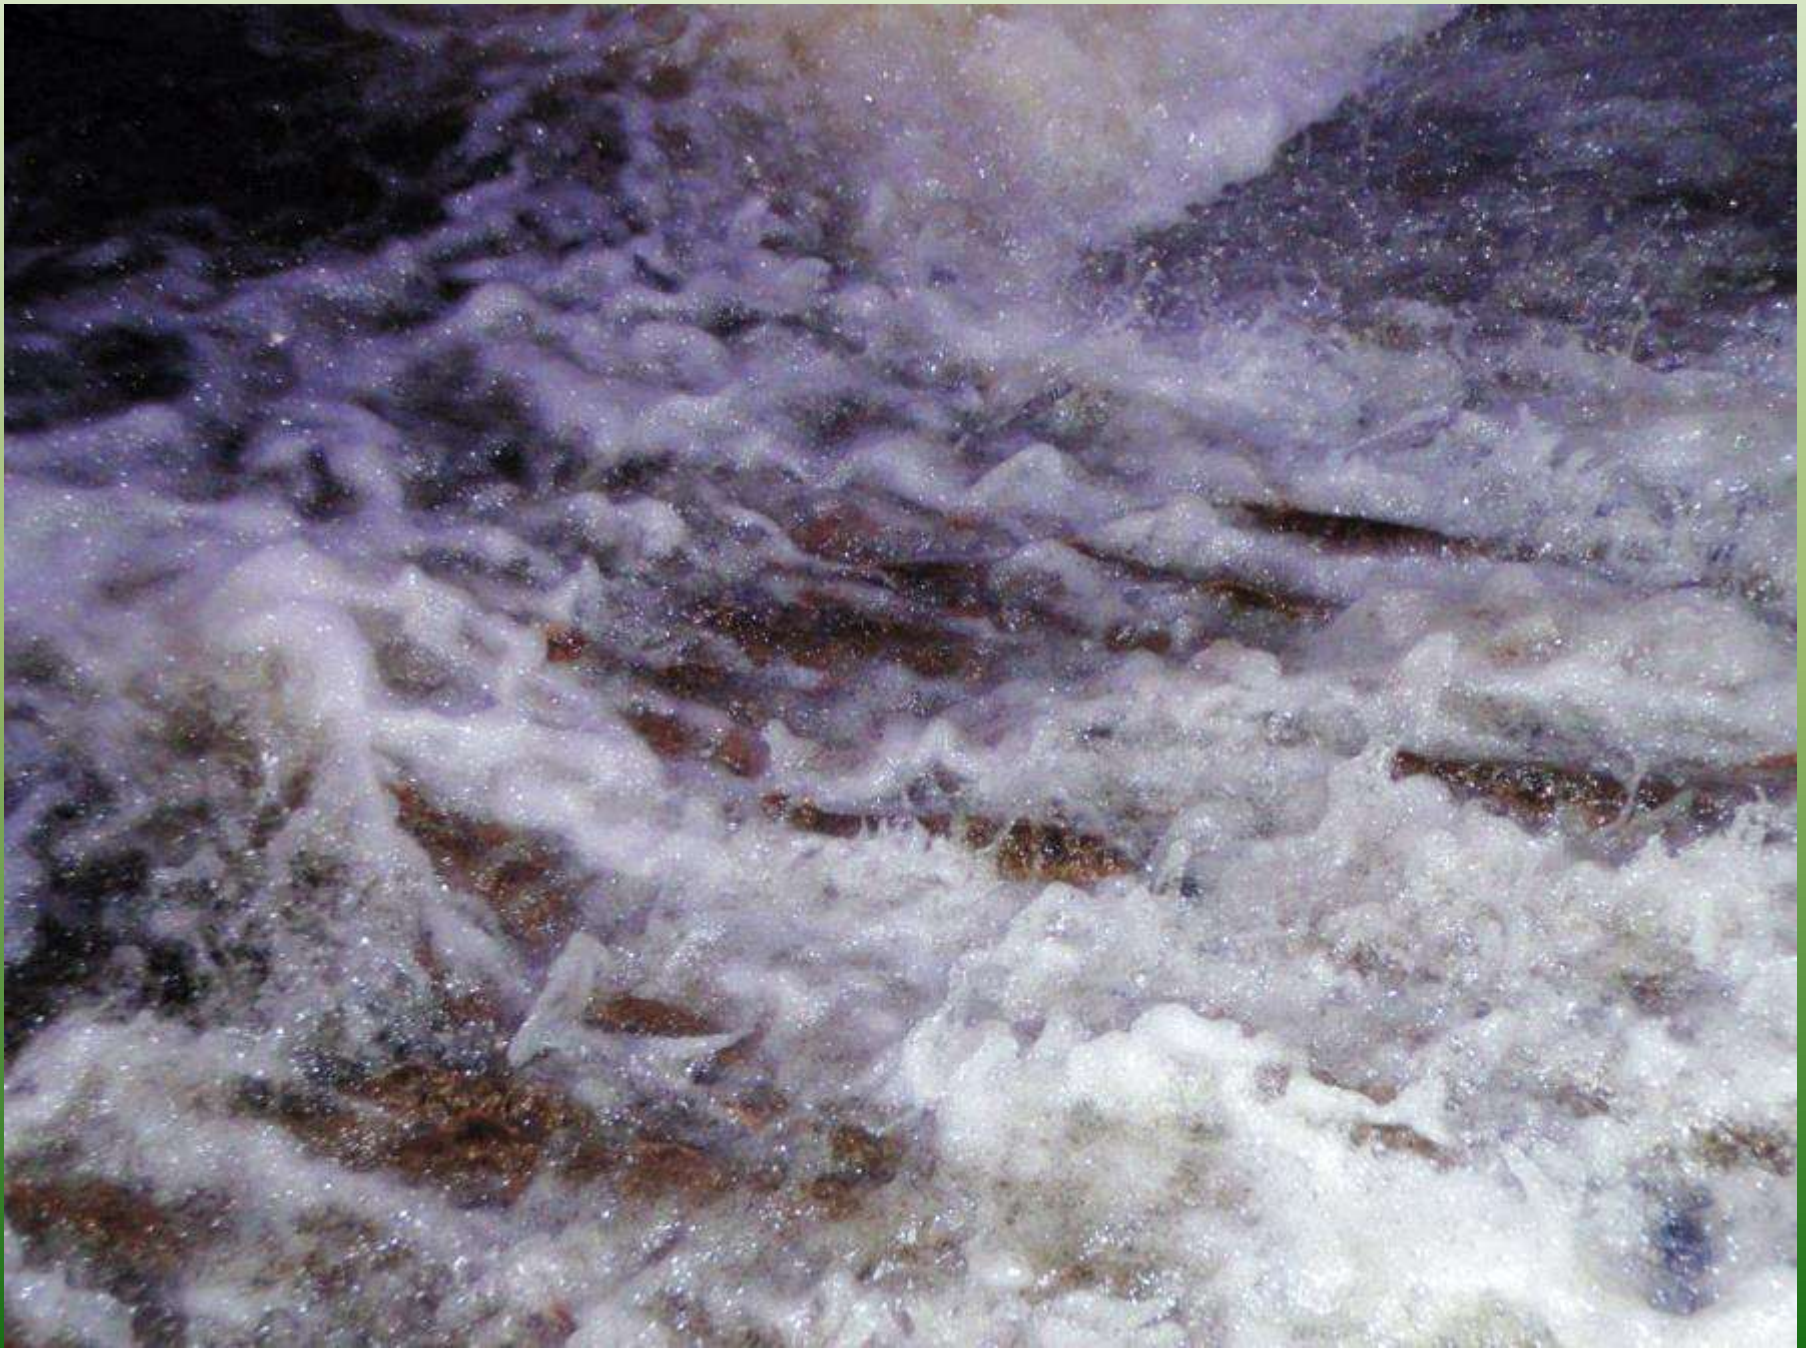
# Passage June 2014 with 34 sea lamprey on pass

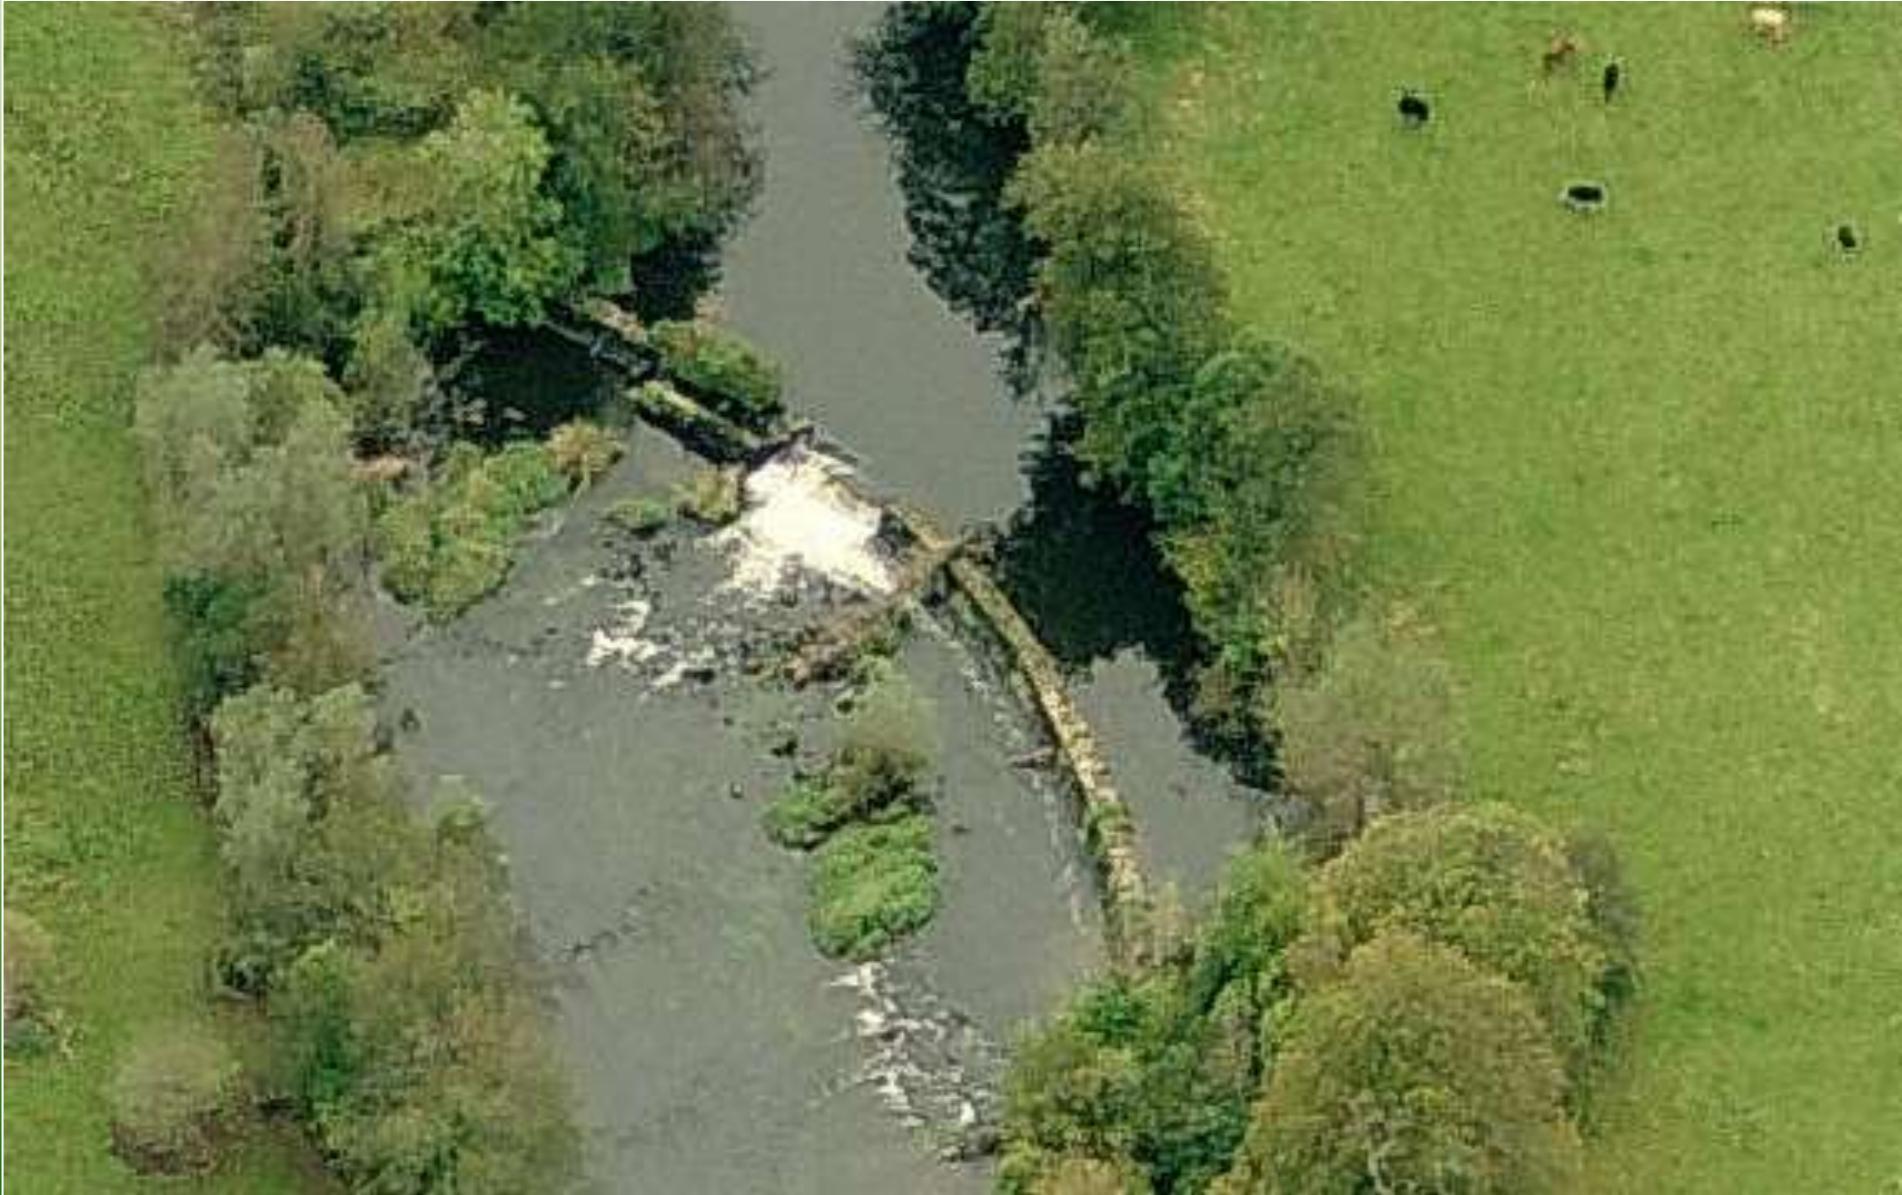
# Ballyclogh Weir

An aerial photograph of a river flowing through a dense green forest. A weir or small dam structure is visible across the river, with water cascading over it. The riverbanks are lined with thick vegetation. Several red arrows point from text boxes to specific areas of the river and weir, indicating work objectives.

**Ensure Fish Passage**

**Undertake Bank  
Protection Work**

**Remove Dysfunctional  
Fish Passes**

**Address Scouring  
Illegal Fishing Activity**

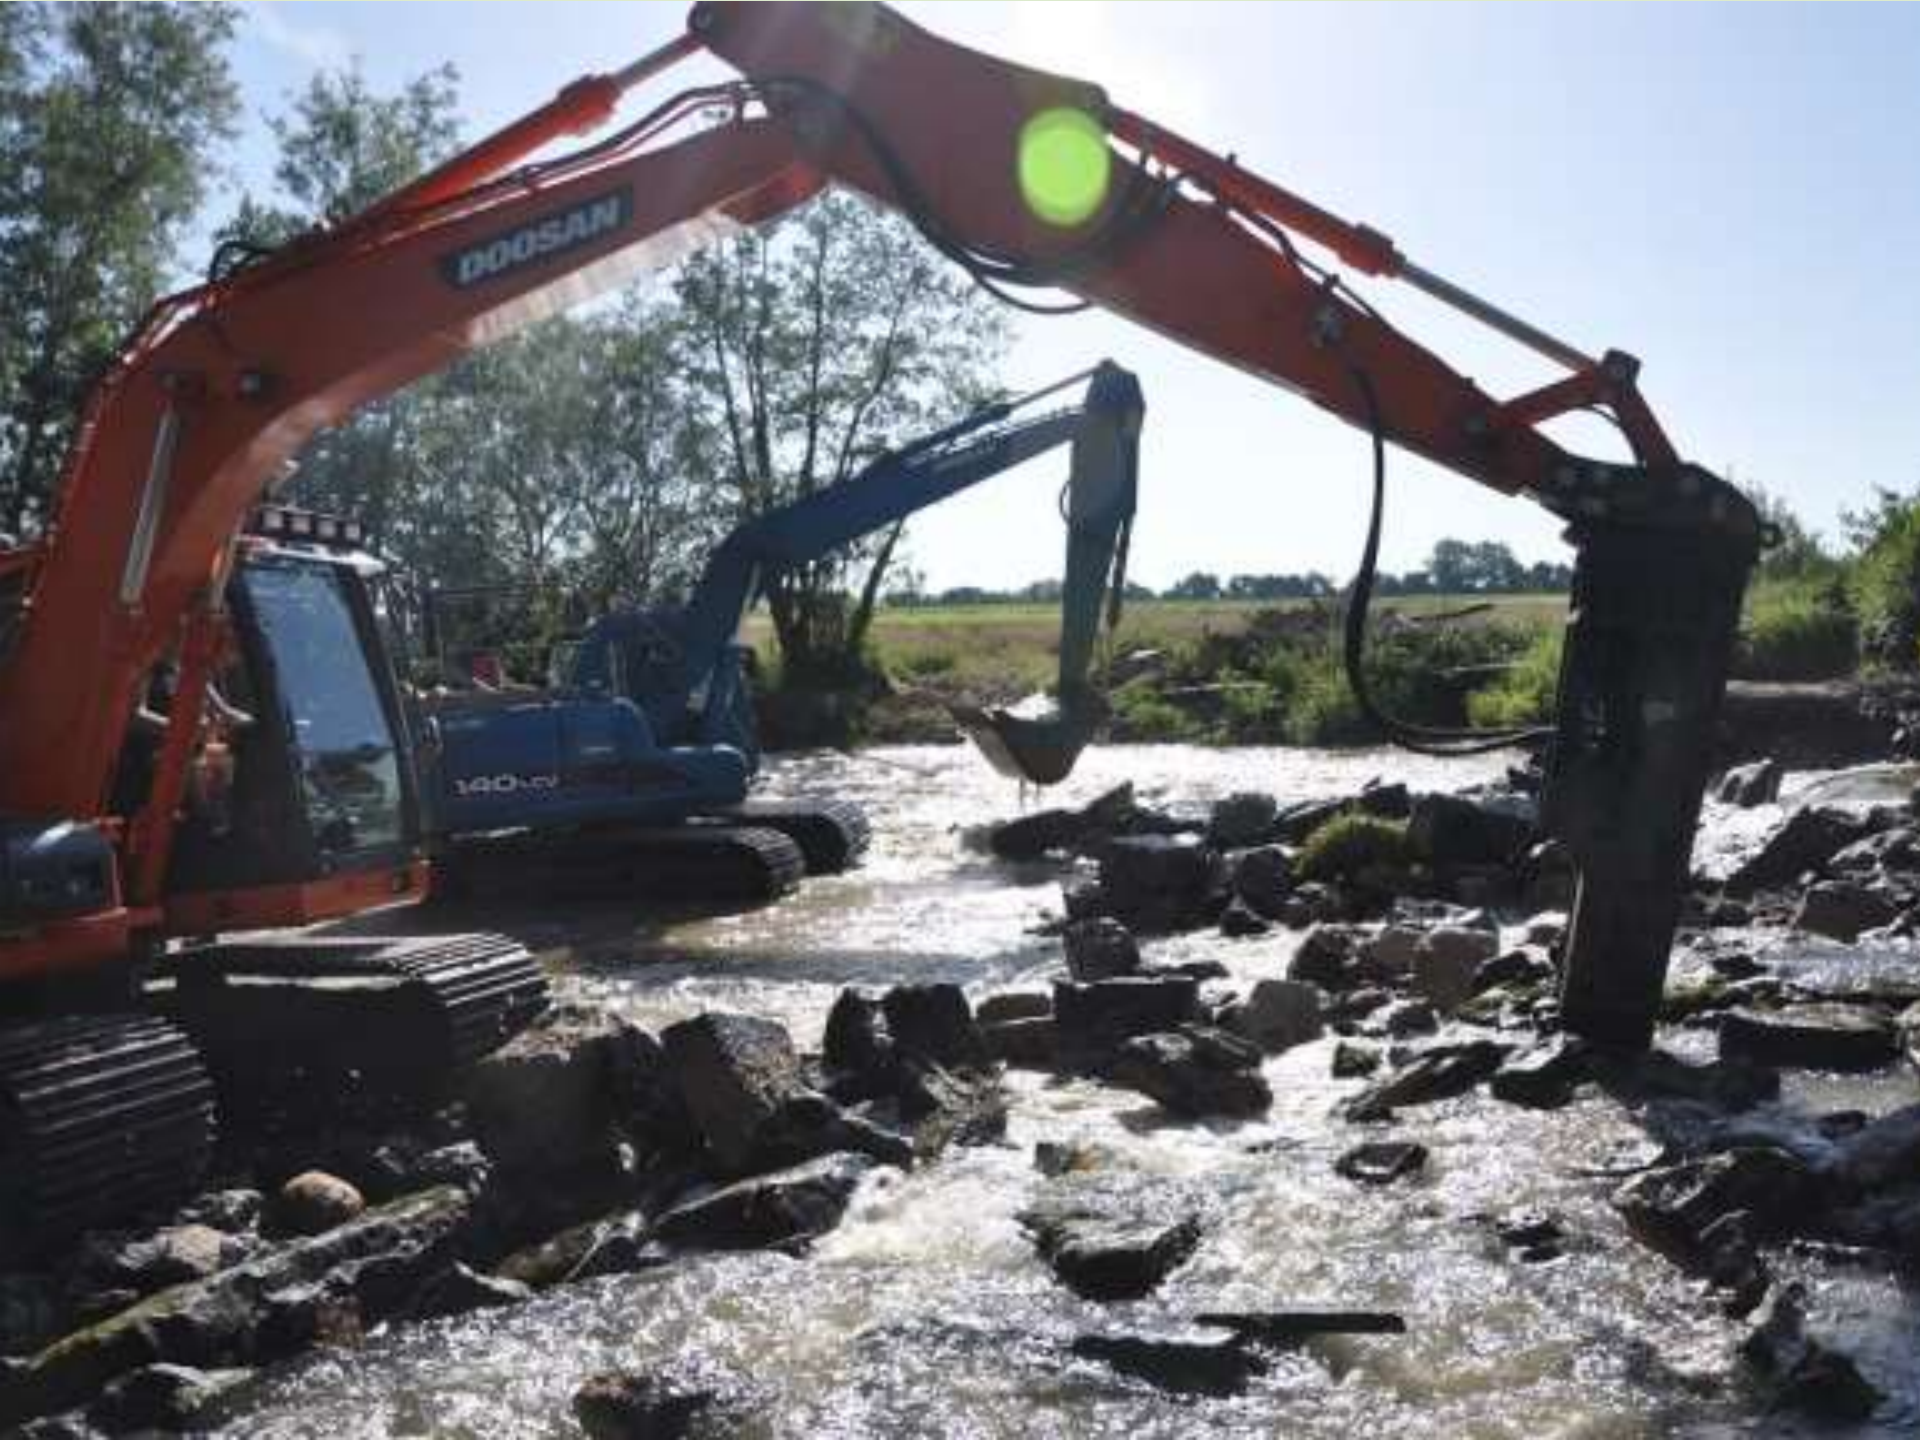
# Partial Removal & Installation of Elongated Mat

An aerial photograph of a river flowing through a dense forest. A rock weir is visible in the center of the river, creating a small waterfall. Two orange callout boxes are overlaid on the image. The first box, located in the upper left, points to a section of the river upstream of the weir with a red double-headed arrow. The second box, located in the lower center, points to the weir itself. A blue rectangular box with white text is positioned between the two orange boxes, also with a red double-headed arrow.

Removal of this section

Continuous elongated rock  
mat installed above and  
below removed section

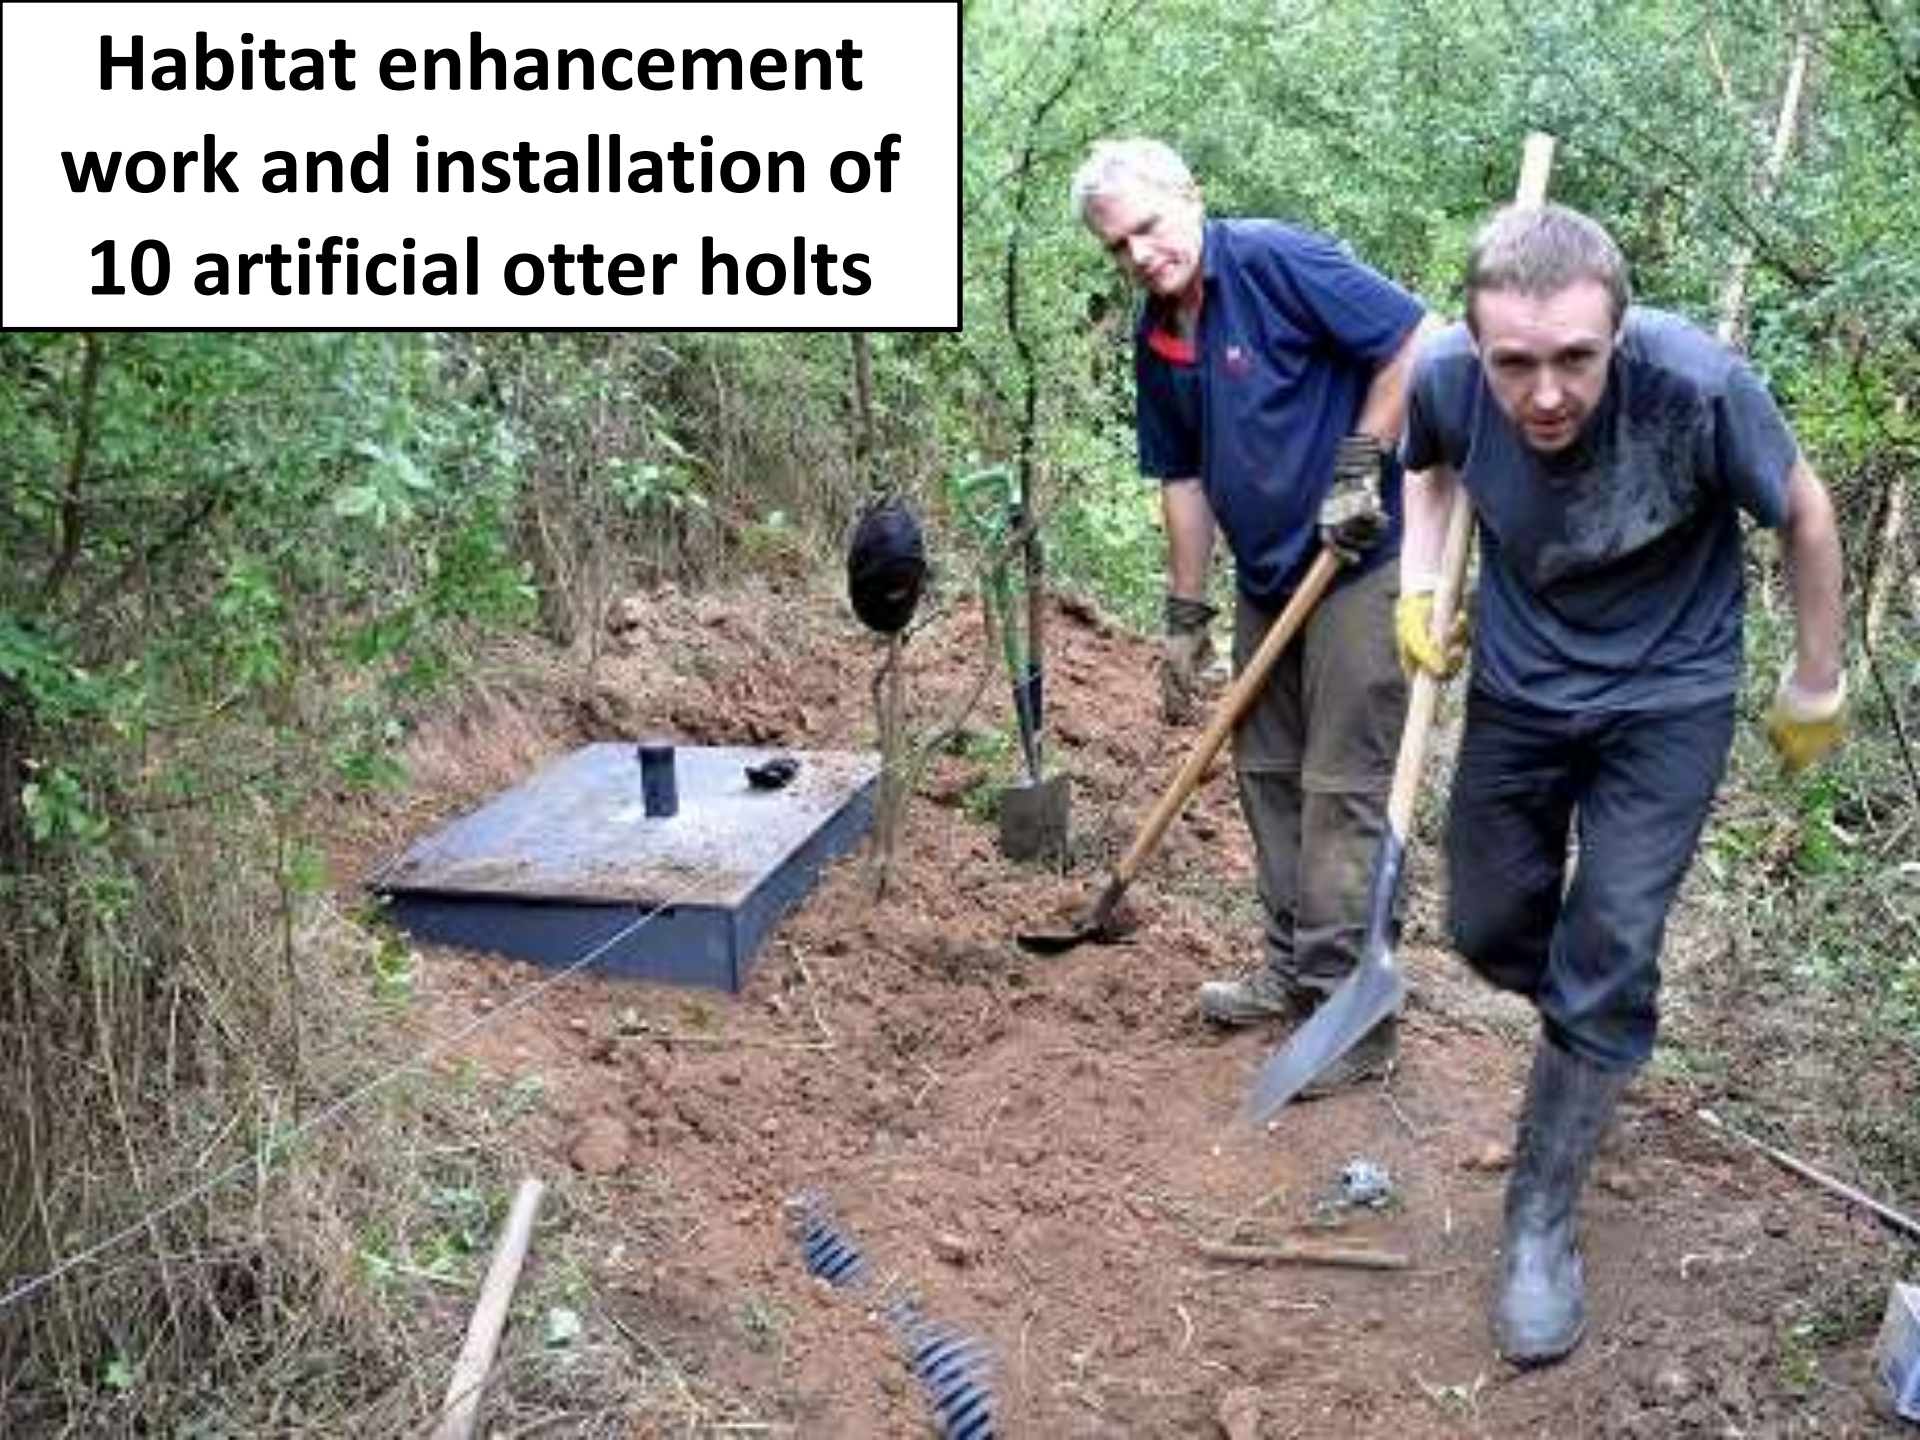
# Habitat enhancement work and installation of 10 artificial otter holts

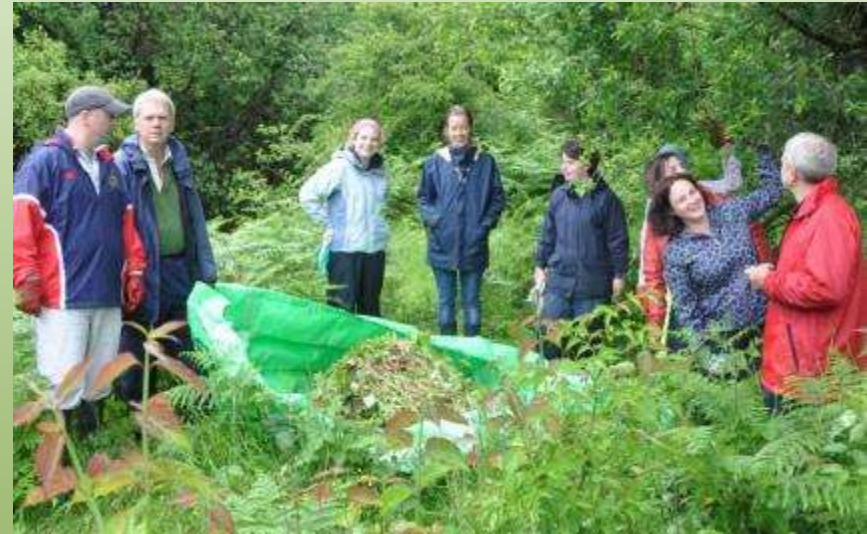
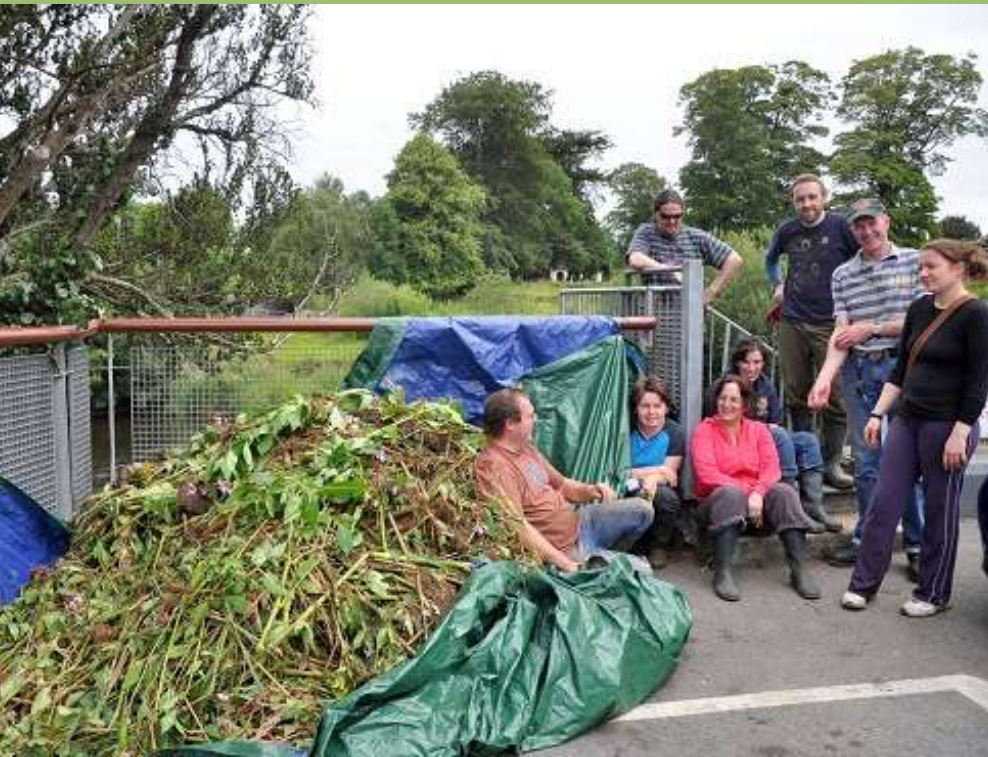
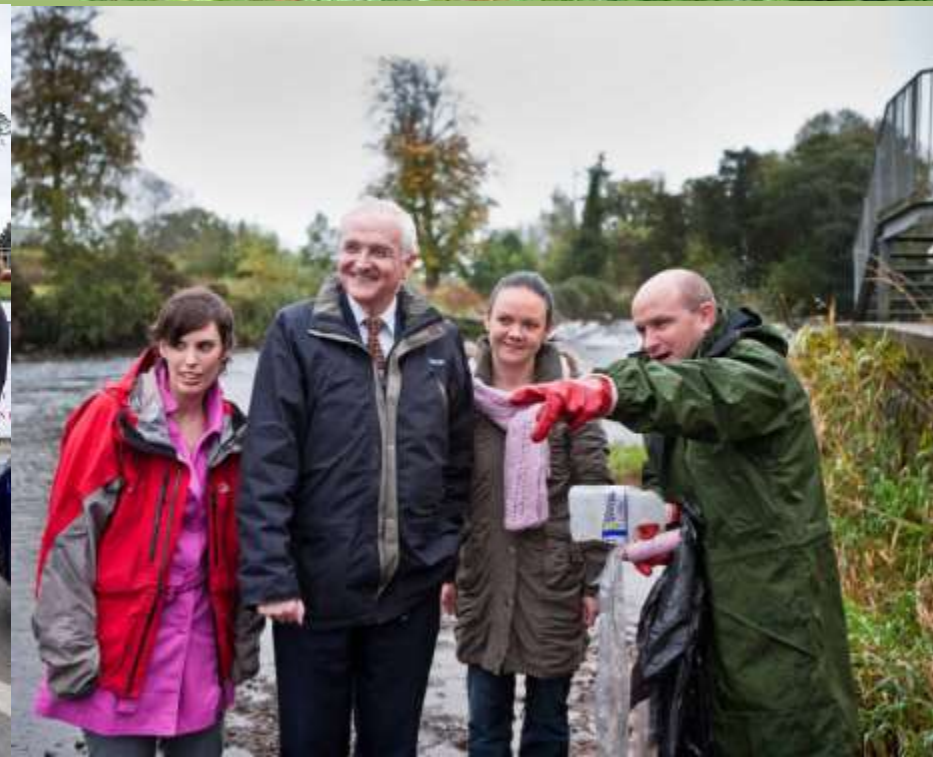
# Control & subsequent removal of Himalayan Balsam

- Manual pulling to control Himalayan Balsam
- Use of the Mulkear Conservation Volunteers (MCV)

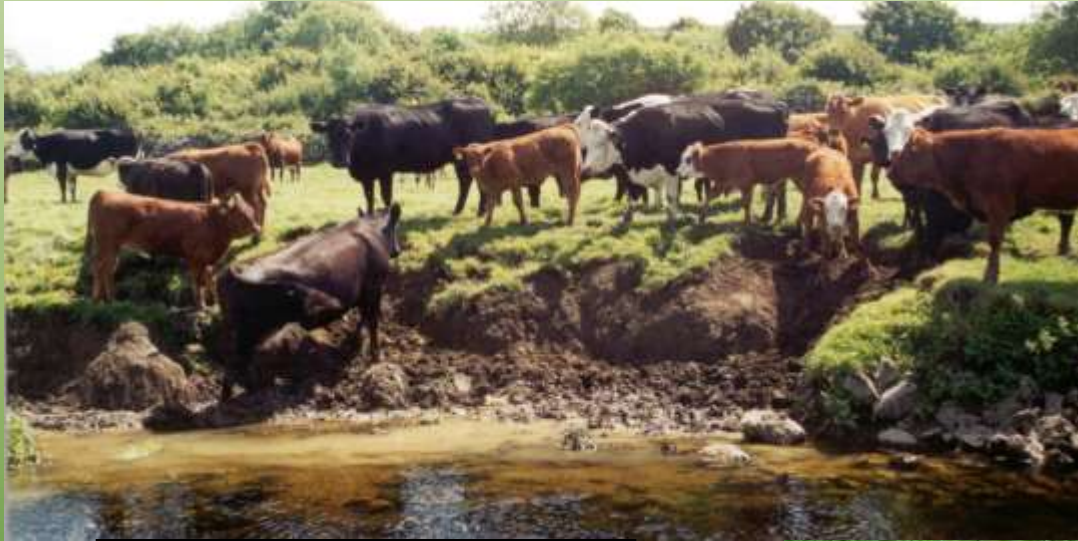
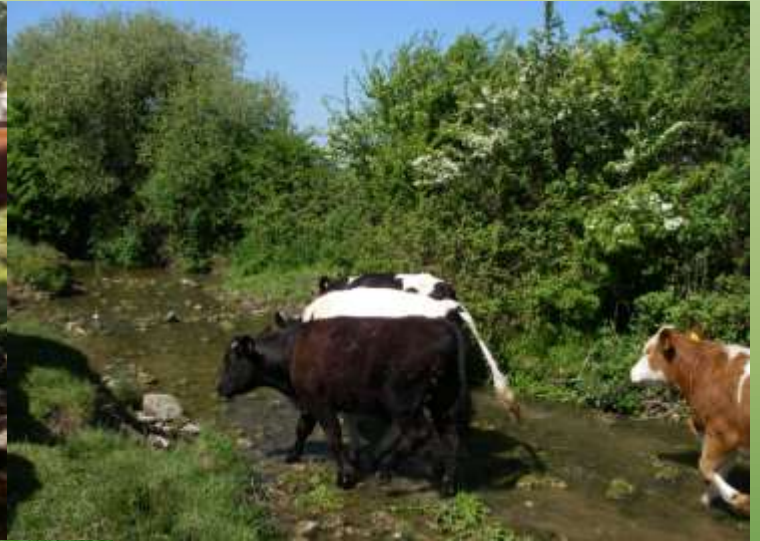
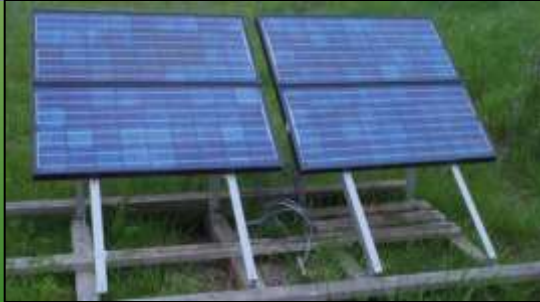
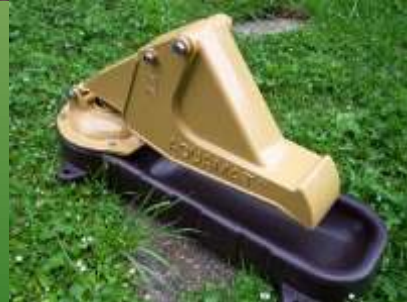
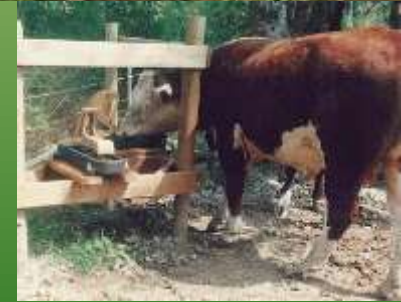
# Conservation Work With Farmers

- Improvement of water quality in areas affected by cattle disturbance (trampling and faecal disturbance)
