Title: Martins River Island Enhancement

Location: Ilsington, Tincleton, Dorset, England

Technique: Placement of large woody debris, removal of embankments, bed and bank reprofiling

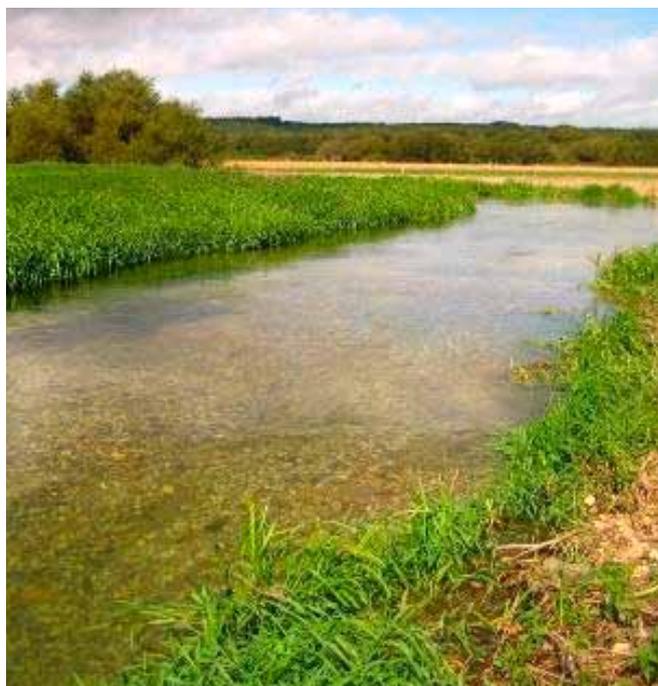
The key aims of the project were to remove artificial raised embankments and return gravels to the dredged reach creating a range of in channel features and a varied bed profile. All images © Environment Agency copyright and database rights 2013

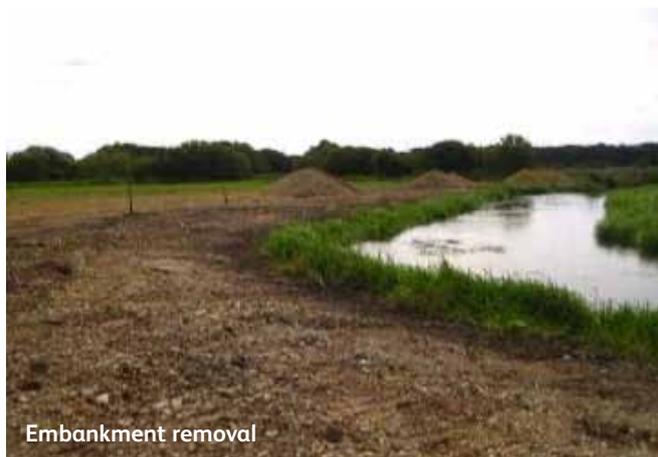
Embankment removal

The embankments were removed and reprofiled to a natural bank level. The material was piled up and consisted of river gravels and finer sediments excavated from the river during the historic dredging.

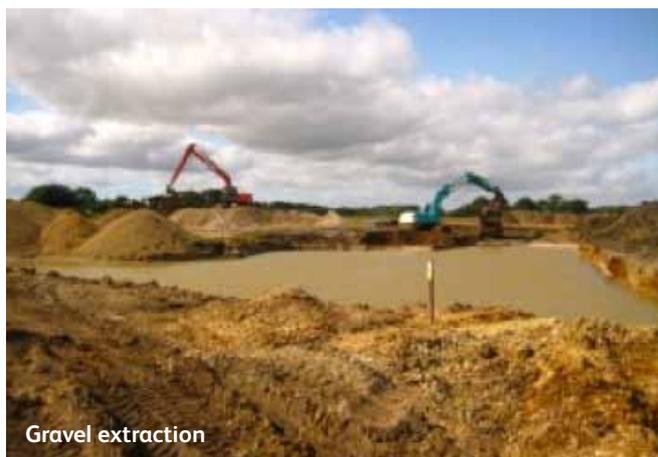
Gravel extraction

A borrow pit was therefore dug in the floodplain to win gravels for riffle creation and bed raising. The hole created was in-filled with the embankment material, and any sands and silts that were screened out of the floodplain gravels. This left a shallow open water wetland area with water levels that fluctuate depending on rainfall and river levels.

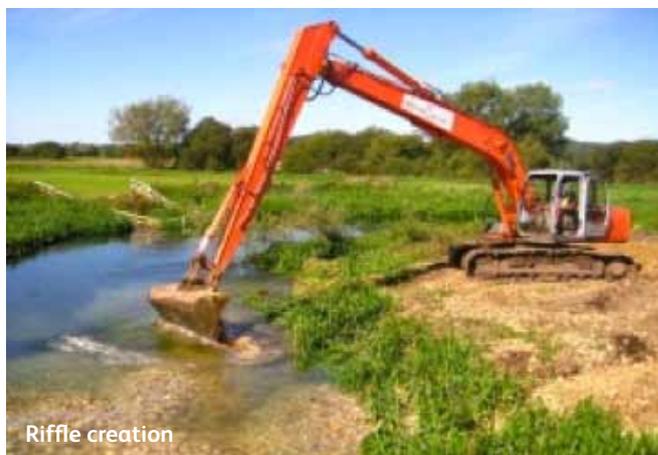
Riffle creation

The won gravels were added to the river at key locations for riffle creation and bed raising to create a range of bed profiles. Gravel was placed in areas where it would naturally be expected to occur in the river channel, such as shallower channel margins on the inside of meander bends, and in particularly deep sections of the channel.

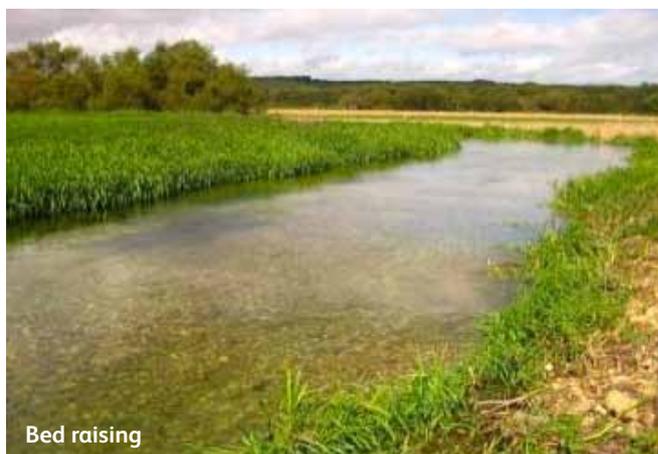
Bed raising
