The revitalisation of kultural hereditary buildings in water streams

Nevenka Ožanić, Josip Rubinić, Barbara Karleuša, Danko Holjević

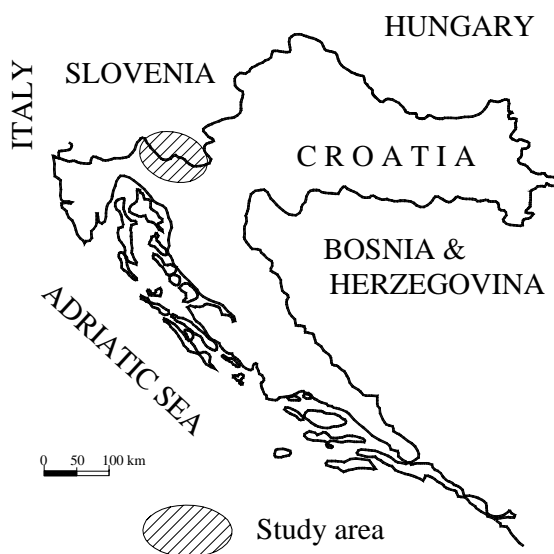
Figure 1: Analyzed area

One of such stories is connected for the upper part of river Kupa stream, located in mountain area. Together with its affluent Čabranka, river Kupa represents the state's border between Croatia and Slovenia in length of about 130 km (Fig. 1). In the past, on that area, upstream from the entrance of Kupa river to the Croatian territory there were as much as 192 wheels propelled by water [9], while in present time only few of them remained active.
