Experiences in meander restoration in Kopački rit nature park

Zdenko Tadić, Ivan Radeljak

KEYWORDS: Kopački Rit, Nature Park, Meander restoration, Natural flow program

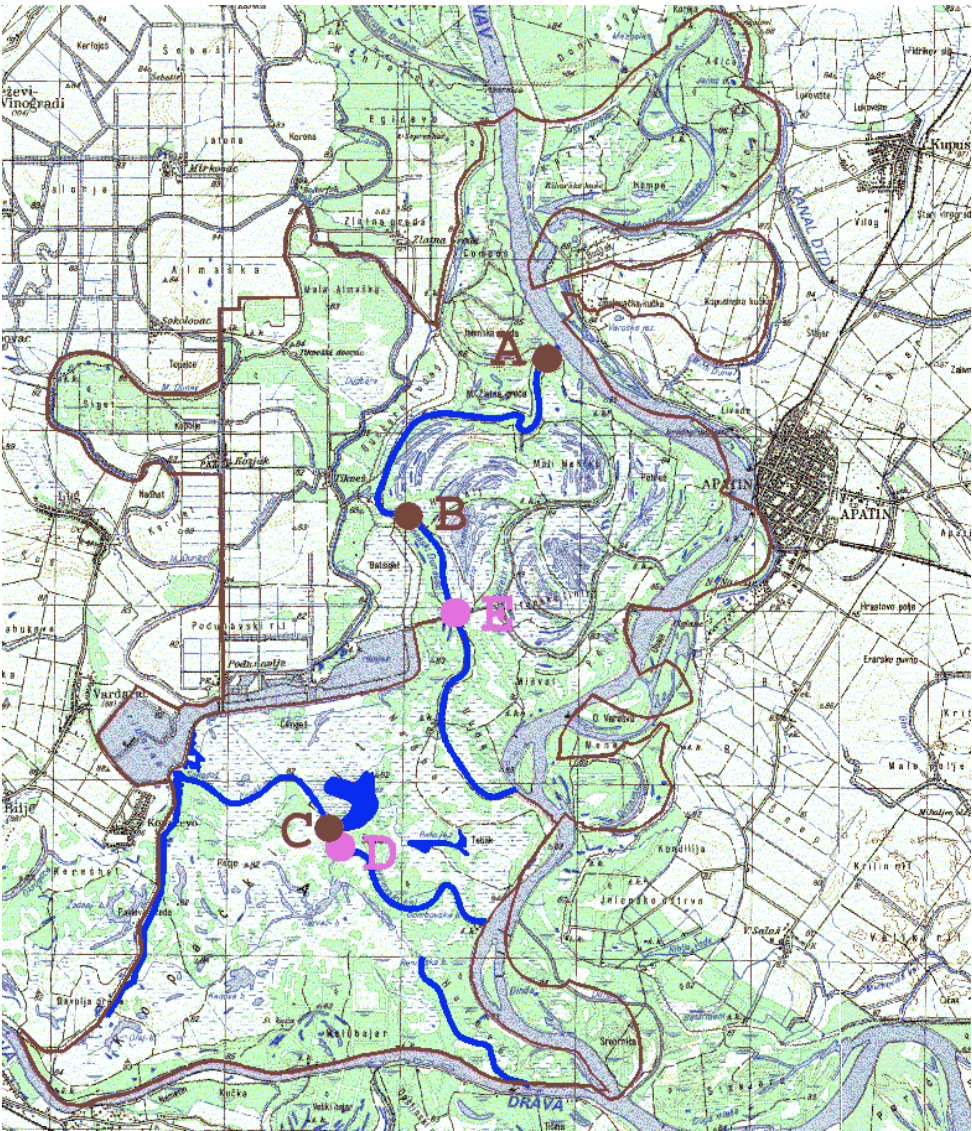
Picture 2: Barrier removal and monitoring locations

Regarding the addressed problems the Project for the removal of anthropogenic influences was started. The funds for the project are donated by Government of the Netherlands through The European Centre for Nature Conservation (ECNC). Only the locations with clear and unquestionable manmade influence are addressed by the Project. The locations of the artificial barriers on the main canals of Kopački Rit (Hulovo and Vemeljski Dunavac) have been found as the most harmful for the water regime of the Kopački Rit Nature Park. Intention of the project is to remove the artificial barriers that are in the middle of the canals while the barriers on the mouth of the canals to Danube are not to be moved as the removal of those barriers would do more damage then good. Hydrological monitoring was predicted as a part of the Project in order to gain basic knowledge on hydrological parameters on main canals of the Kopački Rit Nature Park. The idea was to monitor hydrological parameters on the canals prior to barrier removal and then again after the removal is made in order to compare the values and use the monitoring to track the changes after removal. Picture 2 shows locations of the barriers and monitoring on the Hulovo and Vemeljski Dunavac canals. Points A, B and C present locations of the barriers that will be removed and points D and E present the monitoring locations.

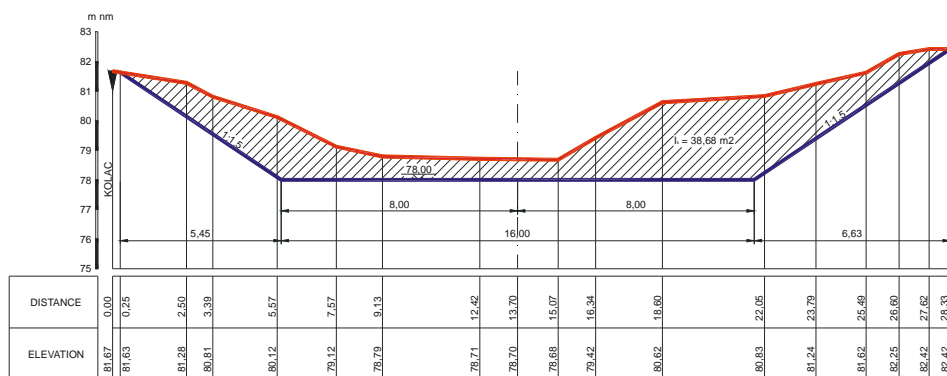
Picture 3: Characteristic profile of the Barrier C on Hulovo canal

Actions on the monitoring and the designs for the removal of the barriers started simultaneously in July of 2003. Unfortunately, due to climatic and hydrologic conditions (drought) it was impossible to monitor the hydrological parameters on canals. Documentation for the removal of barriers was designed to remove all of the human made impact and to preserve natural shape of the canal without the use of artificial or natural materials or constructions made out of them. The stability of the banks after the barrier removal is preserved by applying 1:1.5 slopes for the banks (picture 3). The 1:1.5 is natural slope for the canals in the Nature Park Kopački Rit.

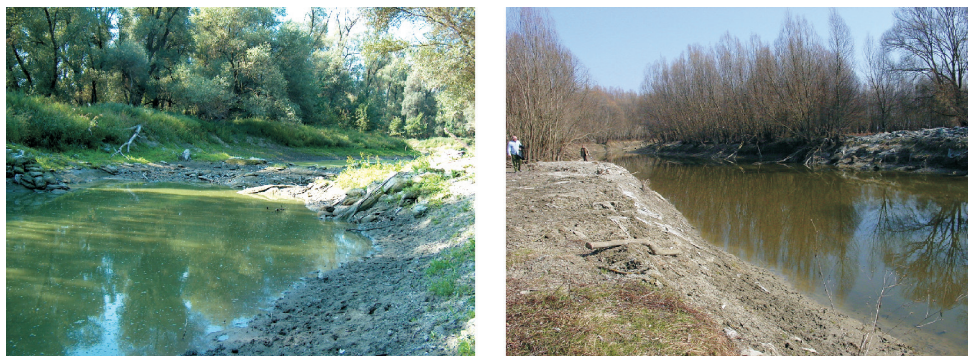
Picture 4: Barrier C location (August 2003 and February 2004)

Designs and tender documentations for barrier C were finished in October 2003. The Barrier C was made out of geotextile and sandbags on the almost on the contact between the Kopačko lake and Hulovo canal. The water surface reduction of the Kopačko lake and changes in Hulovo canal are so significant that it was decided to move the barrier C even without hydrological monitoring. The barrier was successfully removed and all of the work that is left to be done is to remove the geotextile that was left to dry on the banks. Picture 4 shows the Hulovo canal on the location of the barrier before and after the removal.

Barrier C was constructed in order to provide longer water periods in Kopačko Lake, that is to provide more favourable conditions for wildlife. Despite the good intentions the barrier resulted in sediment deposition, i.e. reduction of water surface.

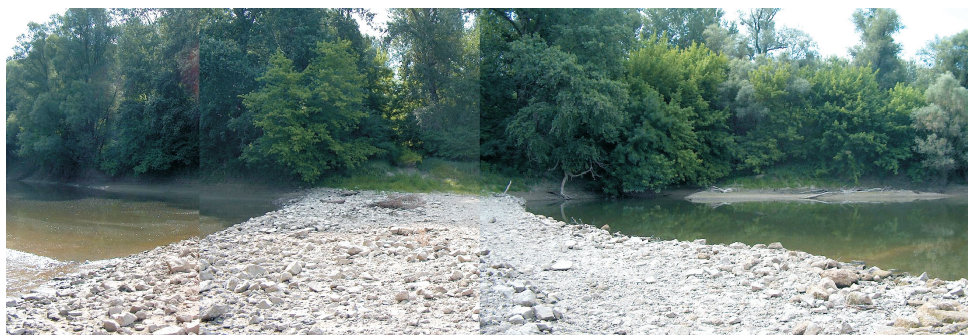
Picture 5: Barrier “A” (July 2003)

Design documentation for the barriers A and B on the Vemeljski Dunavac canal was finished in December 2003. The barriers will be removed in 2004 and the Nature Park will try to find additional funds for hydrological monitoring. Principles for the design of the removal for barriers A and B are the same as for the barrier C. Even though those barriers are made out of different materials and for different purposes they all produce negative impacts and therefore have to be removed.

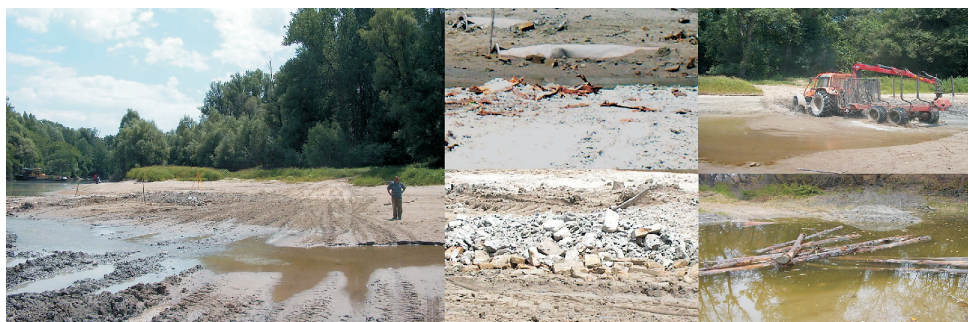
Picture 6: Barrier B (July 2003)

Though it seems small and limited human impact causes great changes. Good example to support this theory is barrier B where the barrier was constructed out of timber and brick waste to ensure crossing of Vemeljski Dunavac during low water levels for wood exploitation. This barrier caused significant morphological changes, i.e. deposition upstream and erosion downstream from the barrier, thus creating flow obstruction that deteriorated living conditions for the wildlife downstream.
