Benefits of European river restoration schemes

An analysis of 13 case studies aiming to integrate improvement of ecological conditions and flood risk mitigation

December 2017

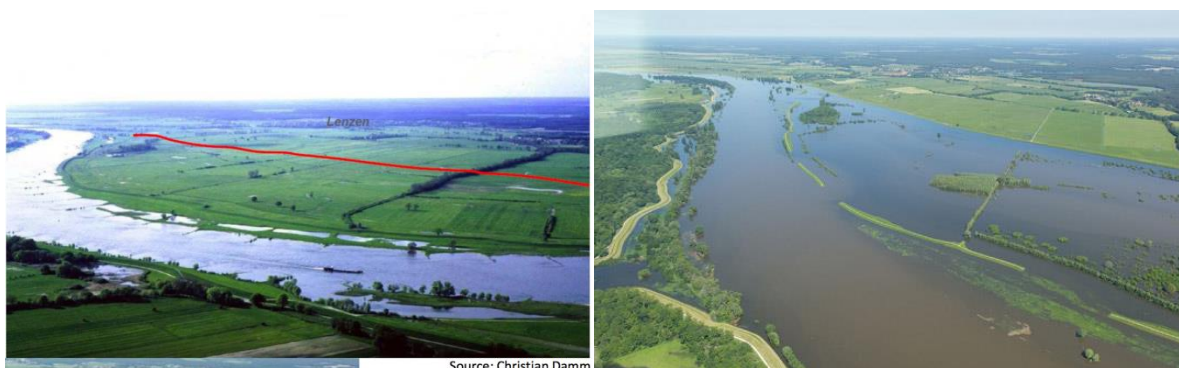
Figure 1. The area affected by the levee set-back: on the left, before the works; on the right, the openings shown at work during a flood. The red line on the left picture indicates the position of the new levee (sources, left: Christian Damm; right: Nora Künkler).

Several openings of 200-500 meters along the old levee were created, thus connecting the floodplain to the river in case of high flows, and a new levee was built 1.3 km further away from the river channel, to maintain control over larger floods. In addition, 160 ha of alluvial forest were planted and 85 ha of half-open pasture landscapes were established. In these areas, small stable ponds were also created. These measures required a land re-organization process in order to make areas available, as well as a new land-use practices, which was both promoted through compensation payments.

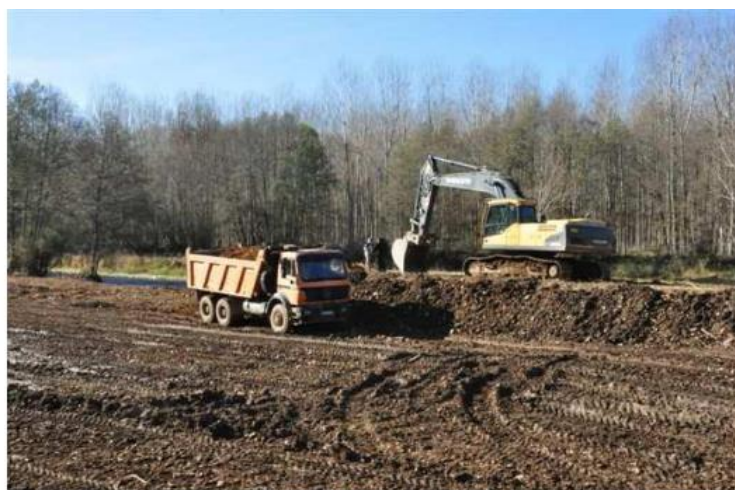
Figure 3. An artificial levee is lowered to recover lateral connectivity.

Rock armoring of river banks and earth embankments were removed from more than 13 kilometers of river channels. Some earth embankments were set-back along 5 kilometers of river channels, and other barriers such as groynes were lowered. 10 kilometers of secondary arms were reconnected and/or directly restored. Moreover, a riverbank vegetation buffer was created along 7.2 ha that were reconnected to the river. Other in-channel obstacles, namely weirs, were modified to restore continuity for fish fauna and sediments. The project approach was very different from the experience of the local stakeholders, who were initially reluctant, especially towards expropriation. However, active public participation was set in place, involving stakeholders in 50 meetings during 3 years and eventually facilitating a successful implementation.

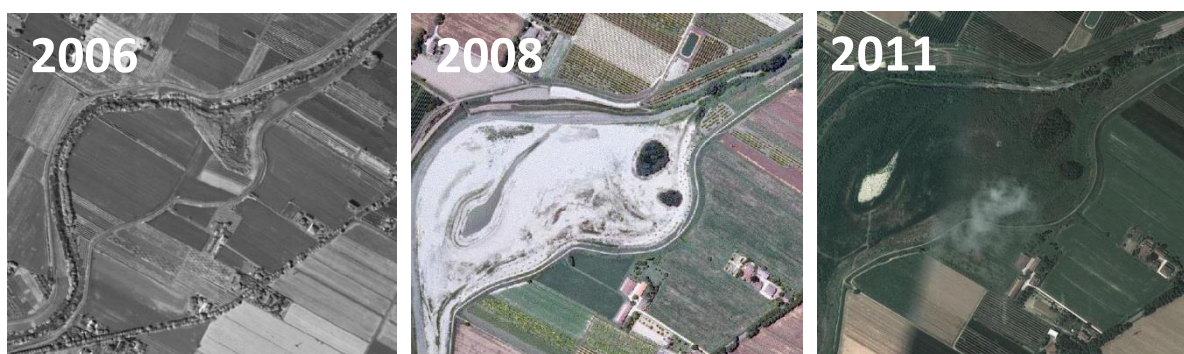
Figure 6. The terrace lowered in the project (source, Regione Emilia Romagna).

Within the restored reach the inner (i.e. secondary) embankments were removed and sixteen hectares of floodplain were lowered and reshaped. Fine material with no commercial interest was introduced in the channel during some ordinary flood events, in order to increase the sediment supply downstream and to ensure coastal replenishment.

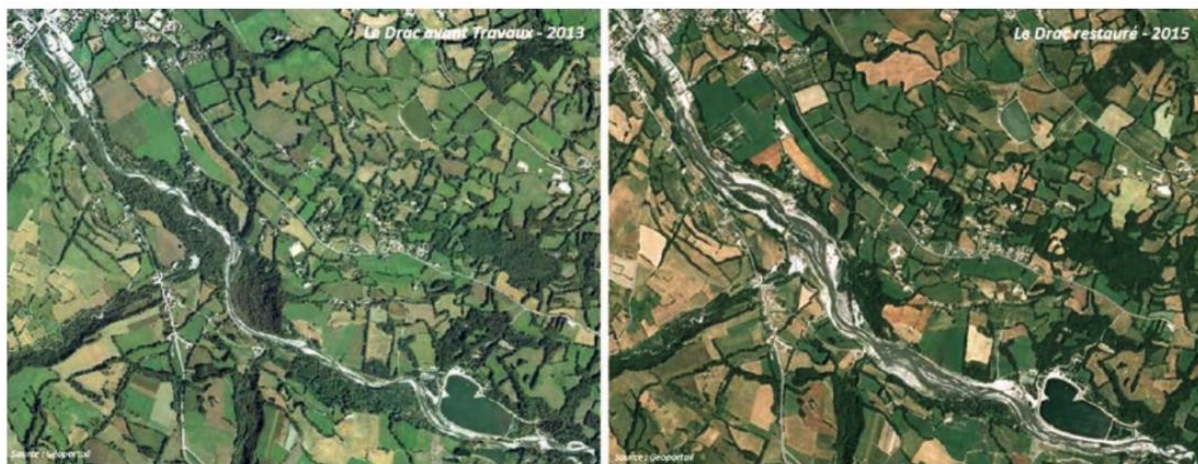
Figure 20. On the left panel, aerial view on the single channel Drac prior the 2013 intervention; the Champsaur dam can be recognized in the bottom right corner. The river flows towards the top of the picture. On the right panel, the same area is covered.
