# Restoration of Ritobäcken Brook

## Project summary

**Location:** Municipality of Sipoo, Southern Finland

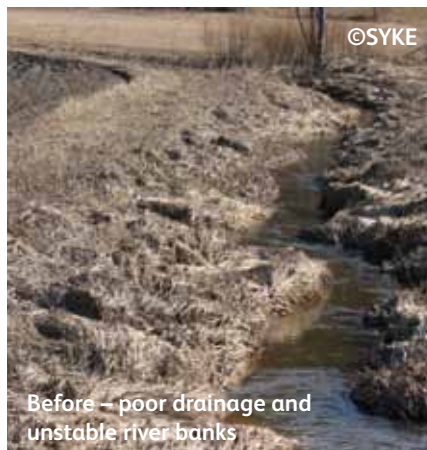
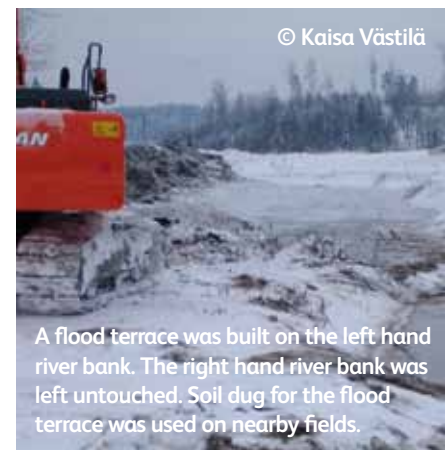
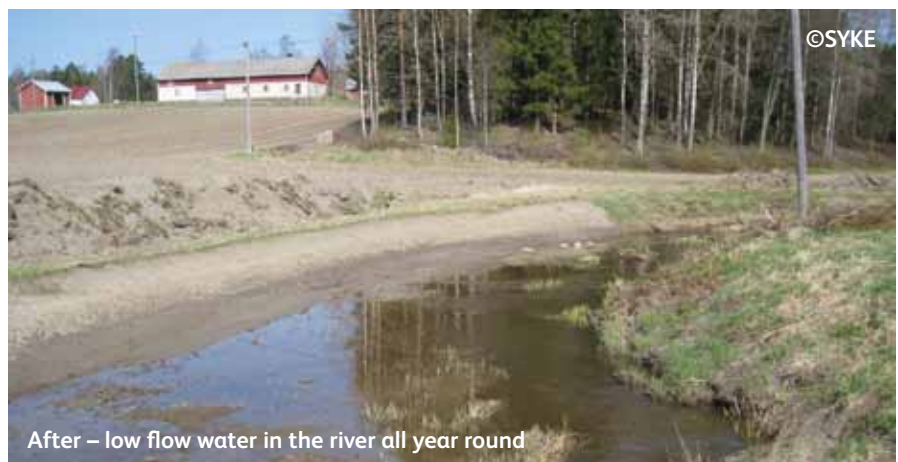
- Poor drainage
- Regular maintenance (such as dredging) necessary
- Unstable banks causing erosion and sediment build up in the river channel
- Agricultural areas frequently flooded.
- Artificial channel due to dredging and straightening in the past.
- Poor habitat for fish caused by river banks being eroded.

1. A digger was used to excavate the flood terrace above the existing river channel, to allow it to carry more water.
2. The excavated soil (2,500 m<sup>3</sup>) was transported to nearby arable land to fill in the lowest areas.
