Use green engineering techniques instead of hard bank protection

Title: River Cole river restoration

Location: River Cole, Shard End, Birmingham, England

Technique: Removal of sheet piling and concrete bank protection

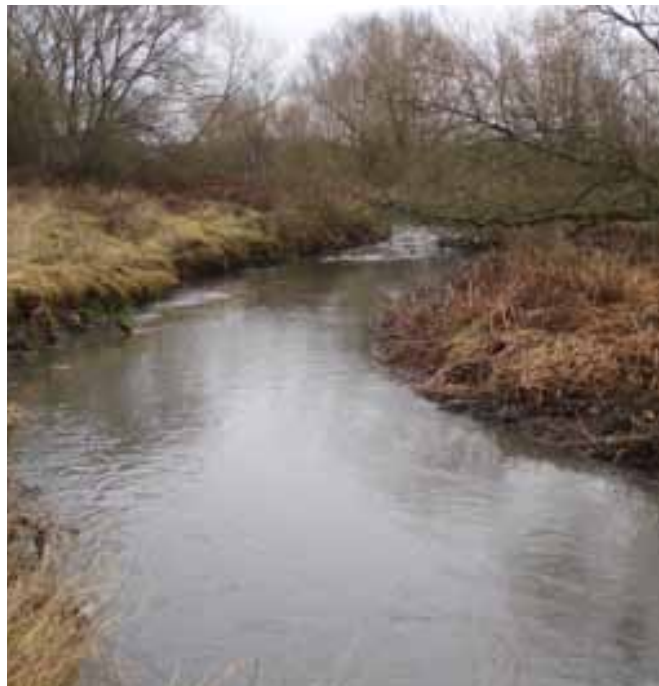
(1) Area of sheet piling prior to works (1994); (2) The same section of bank after removal of the piling and a period of natural development (2011).

- The removal of sheet piling and concrete bank protection on the River Cole has allowed the channel to adjust in a natural fashion, changing the flow conditions and resulting in increased morphological diversity and the reinstatement of natural processes. The channel has widened and meanders have migrated by more than a metre (similar changes have occurred in unprotected reaches downstream of the site).

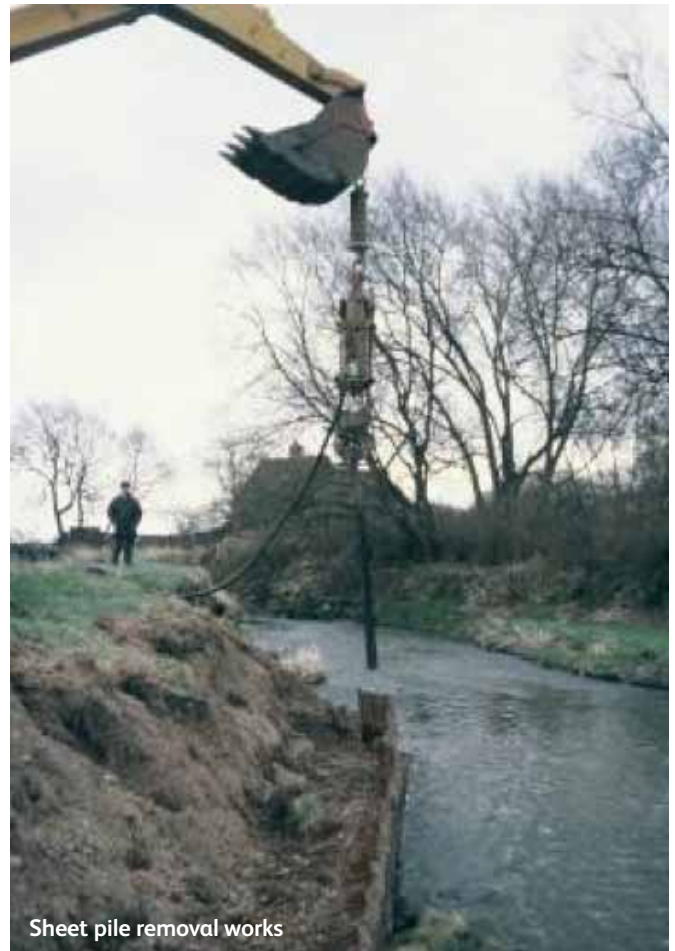
Sheet pile removal works

- Approximately 405 m of sheet piling was removed in discrete lengths from seven different locations (generally on the right bank). The longest continuous length removed was 50 m long and in some cases the banks were reprofiled following removal of the sheet piling.
- A 50 m length of sheet pile was retained and masked with spoil and rocks to form new berms at the bank toe. Willow branches were also planted in the new toe material, and the berms were subsequently colonised by vegetation.

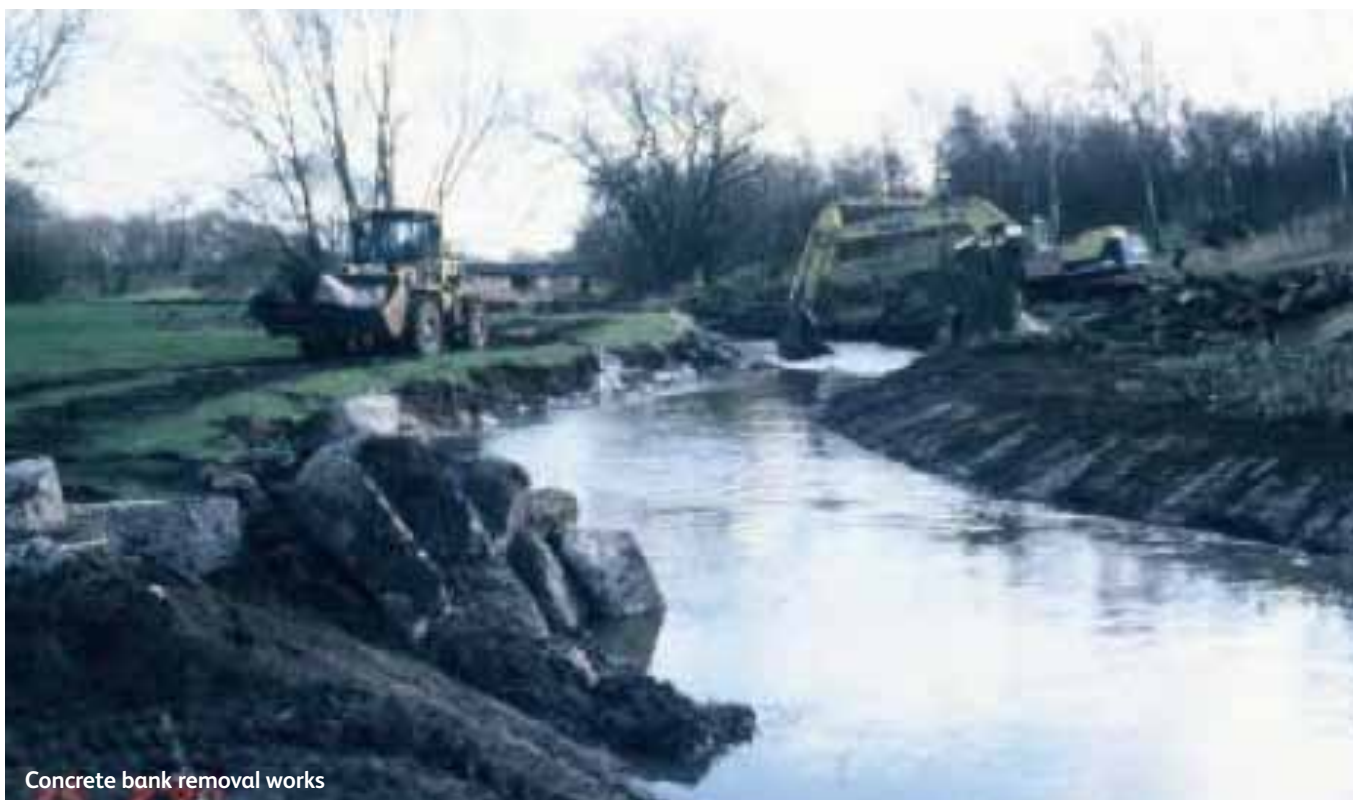
Concrete bank removal works

- Approximately 54 m of concrete bank protection on the left bank and 75 m on the right bank were removed and reprofiled as part of the deculverting project at Yardley Brook which joins the River Cole approximately 200 m upstream of Lea Ford Road bridge.
- In some places, concrete was simply broken up and retained in situ to allow established trees to continue to inhabit the banks.
- A failing outfall was removed from the left bank upstream of the road bridge.

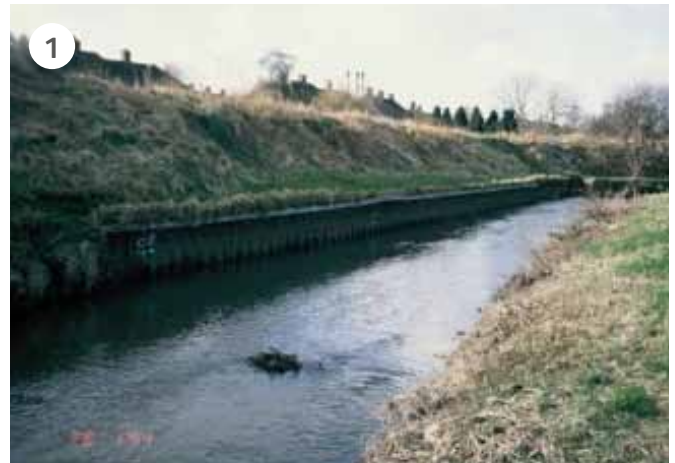
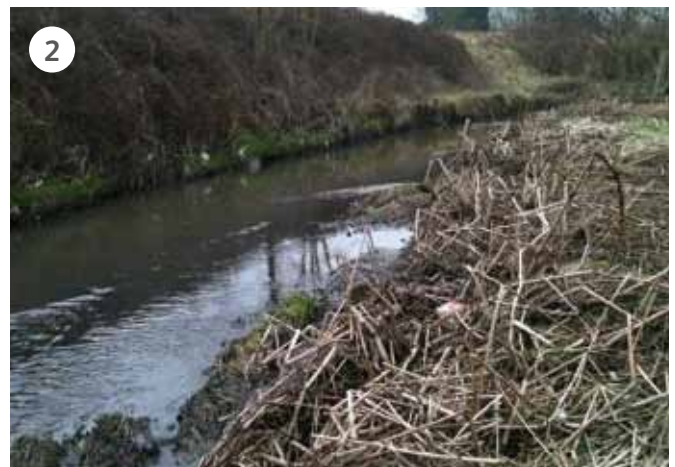
(1) Banks prior to removal of sheet piling; (2) The same banks post-removal

- The removal of hard bank protection has resulted in the creation of new habitat niches due to the more natural banks forms and the creation of an active channel with a plentiful supply of coarse sediment. The renaturalised sediment regime has created a range of depositional features in the channel, including coarse sediments and fine sediments which support a range of different habitats.
