Title: River Mole Head Weir Natural Fish Pass

Location: King's Nympton, Devon, England

Technique: Weir modification to improve fish passage

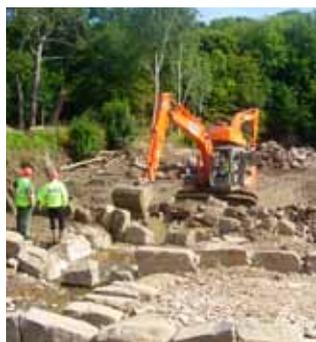
(1) View downstream during construction;
(2) Installing tombstones to low stone weirs

- The River Mole was diverted around the site by the creation of a by-pass channel to link in with an existing ditch adjacent to the weir which discharged back into the river downstream of the site.
- An upstream cofferdam was formed from river bed material and sandbags to divert water down the by-pass channel to enable work to be undertaken in relatively dry conditions.
