Title: River Nar rehabilitation strategy

Location: Lexham, Castle Acre and Narborough, North Norfolk, England

Technique: Bank reprofiling

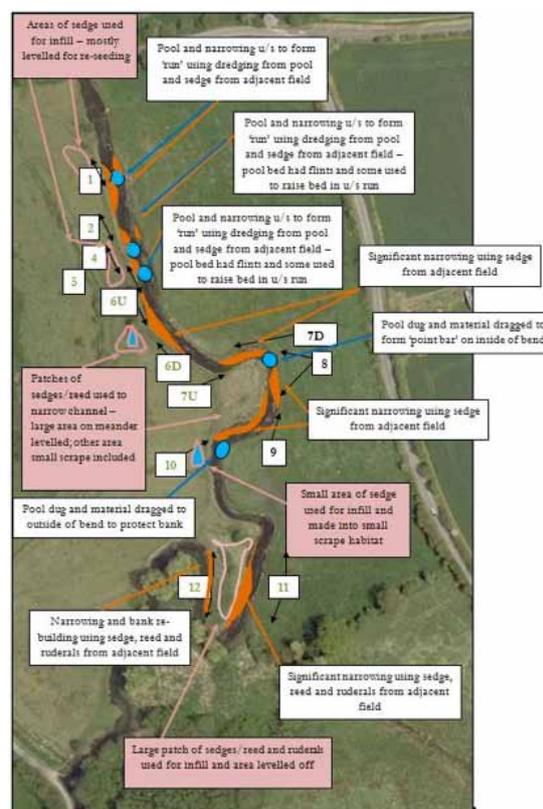
Details of proposed works at Castle Acre, River Nar
Source: Alconbury Environmental Consultants

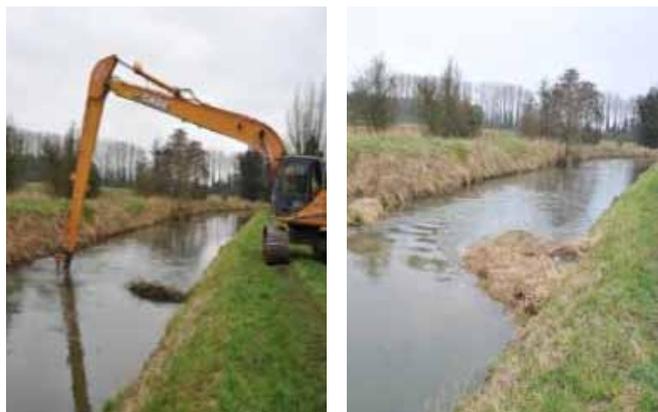
Construction of deflectors using dredged material

- Restriction of machine movement. Machines were never allowed to encroach within 1m of the top of the bank.
- No reprofiling of earth banks. Exceptions were only considered following on-site confirmation from Natural England that no water voles are present.
- Placing of dredged materials along the channel margin, leaving a gap of approximately 10 cm between the inside edges of the existing bank and material deposited in the river, in order to avoid damaging existing bank habitats.
- Where narrowing of the channel with dredged material was undertaken to create deflector “shoulders” or ledges and there is no gap between the dredged

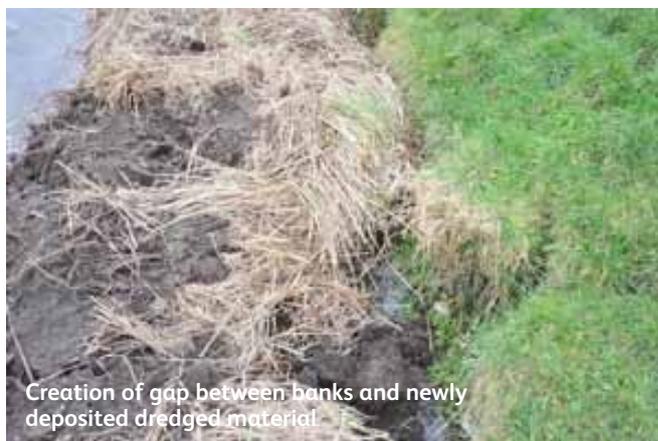
Creation of gap between banks and newly deposited dredged material

material and the bank (this is prime water vole habitat) spades or the back of the excavator bucket were used to reinstate it.
