Title: Riverbank Repairs at Thames Side, Laleham

Location: Penton Hook Reach, Thames Side, Laleham, England

Technique: Installation of coir rolls

Dates: Completed May 2009

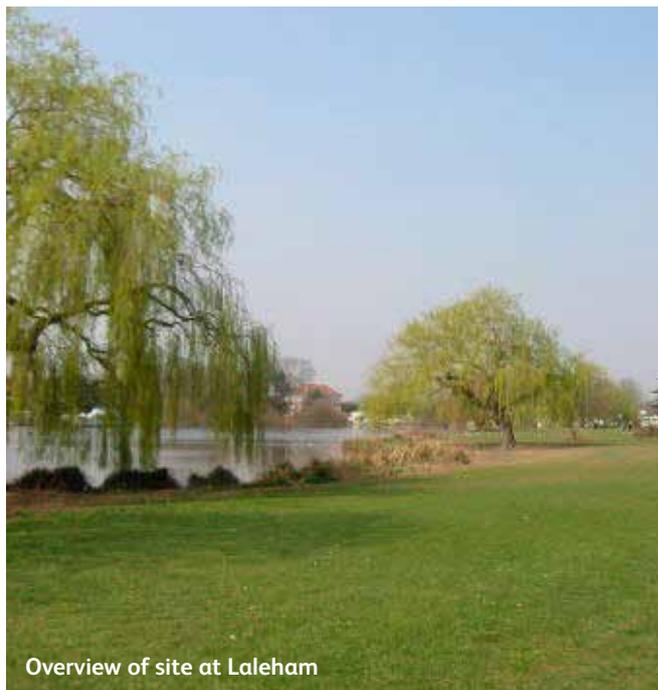
Overview of site at Laleham

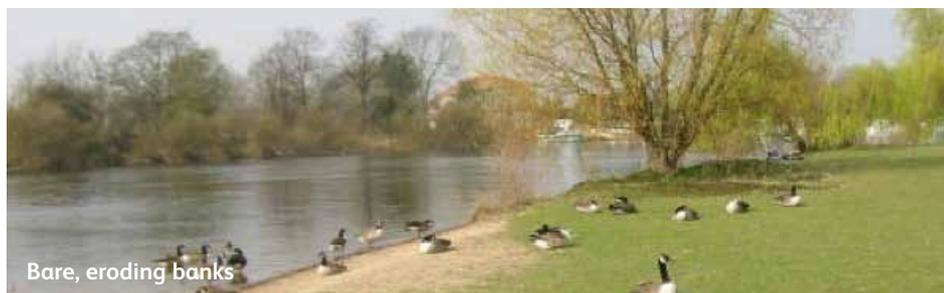
The river banks at Laleham were being eroded by a combination of natural river action and boatwash rolling over the shallow channel margins and up the bank toe.

In addition, waterfowl grazing of riparian vegetation had resulted in the creation of a sizeable area of mudflat. Before the project, bank destabilisation, particularly during high flows, had been further augmented by the lack of rooted foliage on and adjacent to the banks.

Bare, eroding banks

- Installation of soft bank protection in the form of pre-planted coir fibre rolls, which were held in place by stakes through their entire length and dug into the bed level.
- Anti-scour protection was installed to safeguard the coir rolls where water levels deepened.
- Creation of irrigation trenches joined to a rear trench planted with further marginal vegetation.
- Temporary fencing of the area to prevent access and promote establishment of vegetation (some gaps were put in place to allow access to the waters' edge).

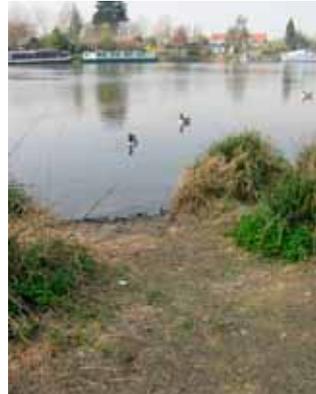
(1) Access point along riverside

- Incorporating specific access points along the bank is important to control trampling of newly established vegetation.
- Fencing off the site during the establishment phase protects the young plants from trampling and animal erosion, promoting the successful establishment of marginal aquatic vegetation.
- Allow some contingency against the failure of one or more species due to external factors, such as the grazing of waterfowl.
- Coir fibre rolls should be installed such that they are partly (2/3rds) submerged below normal summer water level.

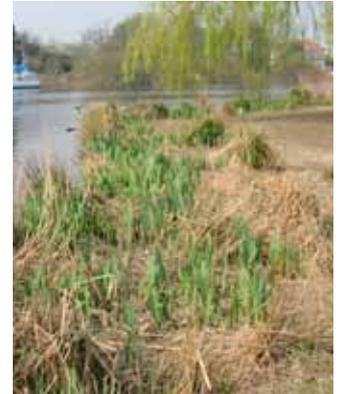
(2) Planting along the bankside

- The coir rolls provide a valuable habitat for fish, mammals and aquatic insects.
- Root systems provide consolidation of sediments and maintain a stable bank through prevention of scour.
- The marginal vegetation absorbs wave energy and boat-wash – boat wave dissipation varies according to species and width of reed bed (typically 2 m of common reed will absorb about 60 % of boat wave energy). In central sections of the project area the marginal vegetation was growing to a width of up to 3 m two years after the project conclusion.
- The natural bank has regenerated and maintained its own stability.
- No further maintenance investment is required due to appropriate selection of vegetation.
