Healthy Catchments – Managing Water for Flood Risk and the Water Framework Directive

Introduction

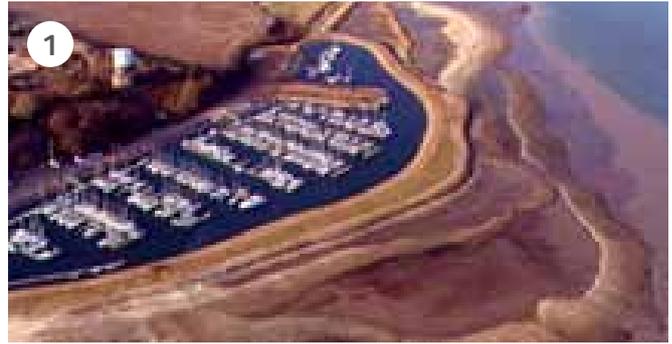
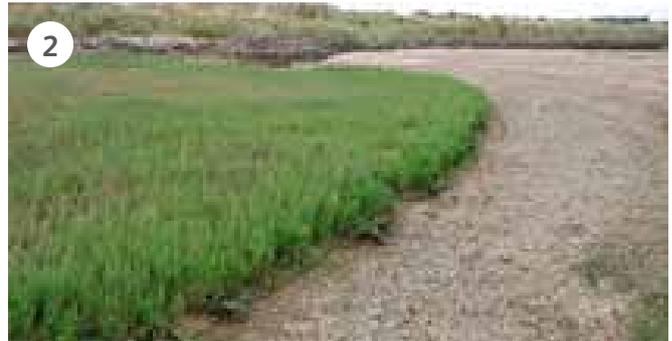
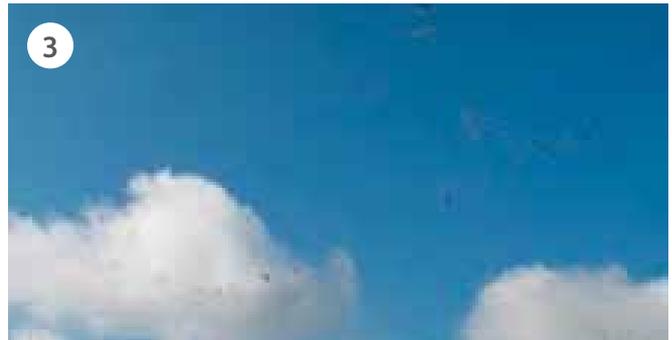
(1) Clay bunds backfilled with silt around Shotley Marina;
 (2) Common glasswort growing on Shotley;
 (3) Wildfowl using the area as a feeding resource.

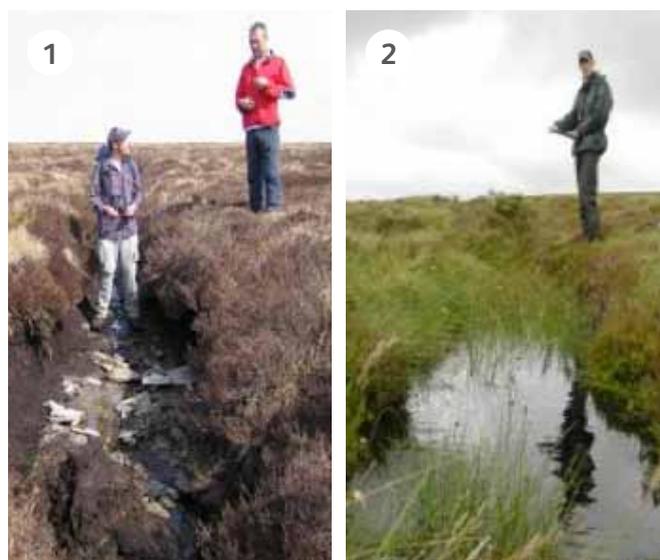
1) Grip before blocking, 2) after blocking

- Impoundment of water behind the dams promotes the raising of the water table in the areas surrounding the ditches, contributing towards the saturation of the soils and the recovery of the peat ecology.
- Improvements to hydrology of the peatland by increasing of storage capacity and flood amelioration.
- Changes to hydrology cause a reduction in stream energy, resulting in a decrease in erosion of peatland and a reduction in sediment supply to the river network downstream; Holden *et al.* (2007) have reported restored grips to reduce sediment production by 54 % when compared to unrestored grips.
- Improvements to local biodiversity;
- Improvements to potential for carbon storage and sequestration within peatland habitat.

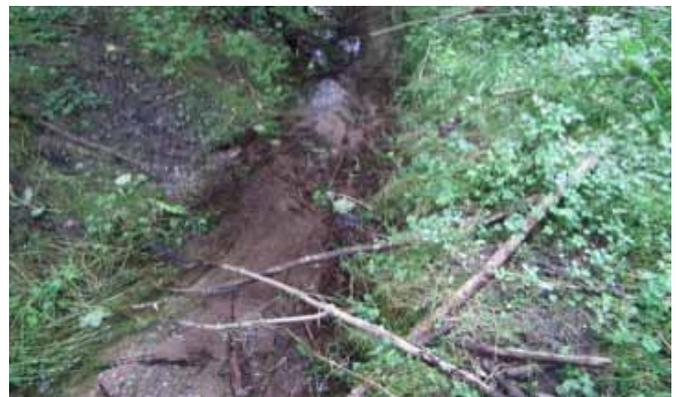
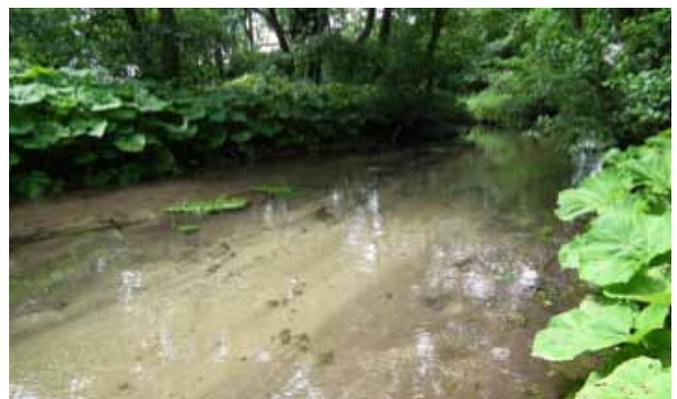
Examples of siltation in Neat Holmes wood prior to implementation of strategy.

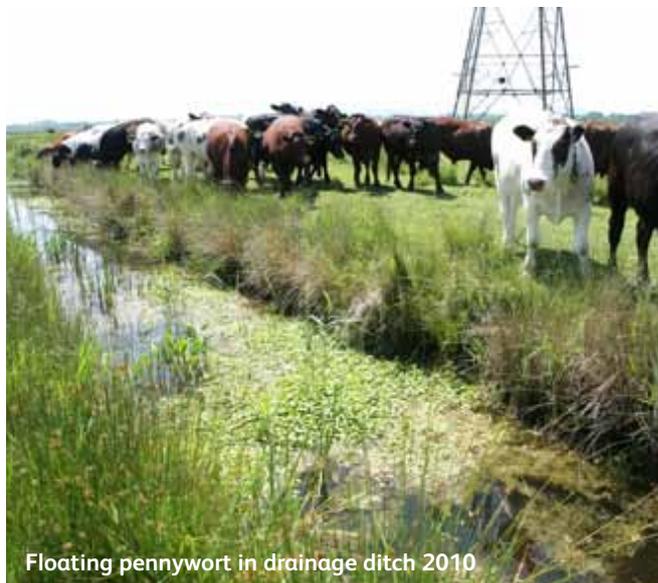
Floating pennywort in drainage ditch 2010

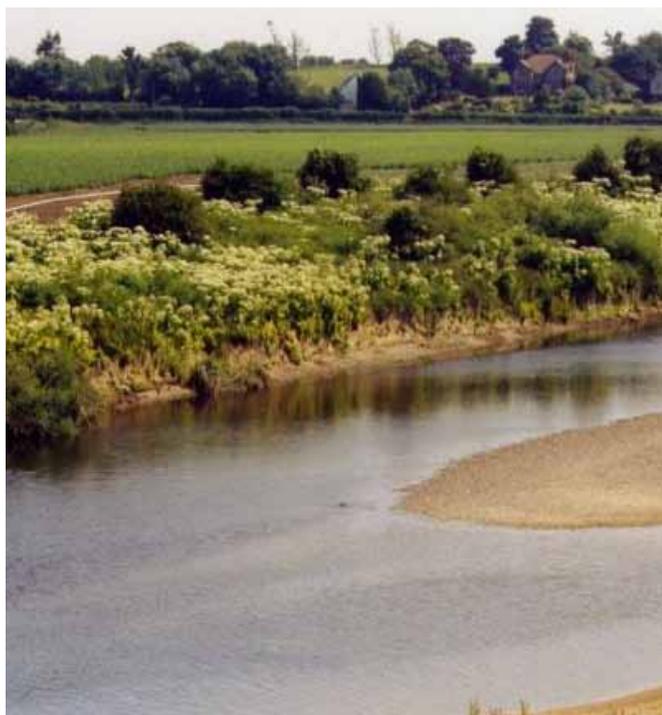
Norham Bank, Northumberland, before treatment. The white flowers of giant hogweed can be clearly identified.

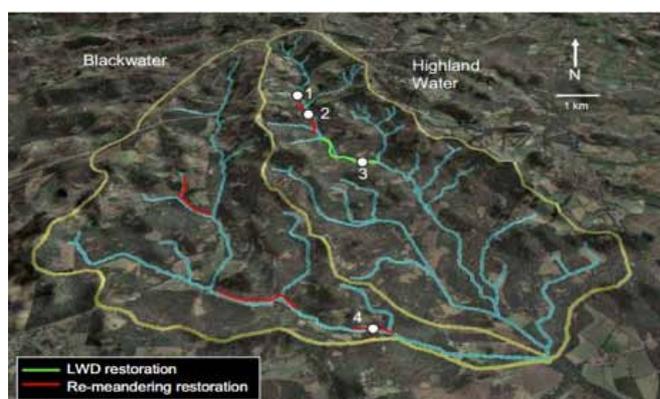
LIFE-3 project catchments showing the locations of channel/floodplain restoration and the main monitoring reaches.

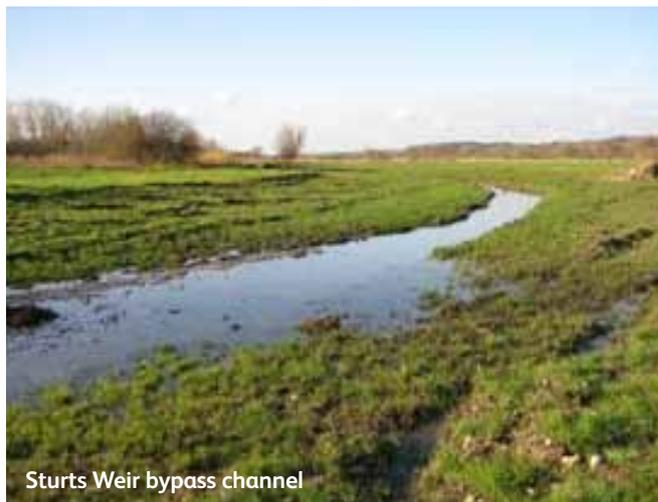
Sturts Weir bypass channel

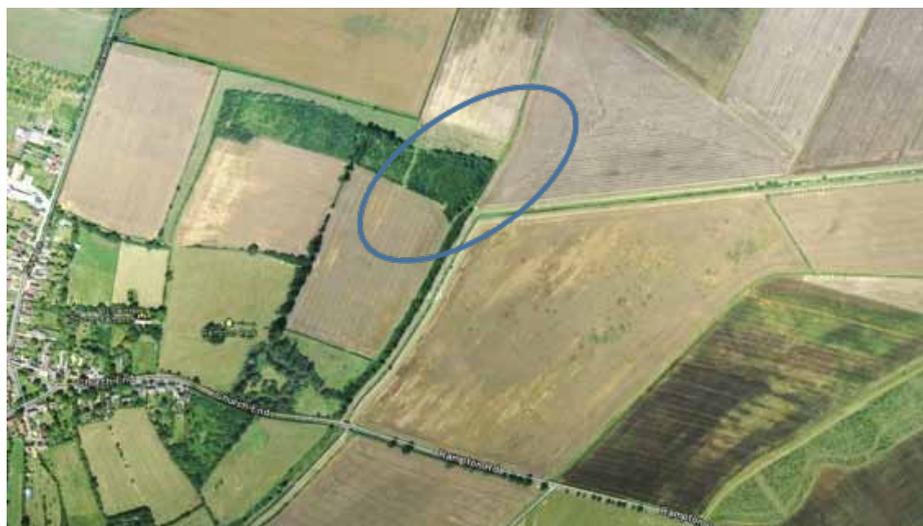
Overview of straightened and impounded project site

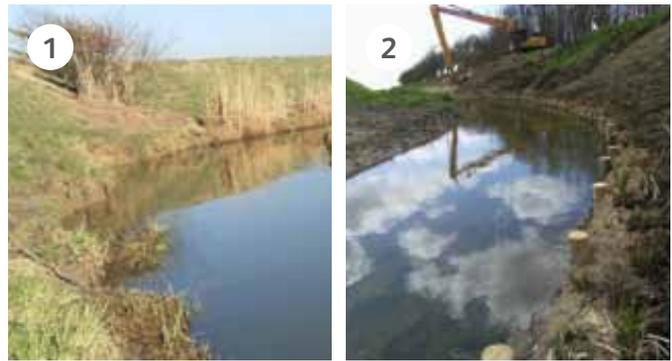
1) Failing bank at Cottenham, before scheme implementation
2) Installation of “soft” bank protection

- Reprofilng of river banks.
- Creation of a new berm along the left bank.
- Use of soft engineering techniques, namely a combination of pre-established coir rolls and matting.
- Installation of piping to allow water voles to gain access to burrow entrance.

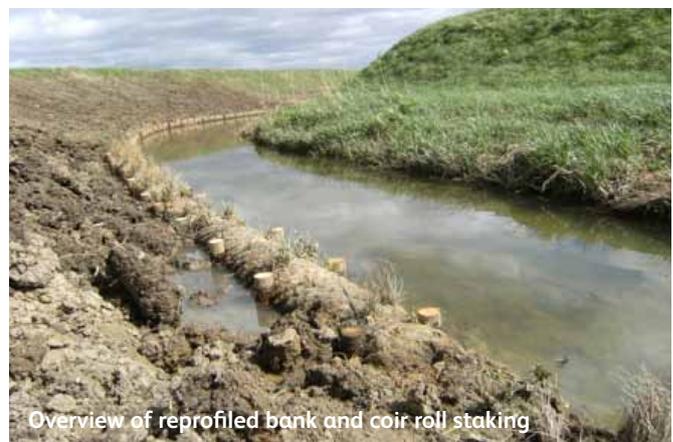
Overview of reprofiled bank and coir roll staking

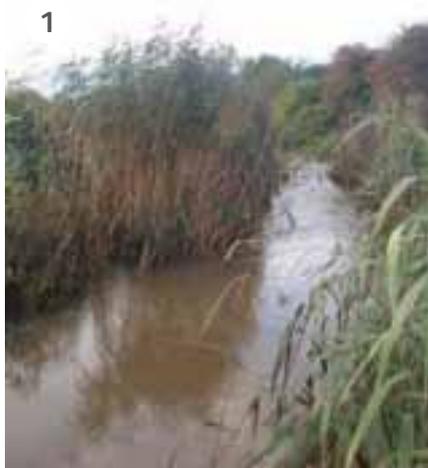
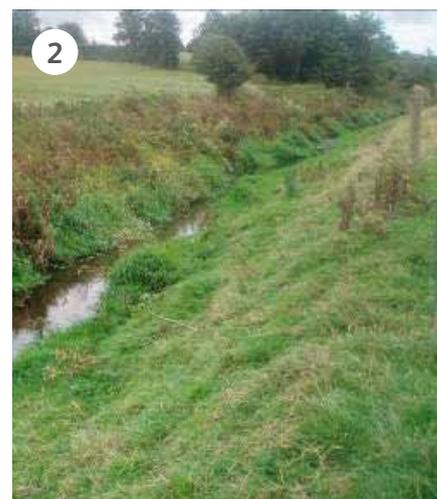
(1) Low water table prior to scheme, resulting in drained marshes and degraded habitat;
 (2) Raised water levels post-scheme have led to restoration of grazing marsh
 © Environment Agency copyright and database rights 2013

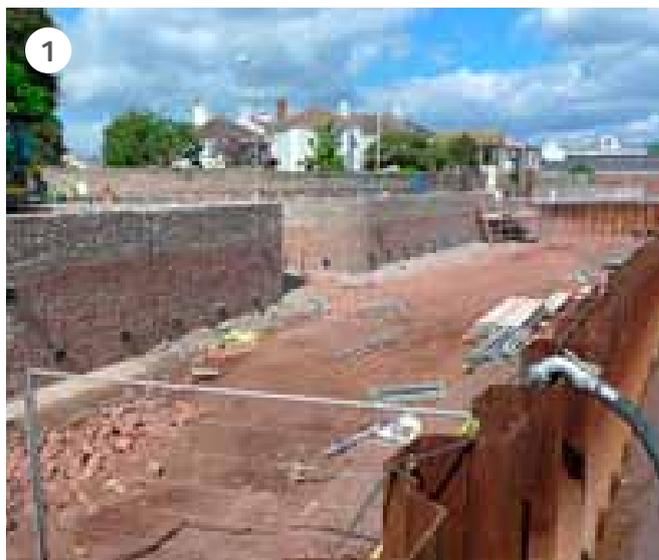
(1) Construction of two walls of the Shaldon and Ringmore tidal defence scheme, into which ecological enhancements were incorporated. May 2010

As several of the existing concrete walls were beyond repair, new walls were required in places. These were built from local stone with mortar pointing (Figures 3 and 4). This necessitated a modest 'advancement' of the line of protection (approximately 1 m). The new walls encroached onto the mixed sand and gravel foreshore, which was not designated for its ecology and was of modest ecological value due to degradation caused by compaction by human activity (e.g. walking and boating) on the foreshore. For these reasons, it was decided that restoration of the foreshore would yield limited ecological gains. However, the scheme required planning approval and the Environmental Impact Assessment required some form of ecological compensation to offset impacts.

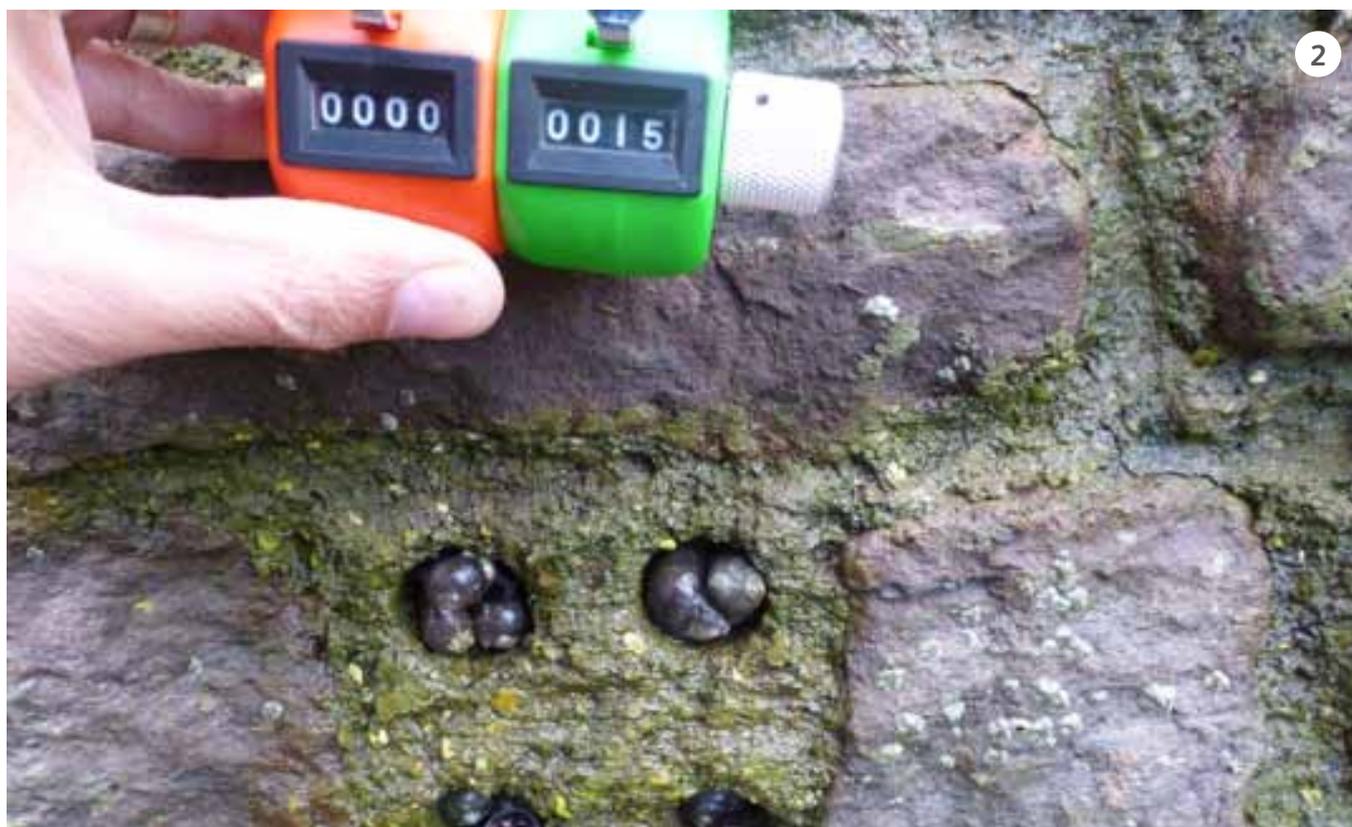
(2) Niche habitat colonisation after 18 months

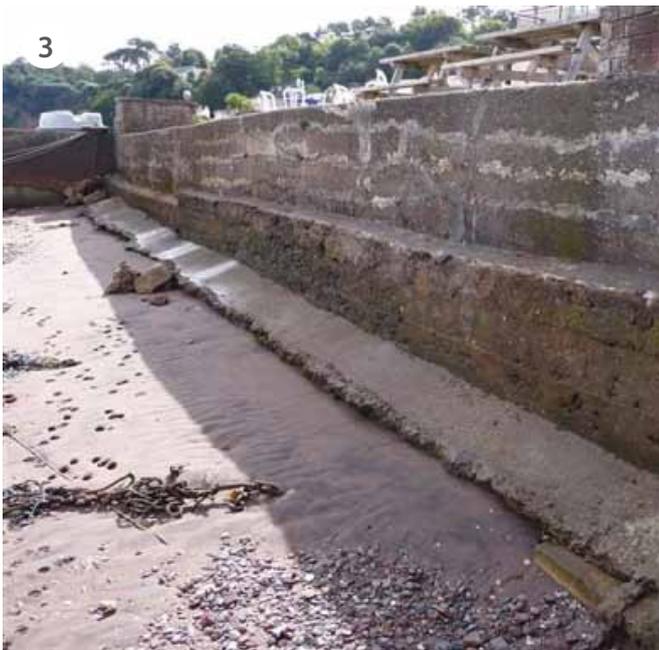
(3) Old flood wall with low numbers of species and individuals

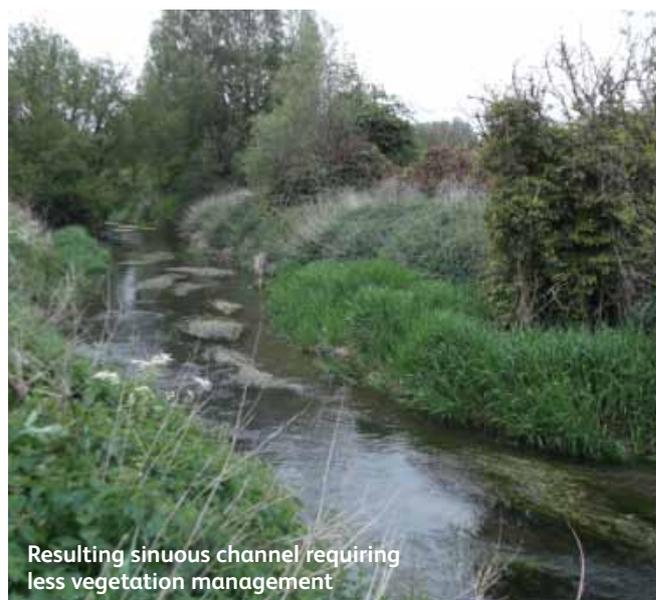
Resulting sinuous channel requiring less vegetation management

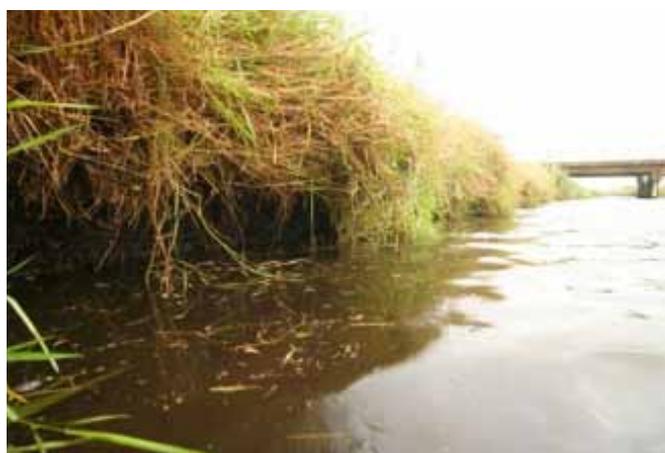
Undercutting erosion caused by wave erosion and discharge from adjacent pumping station outfall

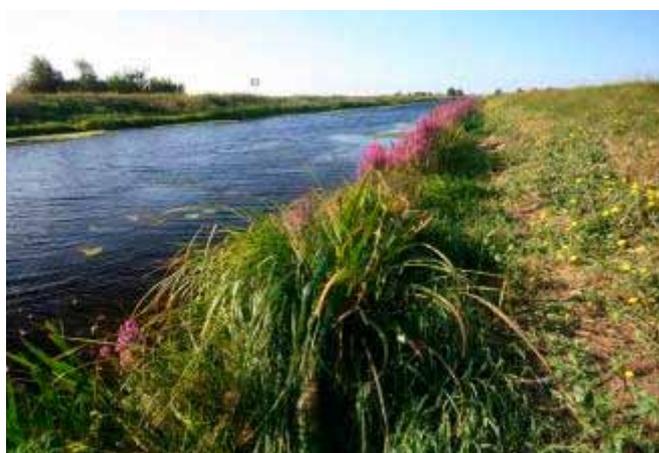
September 2009, seven months after installation, lesser pond sedge and purple loosestrife have developed strongly.

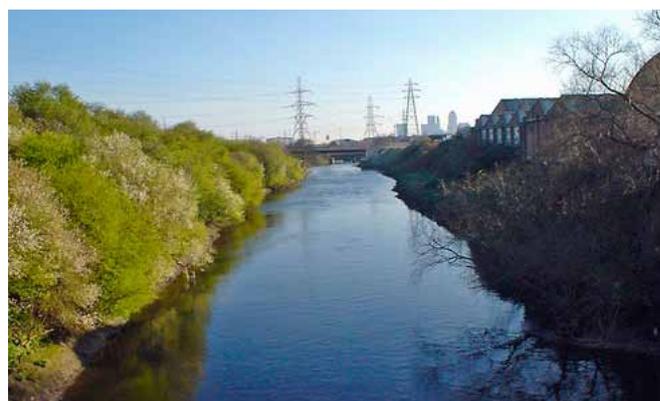
Left: The River Lea prior to reprofiling. Below: Reprofiled bank plan. The diagram shows the existing bank profile in dotted lines with the scheme design of a wider graded back channel profile with backwaters, reed beds, public access routes.

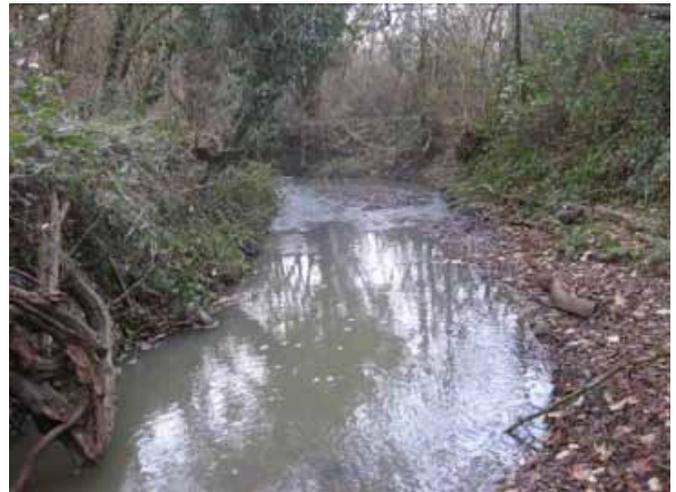
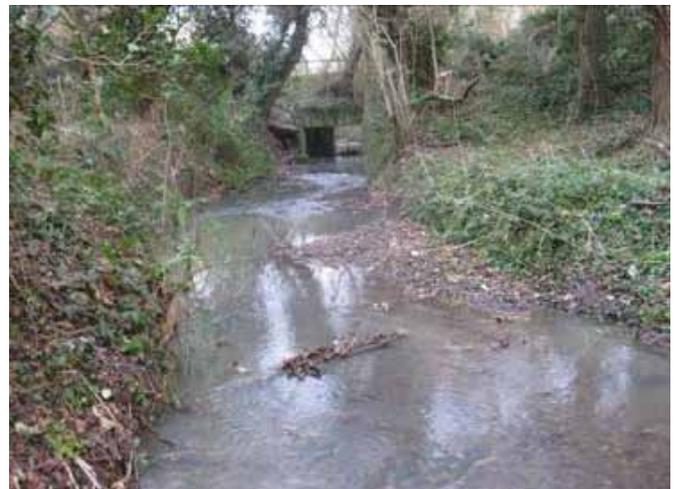
Improved channel conditions resulting from mitigation measures outlined above.

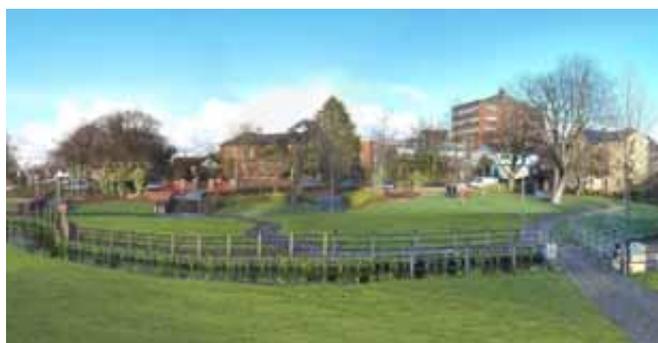
Artist impression of restored Lodge Burn at Anderson Park (Downstream of Poundstreecher culvert)

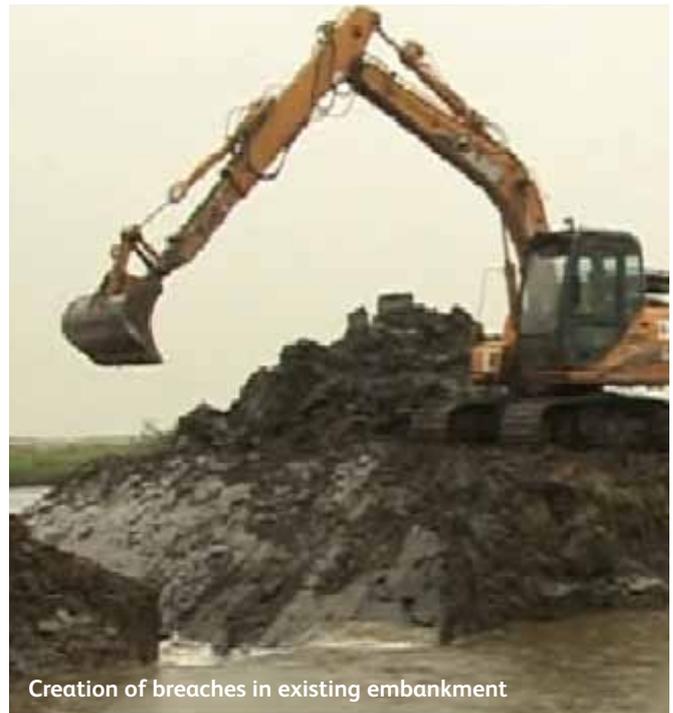
Creation of breaches in existing embankment

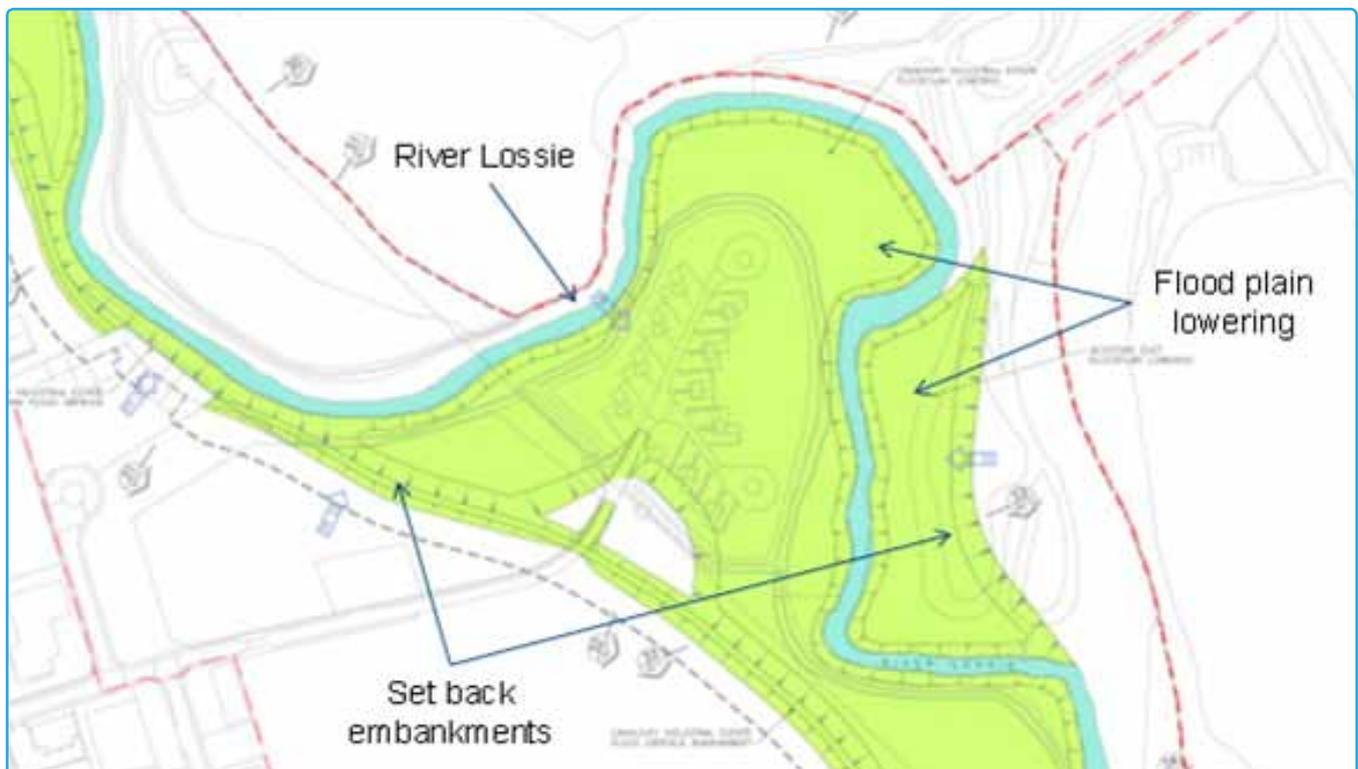
Example design of the Elgin Flood Alleviation Scheme. This section indicates the floodplain lowering and set back embankments used around the Moycroft and Chanonry section of the River Lossie. The full scheme involved modification to 1.5km of the River Lossie, Tyock Burn and Linkwood Burn.

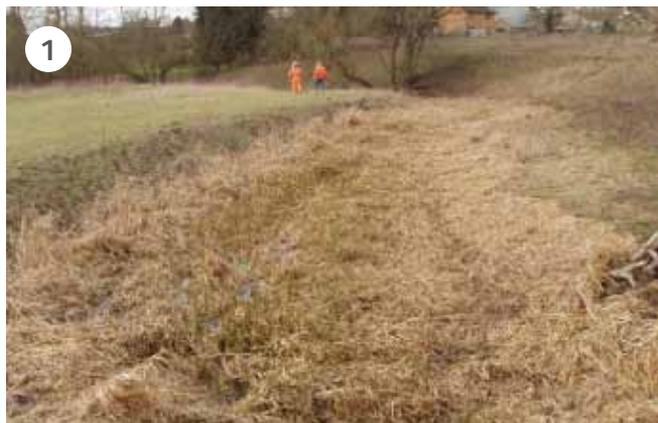
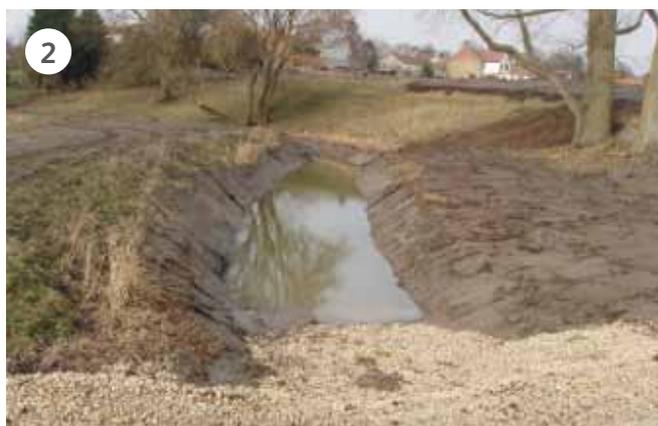
(1) Backwater channel prior to restoration works
(2) Backwater channel post restoration works

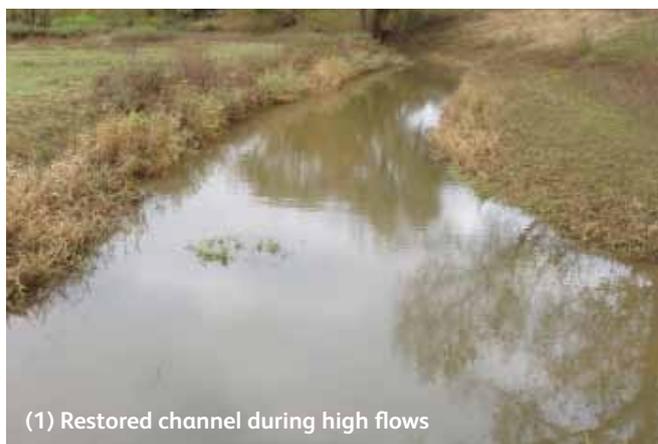
(1) Restored channel during high flows

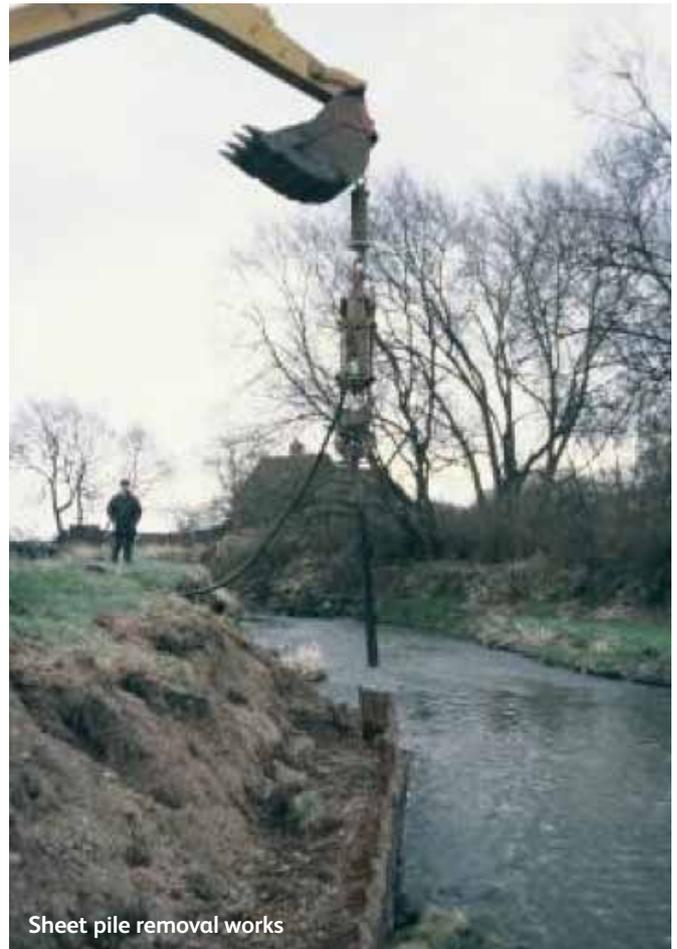
Sheet pile removal works

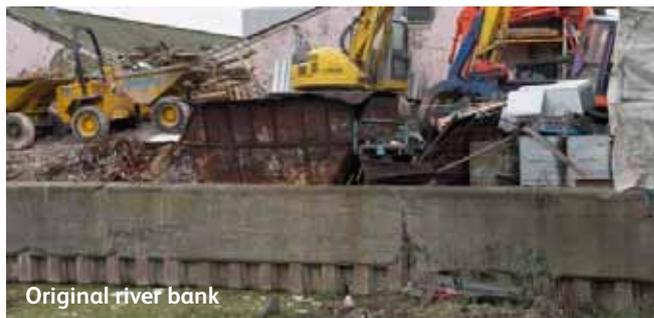
Original river bank

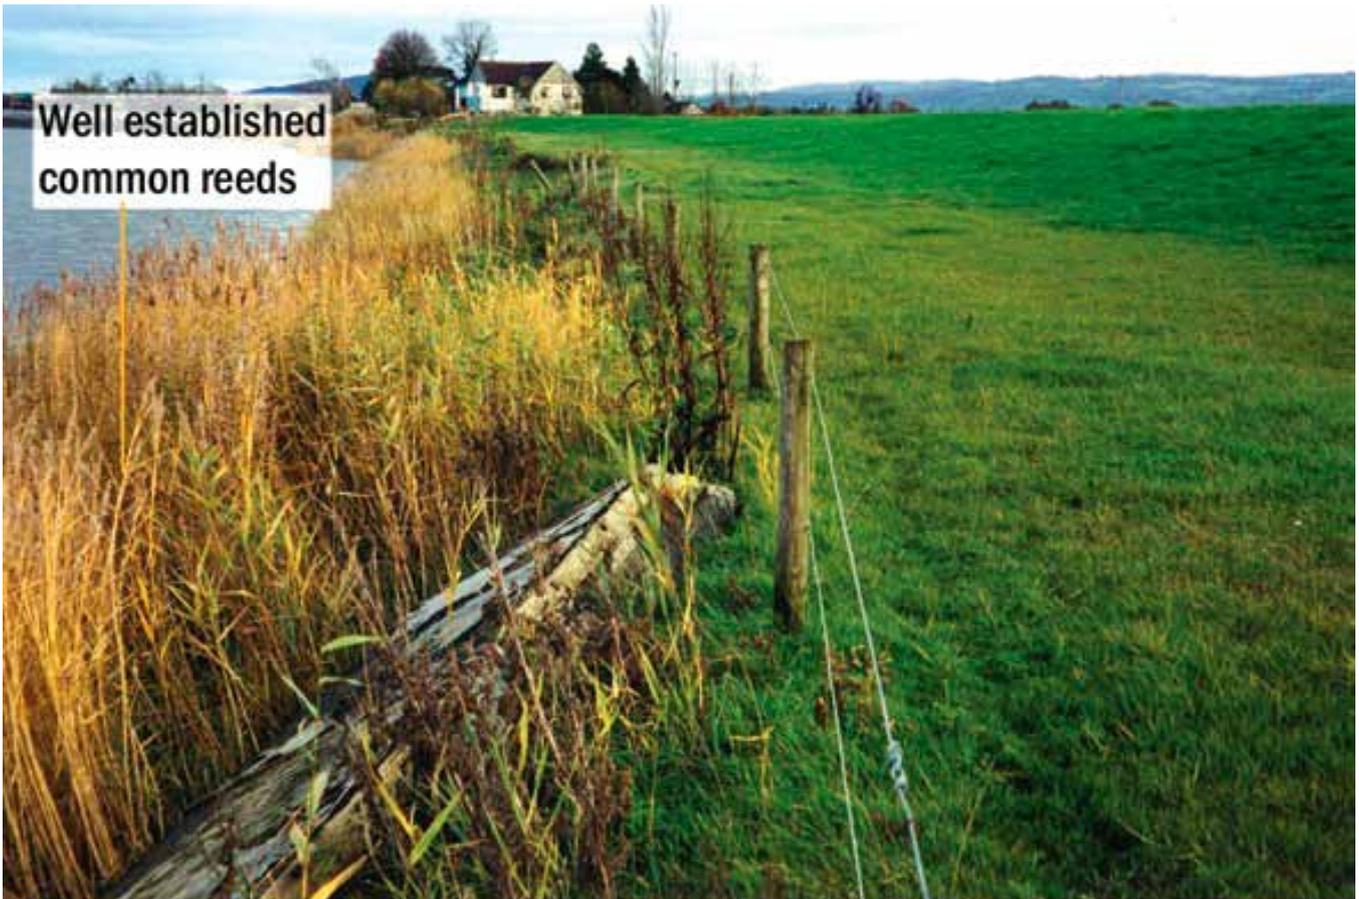
Successful restoration with well-established bankside vegetation

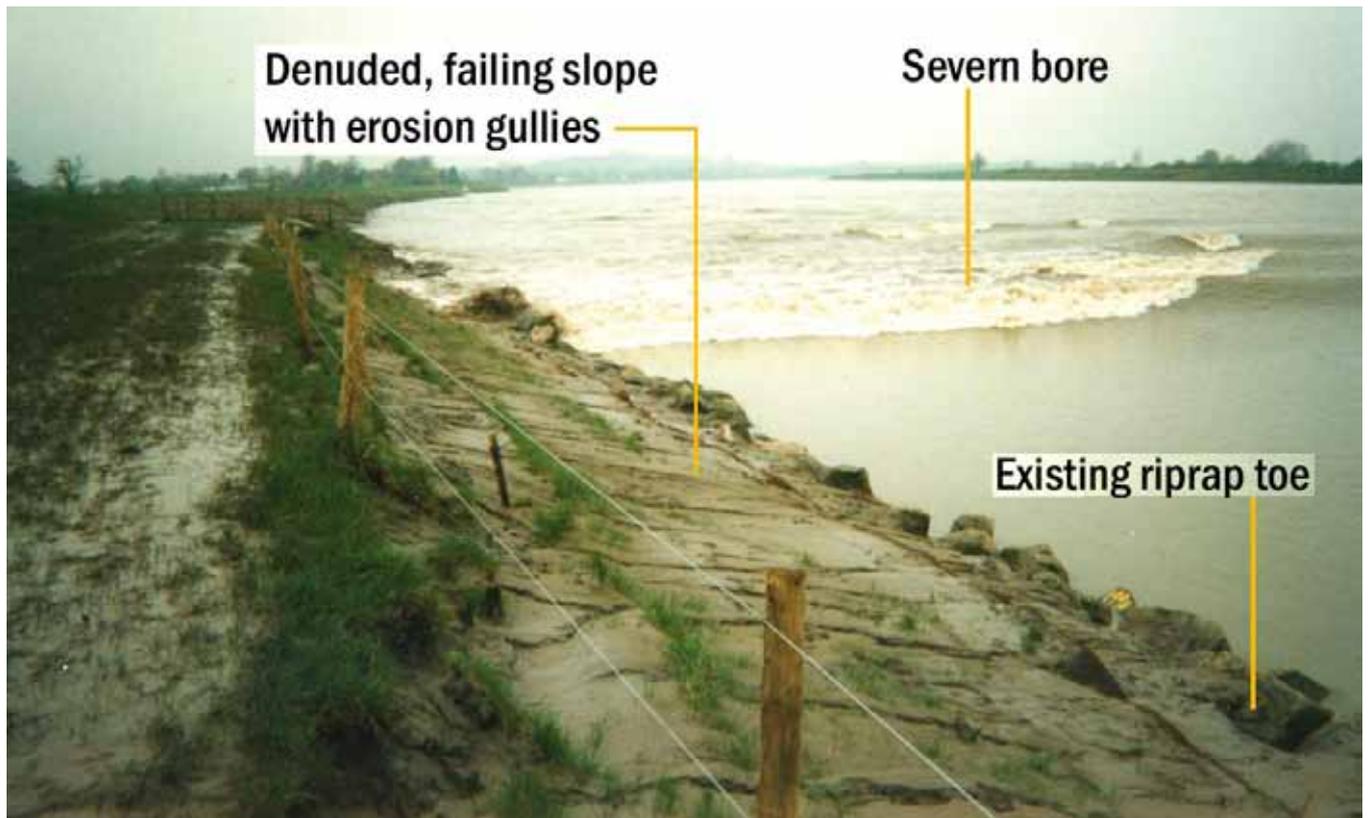
Eroding banks at Longney
