## ÓRBIGO RIVER

| <b>Title</b> | | <b>Órbigo River ecological status improvement (segment I)</b> | |
| <b>Organization</b> | | Duero River Basin Authority (Ministry of Ecological Transition, Spain) | |

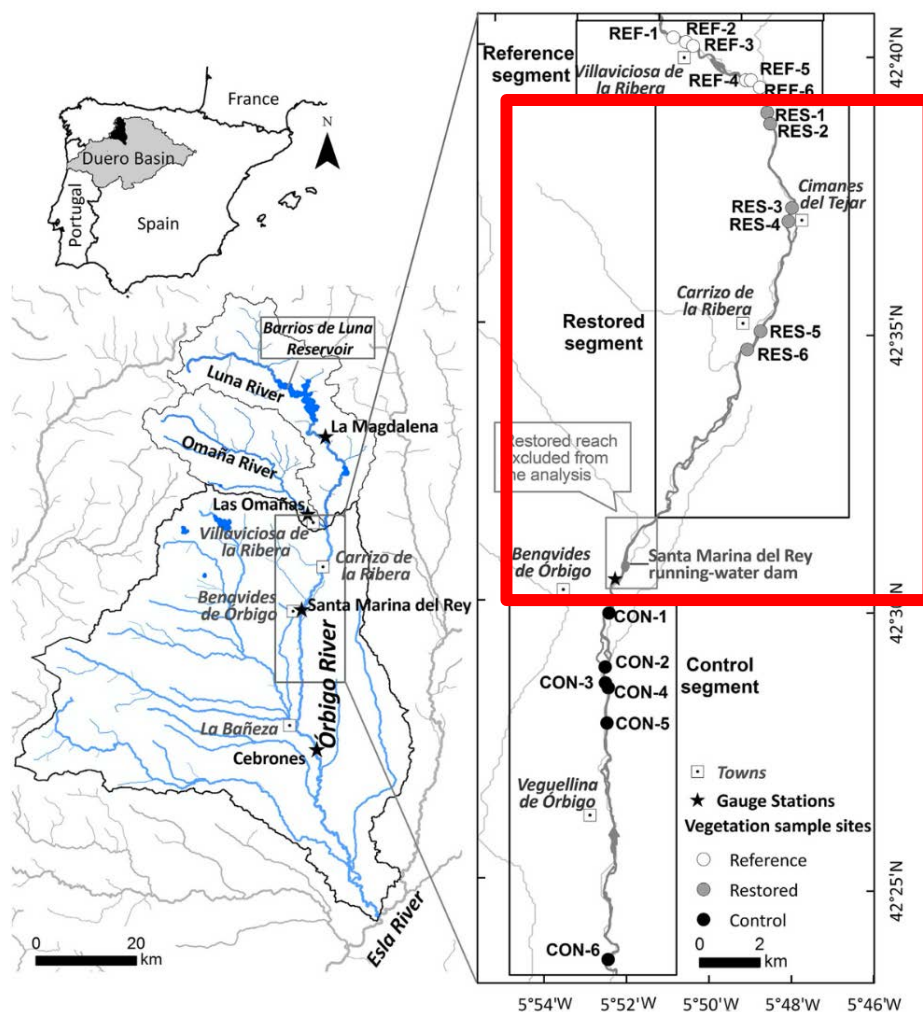
Figure 1. Location of the Órbigo River's restored reach (Martínez-Fernández et al., 2017)

The project comprises the restoration of a 23.5-kilometre segment of the Órbigo River between Cimanes del Tejar and Santa Marina del Rey (Fig. 1), near the city of León.

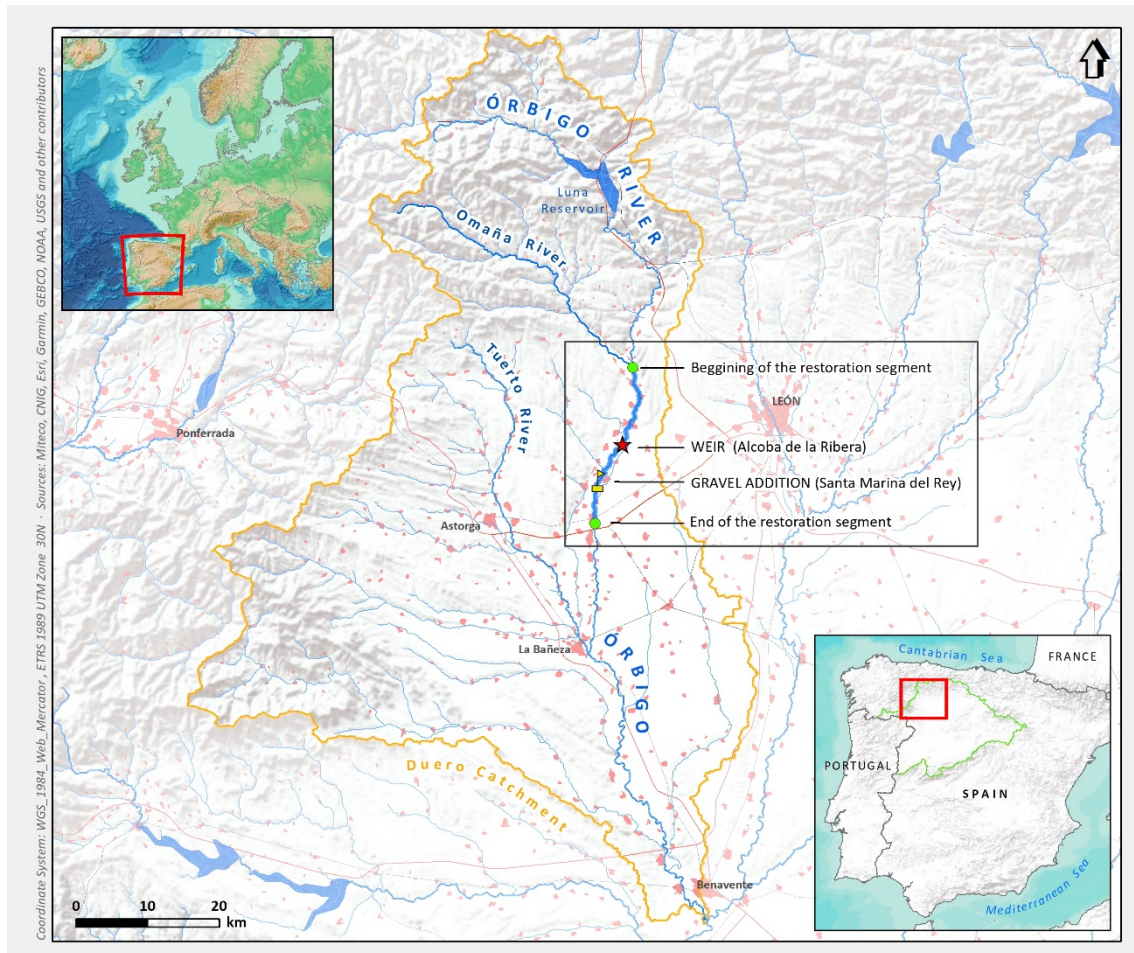
Figure 2. Órbigo River basin and restoration actions locations

The Órbigo River is located in the northern part of the Duero/Douro Basin (NW Spain). Its length is 160 km and the total catchment area is 5,040 km<sup>2</sup> (fig. 2). The catchment area up to the restoration section is 1,600 km<sup>2</sup>. The river is regulated at the head by the Barrios de Luna reservoir (in green in Fig. 2) since 1956.

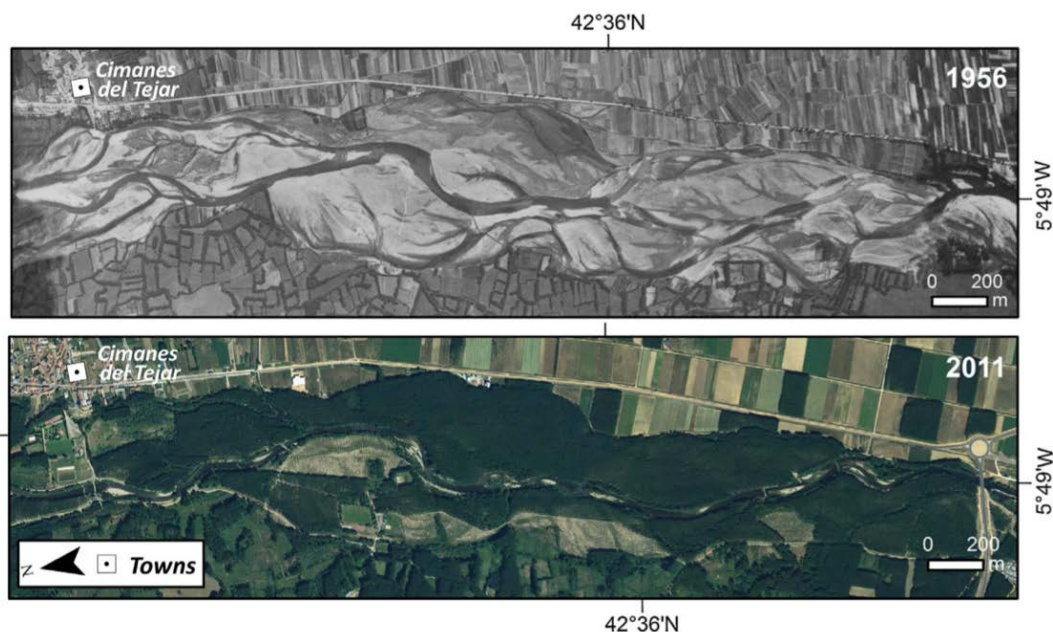
Figure 3. Disappearance of the braided channel of the Órbigo River, narrowing and occupation by poplar plantations (Martínez Fernández et al., 2017)

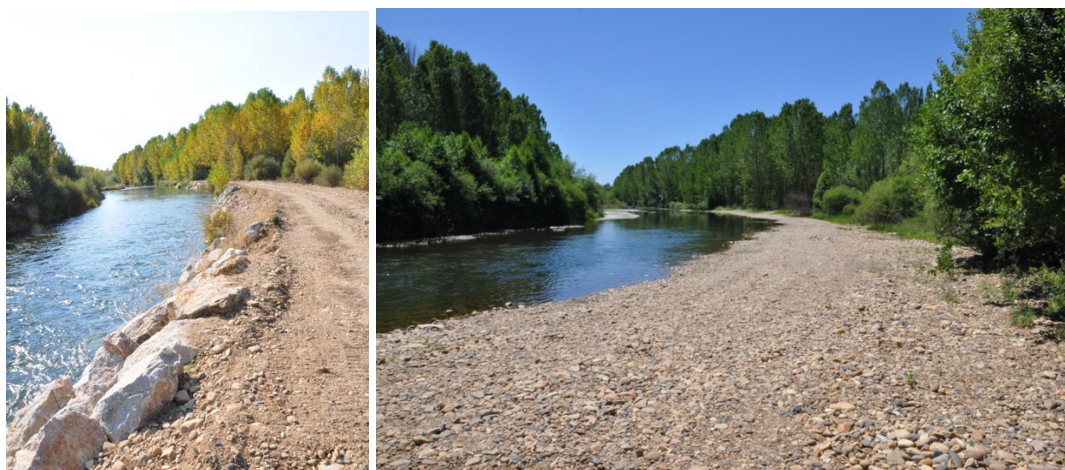
Figure 4. Before and after the river restoration (photo: J.I. Santillán)

The project received an investment of € 2.2 million and formed part of the Spanish National Strategy for River Restoration. Works began in autumn 2011 and was completed in autumn 2012. The main actions consisted of eliminating earth embankments and rip-raps along a total of 13.4 longitudinal km and setting them back along another 5.2 km.

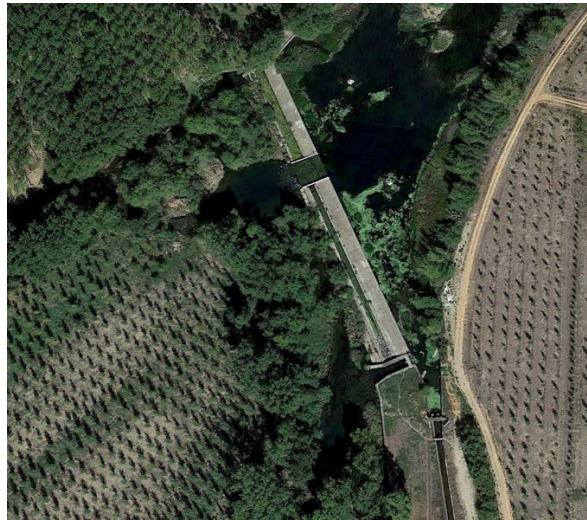
Figure 5. The Alcoba de la Ribera weir (Google Earth, 2017)

Also, the Alcoba de la Ribera weir has also been made permeable by breaking it through the centre for a length of 16 m, adopting a removable system using profiles and planks, so that during the times of migration of salmonids the weir can be completely remountable (Fig. 5). With this action, 22 km of river have been reconnected.

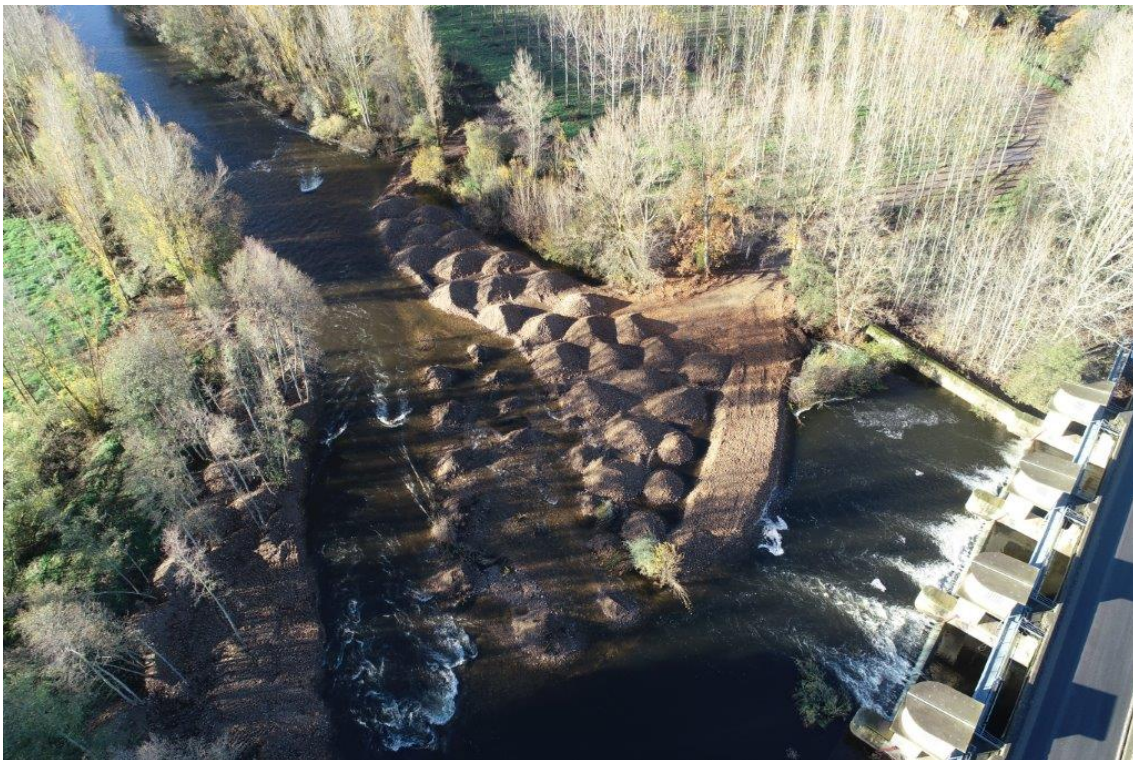
Figure 6. Gravel deposited downstream and extracted from Santa Marina del Rey weir (Google Earth, 2017)

- Gravel from removed lateral dikes, material that had been previously excavated from the river. In 2015 9,500 m<sup>3</sup> from the removed dyke between Castrillo de San Pelayo and Villoria de Órbigo added in Veguellina de Órbigo and 14,000 m<sup>3</sup> from the removed dyke in the confluence of Órbigo and Tuerto Rivers. In 2022 2,300 m<sup>3</sup> of a removed dyke in the Tuerto River tributary.
- 23,680 m<sup>3</sup> of gravel extracted in 2021 and 2022 from the Santa Marina del Rey reservoir and deposited downstream the weir (Fig. 6).

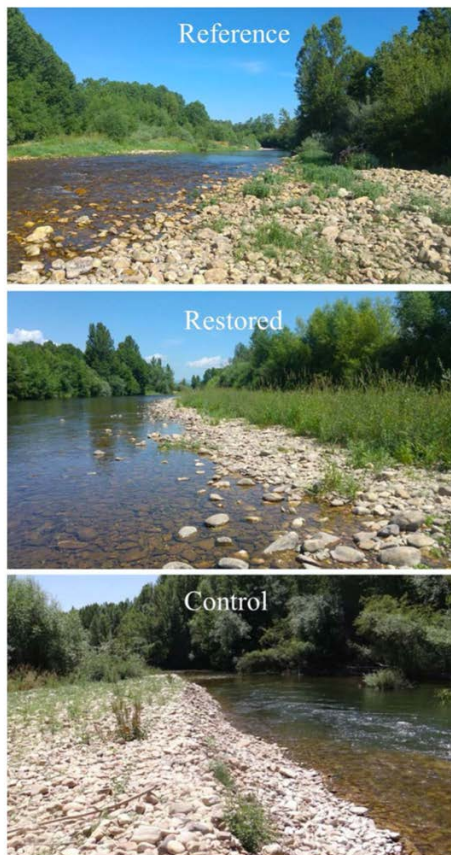
Figure 6. Images of representative sample sites in the reference, restoration and control segments in monitoring research of Martínez-Fernández et al. (2017).

In a complementary way, the research of Martínez-Fernández et al. (2017) carried out morphological analysis and field surveys of vegetation in 2016, working in three segments of the river (Fig. 6).

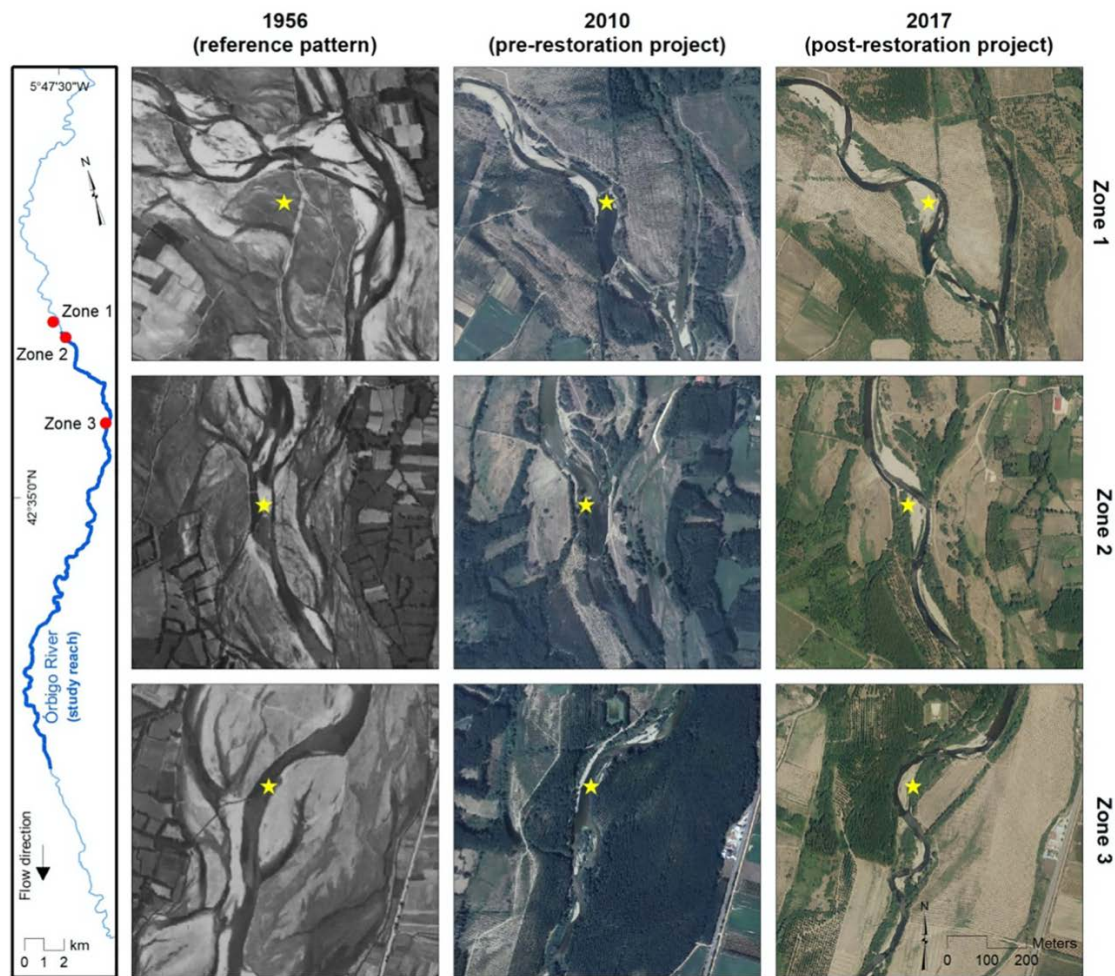
Figure 7. Morphological evolution of the channel and floodplain in the context of the Órbigo River restoration project. The yellow star points to the same site in each period (García et al., 2021)

The project had a positive impact on land planning and flood-risk management (mitigation) and recovery of the river dynamics, morphology and hydraulic capacity of the channel (Fig. 7). The project has meant a paradigm shift on how to treat rivers and the problems that affect them (García et al., 2021).

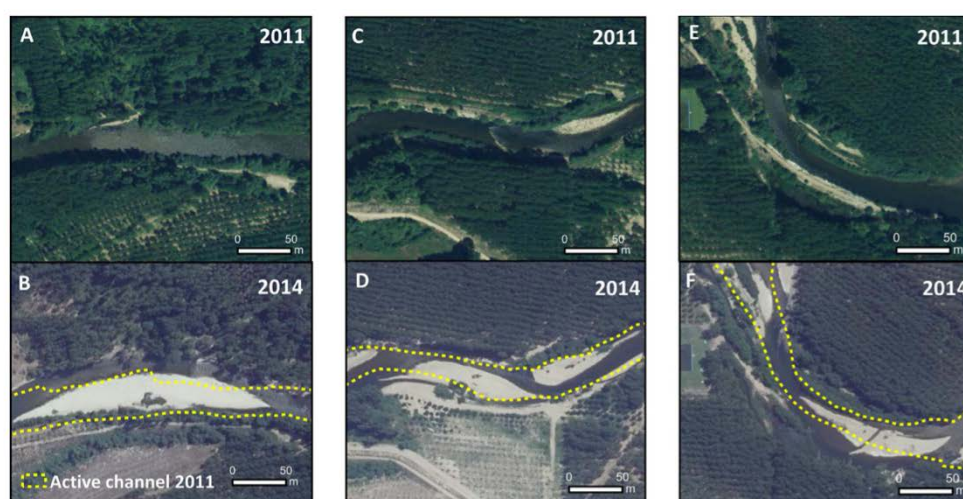
Figure 8. Reactivation of the channel between 2011 and 2014 (Martínez-Fernández et al., 2017)

Lateral and longitudinal connectivity are recovery: riprap, embankments and deflectors removed; 26 secondary arms (side-arms) recovery (10 km overall length); modification of transversal obstacles to allow fish and sediment transport (weirs of Alcoba de la Ribera and Santa María del Rey). The river has achieved to reactivate the channel (Fig. 8) and increase its sinuosity and braiding (table 1).

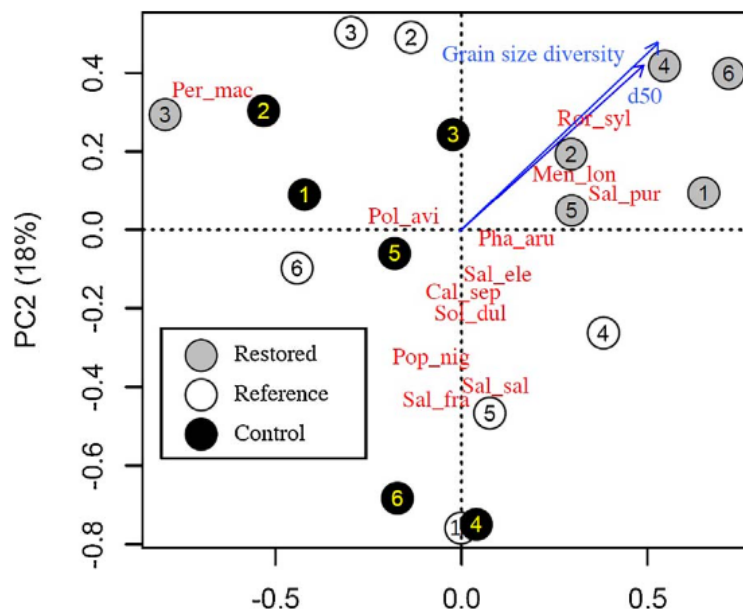
Figure 9. Monitoring of riparian vegetation recovery (in Martínez-Fernández et al., 2017): Plot of the two first axes of the Principal Component Analysis (PCA) processed from the community composition (Hellinger transformation, red acronyms) observed at the 18 study sites. Only the scores of the 10% species with the highest weight in the two first axes of the PCA are shown, multiplied by 1.2 to improve visual clarity. The positions of the three site types were compared on each axis using t-tests with site scores as the dependent variable. Letters indicating homogeneous t-test groups ( $P < 0.05$ ). PC1: Reference = ab, Restored = a, Control = b; PC2: Reference = ab, Restored = a, Control = b. Species abbreviations are: Cal\_sep = *Calystegia sepium*, Men\_lon = *Mentha longifolia*, Per\_mac = *Persicaria maculosa*, Pha\_aru = *Phalaris arundinacea*, Pol\_avi = *Polygonum aviculare*, Pop\_nig = *Populus nigra*, Ror\_syl = *Rorippa sylvestris*, Sal\_ele = *Salix eleagnos*, Sal\_fra = *Salix fragilis*, Sal\_pur = *Salix purpurea*, Sal\_sal = *Salix salviifolia* and Sol\_dul = *Solanum dulcamara*. The blue arrow indicates the direction and strength of the correlation between PC1 and PC2 and the d50, i.e., 50th percentile of the grain size (PC1:  $P = 0.025$ , PC2:  $P = 0.086$ ). The blue arrows indicate the direction and strength (see axes values) of the correlations between PC1 and PC2 and the d50, i.e., 50th percentile of the grain size (PC1:  $P = 0.025$ , PC2:  $P = 0.086$ ) and the grain size diversity (PC1:  $P = 0.024$ , PC2:  $P = 0.049$ ).

Revegetation with riparian trees (*Salix alba*, *Populus nigra*, *Alnus glutinosa*, *Fraxinus angustifolia*): 7.2 ha (recovery of riparian vegetation: 0.6%). This is an aspect to be expanded in subsequent phases of the project (not yet implemented). Riparian vegetation recovery has been analyzed in the monitoring research of Martínez-Fernández et al. (2017) (Fig. 9).
