# Reopening existing culverts

**Title:** Wandle Park River Restoration

**Location:** London Borough of Croydon, England

**Technique:** Providing ecological and landscape enhancements through daylighting a culverted urban watercourse

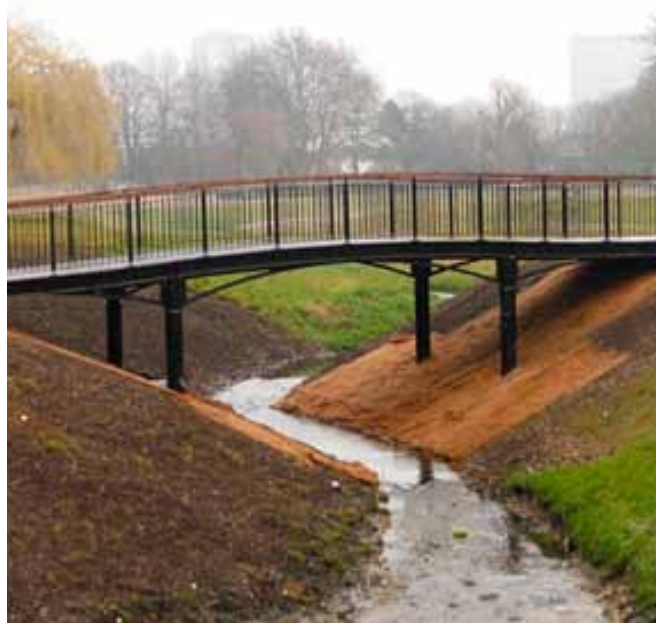
New ornamental bridge over the deculverted River Wandle through Wandle Park All images © Royal HaskoningDHV copyright and database rights 2013

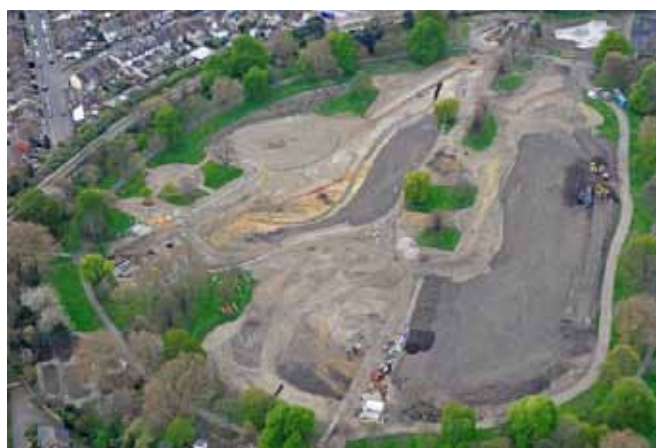
Layout of the park during the early stages of scheme construction

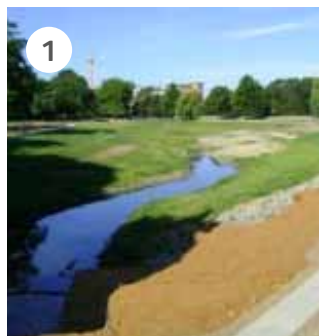
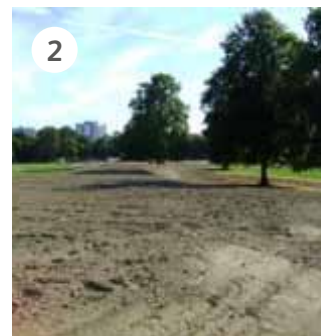
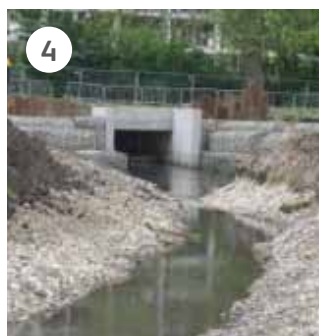
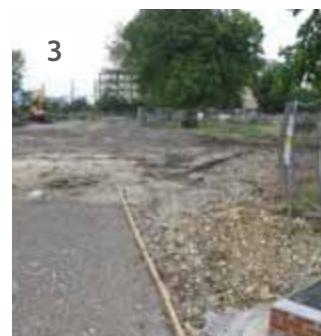
Clockwise:

- (1) Looking downstream from culvert at eastern end of park;
- (2) earthworks adjacent to the watercourse;
- (3) construction of amenity access routes;
- (4) excavation and landscaping of banks around downstream culvert

- Diversion of the River Wandle.
- Removal of the previous culvert.
- Placement of a 300 mm capping layer of topsoil on the banks to prevent contaminated material from entering the watercourse.

- Diversion of a 900 mm Thames Water pipe.
- Excavation of 28,000 m<sup>3</sup> of soil as well as dealing with the high quantities of contaminated ground.

- Construction of flint walls to complement the existing Victorian flint walls.
- Building of two river control structures at the culvert inlet and outlet to the Park with trash screens, erosion control measures and landscaping.

- Landscaping of 50,000 m<sup>2</sup> of park.
- Play area works and recreating, through different types of paving, the abandoned River Wandle route.
- Construction of new ponds, footpaths and a pedestrian bridge over the river.
