# Remove structures that are no longer needed

**Title:** River Uck, Buxted Park: Middle Ouse Restoration of Physical Habitats (MORPH)

**Location:** Buxted, East Sussex, England

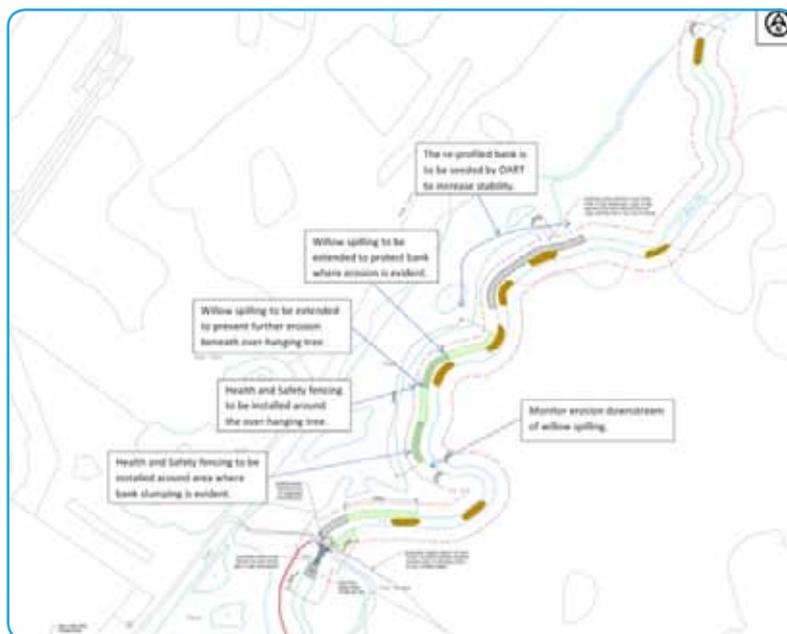
Overview of the Buxted Park restoration scheme, including the weir at the southern end of the reach.

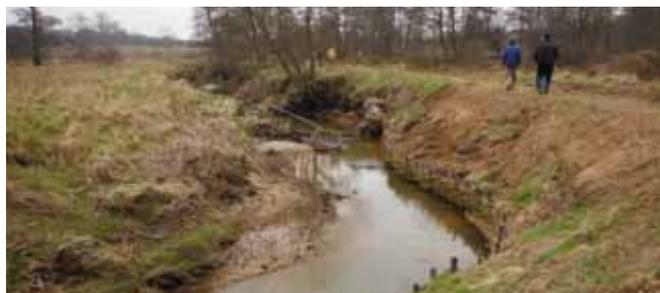
- The reduction in water levels has allowed the banks to collapse naturally, markedly increasing morphological diversity in this formerly uniform reach;
- Seeded gravels have successfully supplemented the naturally occurring gravels in the reach to create areas of increased flow diversity and depositional features. The features have been reworked during large floods but remain in place;
- The new natural bank profiles, in-channel features and gravel deposits provide valuable habitat for coarse fish species, aquatic invertebrates and plants.
- Targeted bank reprofiling and installation of willow spilling is effectively preventing erosion of the bank

toe, and has stabilised vulnerable banks adjacent to the footpath and fishing lakes. This has been used sparingly to maximise the operation of natural processes.
