# Meetings

# **Restoration of river continuity:** model initiatives across France and Europe

Summary of a day workshop organised by the French Agency for Biodiversity on 9 November 2017 in the Paris region (Ile-de-France), with the Yvette valley hydraulic-development syndicate (SIAHVY) and the regional nature park of the upper Chevreuse valley during the European Centre for River Restoration General Members' Meeting, held in France for the first time.

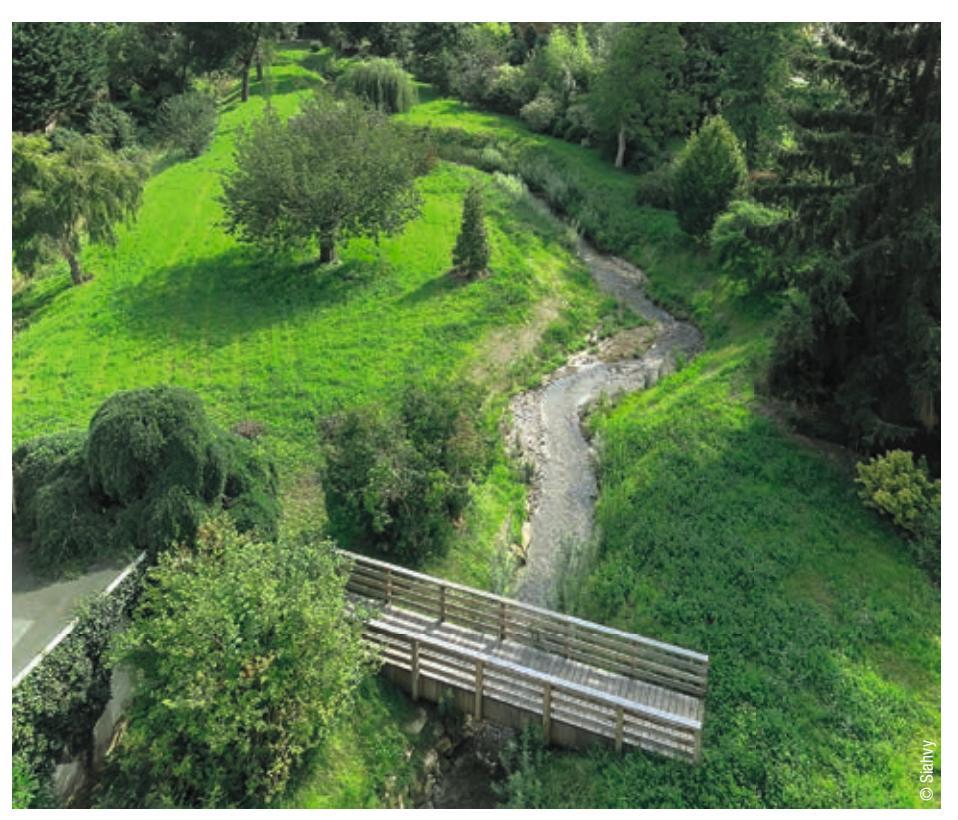
View from the Gibeciaux watermill in Gif-sur-Yvette after work on the River Mérantaise.

We wanted to keep the characteristics of the garden and a water network that respects the Gibeciaux watermill as a historical landmark. We therefore struck a compromise. For example, we agreed to modify the banks and re-establish a riparian vegetation, but we considered their maintenance too complex, which will therefore be carried out at least twice a year by the syndicate. We are generally satisfied with the restoration and any high waters since have not overflowed from the river bed, despite this being a common occurrence in the past!

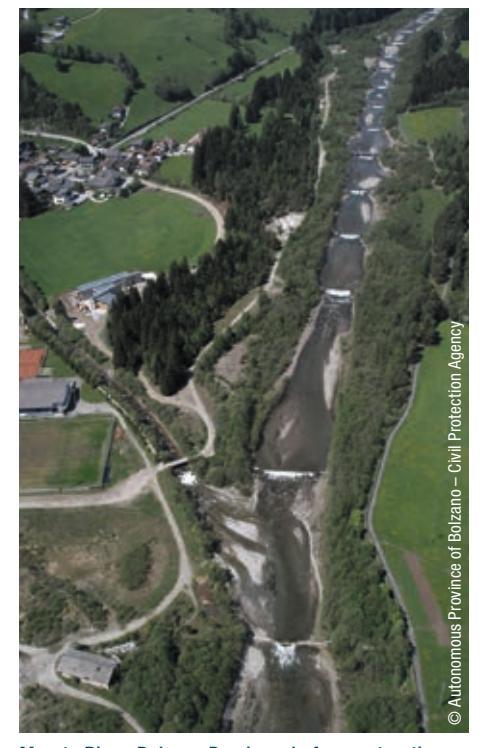
Mareta River, Bolzano Province, before restoration work in 2005, Stanghe, Italy.

The large number of barriers and small hydroelectric plants on watercourses is also an increasing problem in Italy. "These barriers retain sediments upstream, leading to coastal erosion. The modification or removal of these barriers has become important because erosion is now responsible for financial losses. In the past forty years, Italy has lost 14.5 km<sup>2</sup> of beach," explained Giancarlo Gusmaroli from the Italian national centre (Cirf). On the Noce River, 18 of the 25 barriers were lowered between 2001 and 2006, enabling the watercourse to resume its ecological function and the beach to grow once again along the Tortora coastline (Calabria). Another example of restoration is the Mareta River in Northern Italy, which was home to numerous structures and major sediment extraction for the construction of a motorway in the 1970s. A major incision and narrowing of the river bed led to the disappearance of water retention zones, exposing the Vipiteno basin to more intense flooding. Thirty years later, restoration actions were carried out to extend and recreate the river bed. 16 weirs were also destroyed along a 2 km stretch in order to ensure longitudinal continuity on the Mareta.

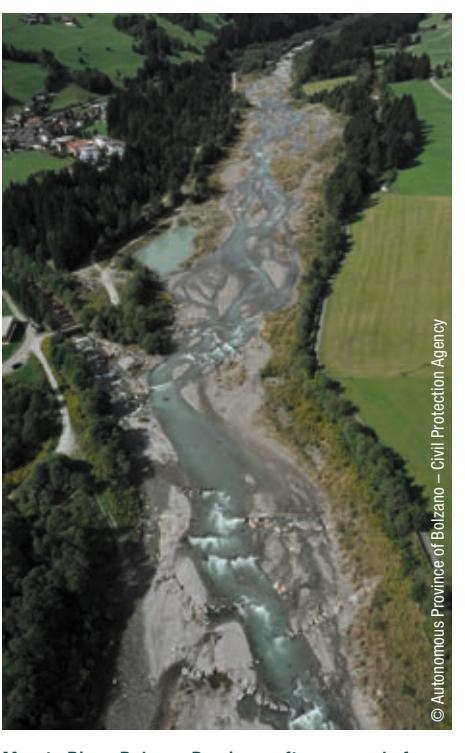
Mareta River, Bolzano Province, after removal of check weirs in 2010, Stanghe, Italy.

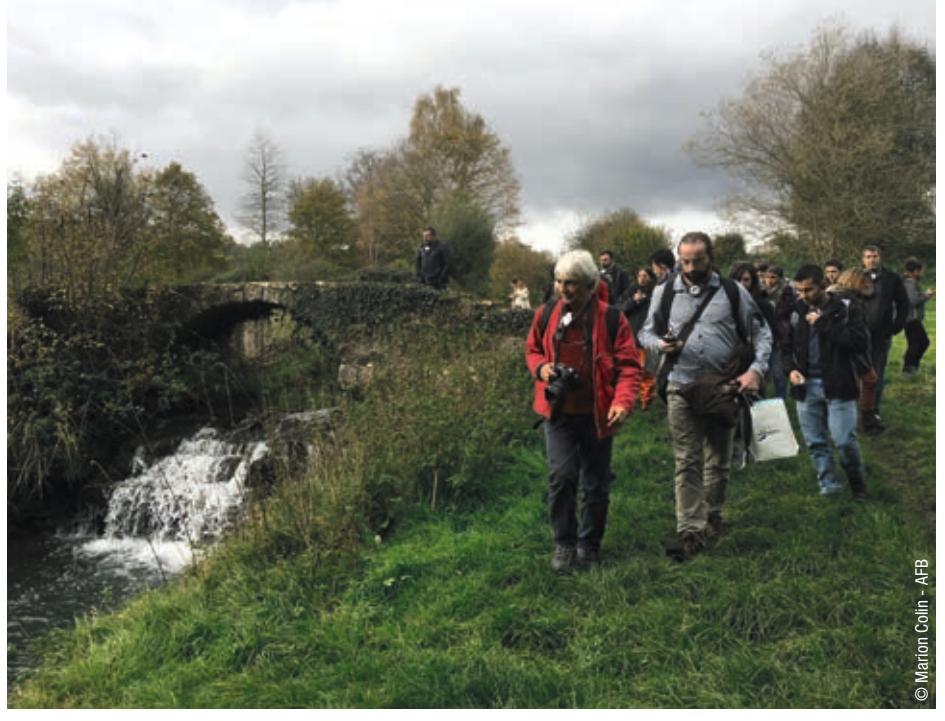
River barrier at the Ors watermill on the Mérantaise, 9 November 2017.

These operations were carried out on private land and consultation with owners was required before project approval. Heritage aspects were also taken into account, such as the Le Lavoir and Gibeciaux watermill sites and CNRS park. "The owners of the restored sites **demonstrated real solidarity** to protect downstream dwellings from the risk of flooding," explains Jérôme Rozanski, adding that "flood mitigation remained the project's no. 1 objective." With the rehabilitation of the spillway, the watercourse can now absorb a fifty-year flood with a flowrate of 8 m<sup>3</sup> per second. These structures have already proven their effectiveness during the floods of June 2016. The work re-established river continuity over a nearly 4-kilometre stretch, but fully impassable barriers still exist upstream, at the Ors watermill.

However, this barrier is not likely to last forever. The watermill is one of the priority targets of the river continuity restoration programme carried out by the HCV RNP. Fish, spawning ground and

barrier inventories established in partnership with Irstea since 2008 have shown that the Ors watermill and building are an upstream limit to trout colonisation, despite favourable rearing and spawning habitat being available upstream. However, it is not easy to remove this structure and restore the watercourse. "This watermill still welcomes visitors and the issue of preservation of built heritage is also important. We need to reconcile these two approaches," explained Virginie Pastor, head of the rivers unit at HCV RNP. Especially as "the 1.5 metre weir is essential to maintaining the road and bridge." The proposed restoration project has been submitted to the DDT (departmental directorate for territories) and consists in conserving the old millstream and creating a bypass channel to go round the weir. If the project is approved, work could start as early as 2020.
