3rd European Conference on River Restoration**RIVERRESTORATION**2004

Removal of riverbank protection along the River Rhine (the Netherlands)

L.J. Bolwidt, H.E.J. Simons, F.R. Kok

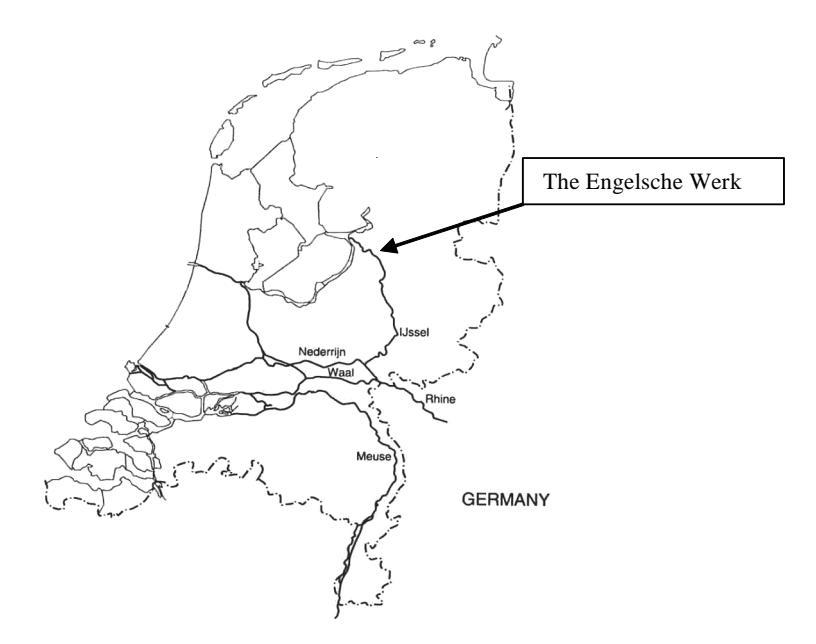
Figure 1: The Rhine branches in the Netherlands; with an arrow the project area is indicated.

In the 1990s more attention was focussed on nature development on riverbanks. A plan for 700 m of riverbank on the right side of the IJssel near Zwolle ('The Engelsche Werk') was developed ([1]; figure 1). In 1995 the riprap revetments where replaced by groynes with unprotected banks in between. Current, waves, sedimentation and erosion processes on the banks could take place again.

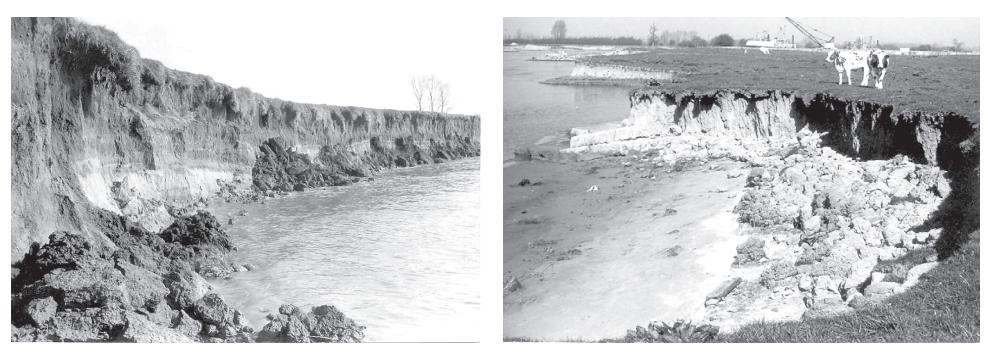
Figure 2: Bank erosion along the IJssel in the 1960s and 1970s (RWS/Directorate Eastern Netherlands)

Along the IJssel during the 1960s and 1970s, bank erosion was rapidly proceeding and dikes, constructions and shipping were in danger (figure 2). The banks were protected with riprap river revetments, to prevent further erosion. Due to these constructions the gradual zonation between the channel and the floodplains disappeared. Shallow waters, frequently flooded parts of the riverbanks and steep clay banks disappeared. Because of this the morphological dynamics on the riverbanks decreased and through this the possibilities for accommodation of birds, fish and plants decreased sharply.

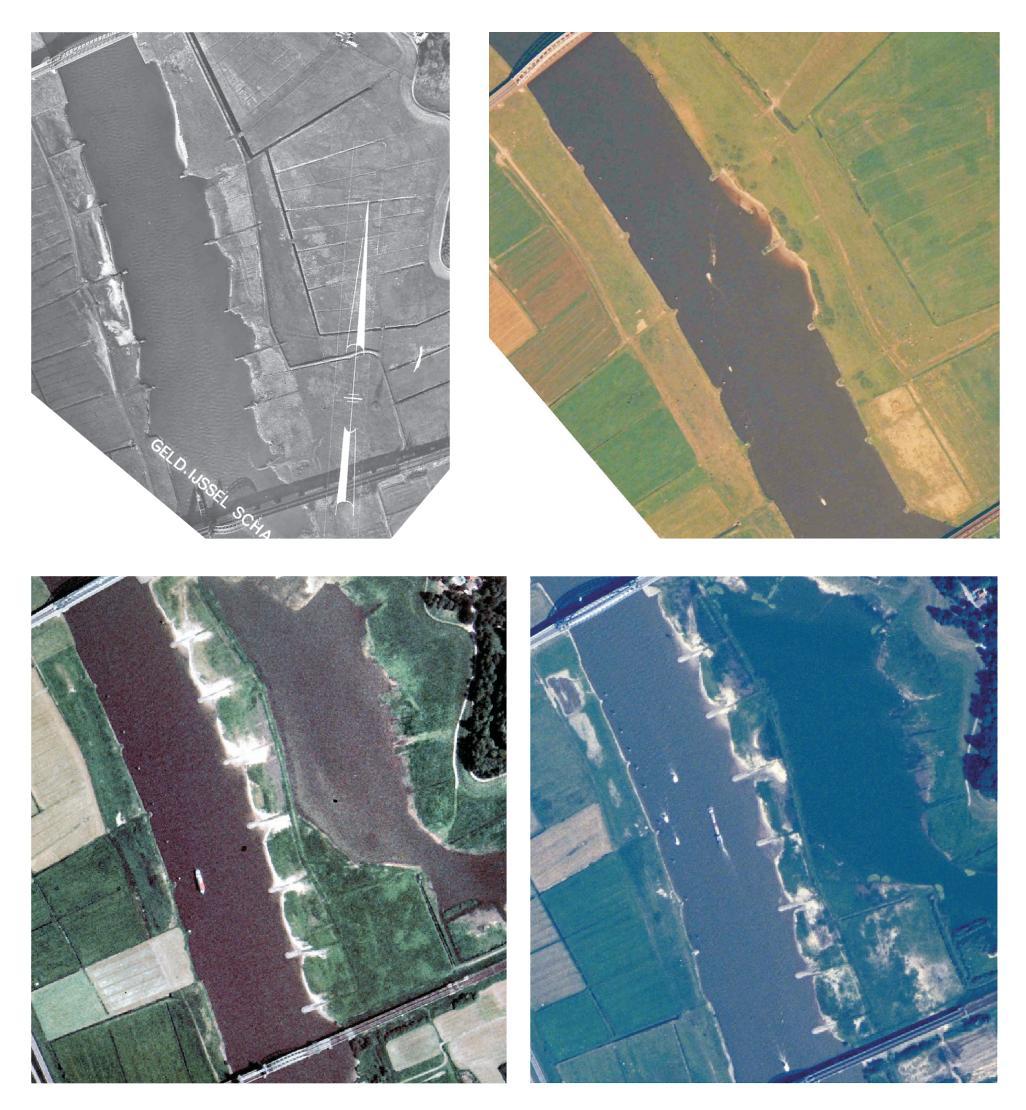
Figure 3: Aerial photos of the bank and part of the floodplain of the 'Engelsche werk'. A: the situation in 1970, preceding the fixation of the banks;
B: The situation in 1991 preceding the re-landscaping of the banks; C: The situation in 1996 after re-landscaping;
D: The situation in 1999 (RWS/Directorate Eastern Netherlands).

In figure 3 the situation before and after the riprap revetments and the situation after the re-landscaping of the area is presented.

On the river bank ecological recovery has occurred. By removing the riprap revetments and replacing them by groynes, the riverbank has been exposed again to water and water level changes and erosion processes took place. This caused a retreat of the riverbank. The hydraulic and morphologic processes reshaped the riverbank. Plants and birds immediately responded to the created variety of the riverbank. Whenever the conditions changes again, so did the composition of vegetation and birds.

After six years, a more gradual transition between land and water, with shallow water zones and sandy beaches, and occasionally small steep clay banks had been formed. This is characteristic for the other Dutch Rhine branches, but exceptional for the IJssel. Grazing in low densities created, higher up the banks, a rich structured herbaceous vegetation. In relatively wet years, even marshy herbaceous vegetation was recorded on the banks.
