3rd European Conference on River Restoration**RIVERRESTORATION**2004

Oder border meanders – experience from the countries of transition

Petr Obrdlík

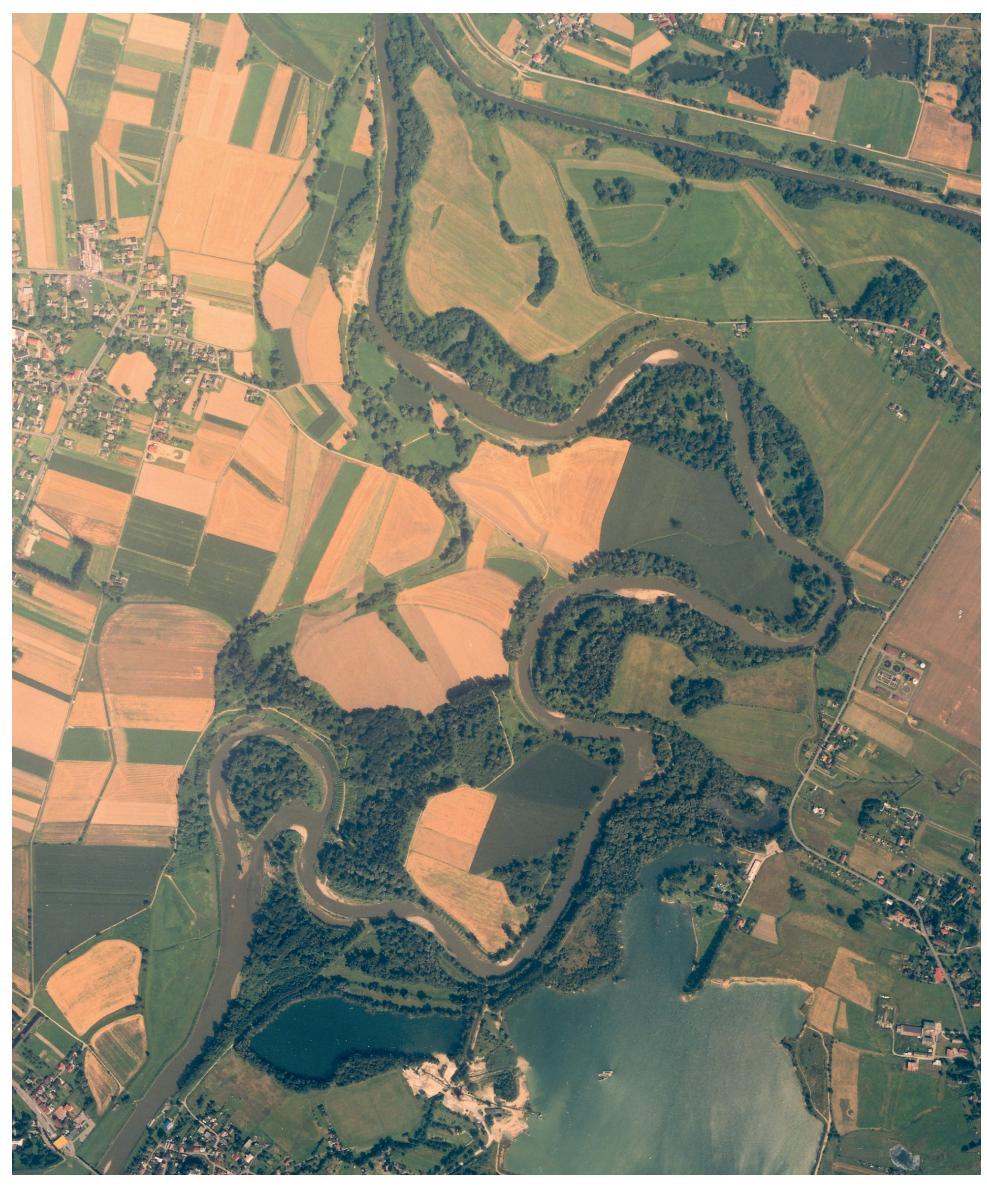
Fig. 1 Arial view of the border meanders, August 2001.Oder-Olza confluence on the top, Polish villages Chałupki and Zabełków west-, the edge of Bohumín suburbs east of the Oder (Photo: by courtesy of Městský úřad Bohumín)

The border meanders form the final stretch of the upper reaches of the Upper Oder River. They begin at the Bohumín - Chałupki border crossing and wind their way for 7 km along a broad floodplain as far as the Oder-Olza confluence. The Czech town of Bohumín lies in the floodplain while the Polish villages Chałupki and Zabełków (Fig.1) have been established on the river terraces.

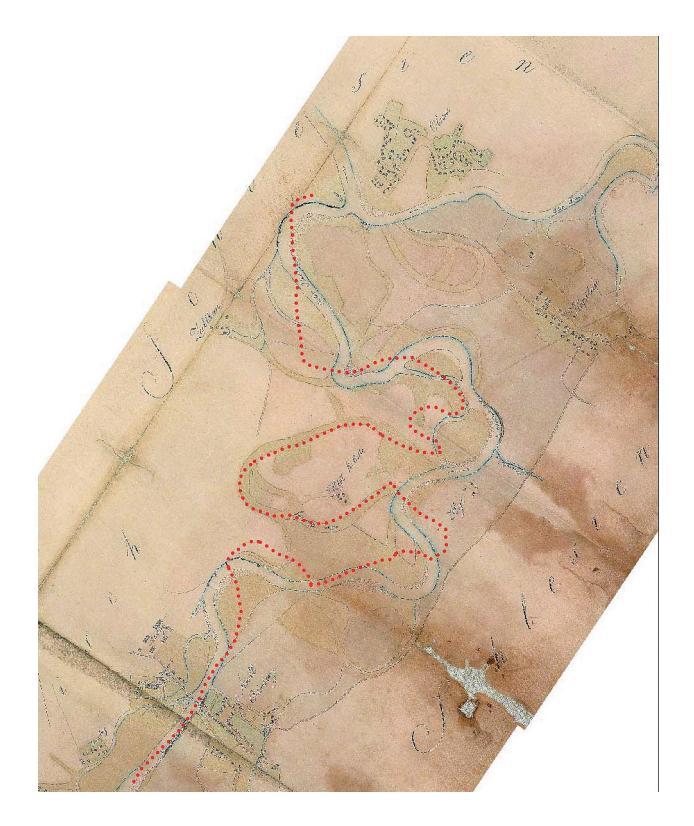
Fig. 2 Main Oder River course 1742 (red dotted line) in a historical map of the meanders from 1829 (by courtesy of Zemský archiv Opava)

Since 1742 the state Czech-Polish border on the Oder River has been movable thanks to a contract between the Prussian and the Austrian monarchies. It lies in the central line of the Oder. Following agreements between the then Czechoslovakia and the Republic of Poland in 1959, the position of the border was confirmed. The "wet" movable border in the untamed river underwent constant, relatively-quick changes. This is why the state border had to be regularly measured and corrected. The morphological changes of a river from the point of view of gaining or losing state territory are in the long-term balanced, as it has been confirmed by the comparison of historical maps over the last 250 years (Fig. 2).
