Lowering the weir of the Houël mill on the Leff River

Category	Restoration
Type of operation	Partial or total weir/dam removal
Type of environment	Lowland rivers
Issues at stake (water, biodiversity, climate)	River continuity, good status of habitats

Start of operation	September 2010
End of operation	September 2010
Length of river affected by the works	700 m

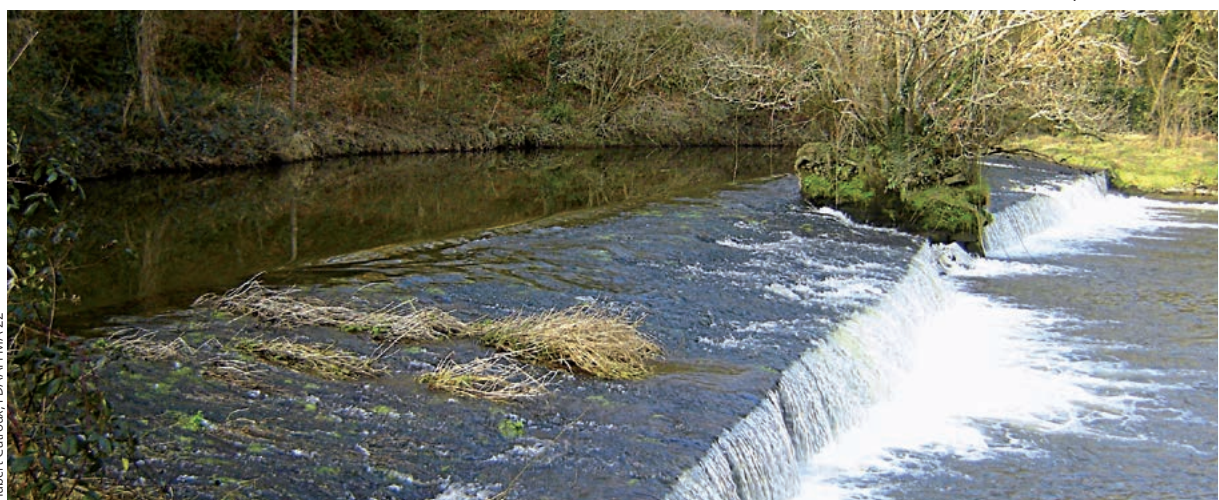
The weir of the Houël mill, in 2010 prior to the works.

The weir of the Houël mill was not maintained and had fallen into disrepair. It impacted habitat diversity and the flow of water in the impounded reach. It also disturbed sediment transport.

The project consisted of lowering the weir by over one metre over half of its total length. The rocks resulting from the removal of a part of the weir were spread over the banks to prevent erosion or laid in the river bed to increase the diversity of flows and create rapids for the kayakers. The old buildings were enhanced by clearing the area around the ruins and trimming a number of trees.

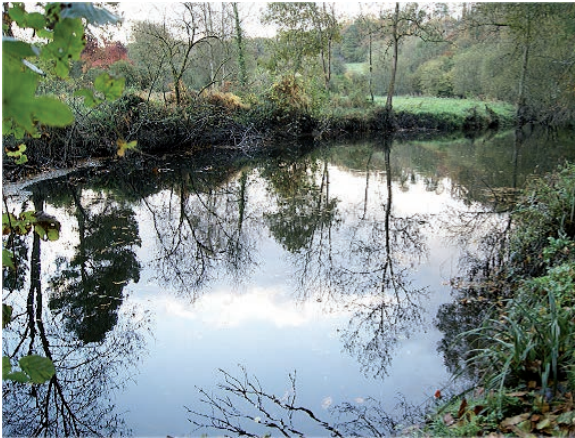
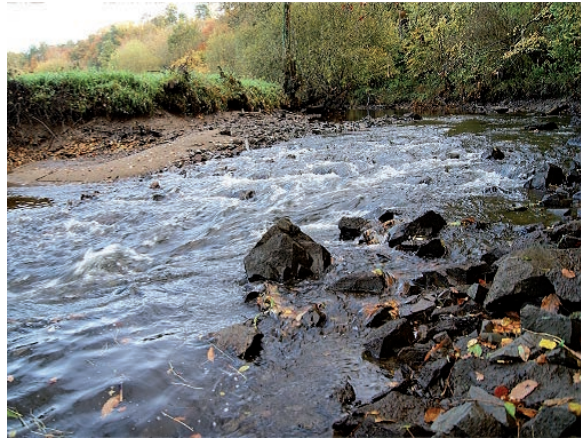
The impounded reach of the Houël weir before the works (2010) and after (2011).

The continuity of the Leff River has been restored over a 700-metre section up to the next hydraulic structure. Flows are now more rapid and the fine sediment deposited in the impounded reach was carried off to reveal a more coarse substrate made up of rocks and gravel. The diversity of habitats, flow patterns and new substrates revealed upstream of the former weir is favourable for diadromous migratory species that have found along the 700-metre section new spots suitable for their reproduction (well oxygenated gravel) and to the growth of juveniles (riffles). In 2011, approximately 30 spawning grounds for sea lampreys were observed upstream of the former weir. Prior to the lowering of the weir, the water was too deep and hindered the reproduction of the species. Juvenile salmon use the new riffles created in the former impounded reach during their growth phases. On the other hand, no shad have been observed upstream of the former weir, possibly because the species has not yet colonised the new environment.

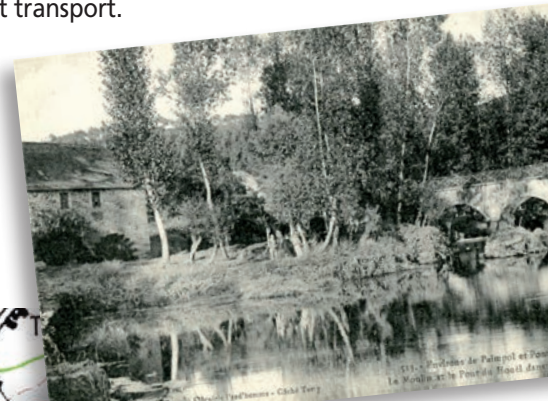
The Houël mill around the year 1910.
