# inpractice

Issue 95 | March 2017

# Rewilding in a Managed Landscape – The Swindale Beck Restoration Project

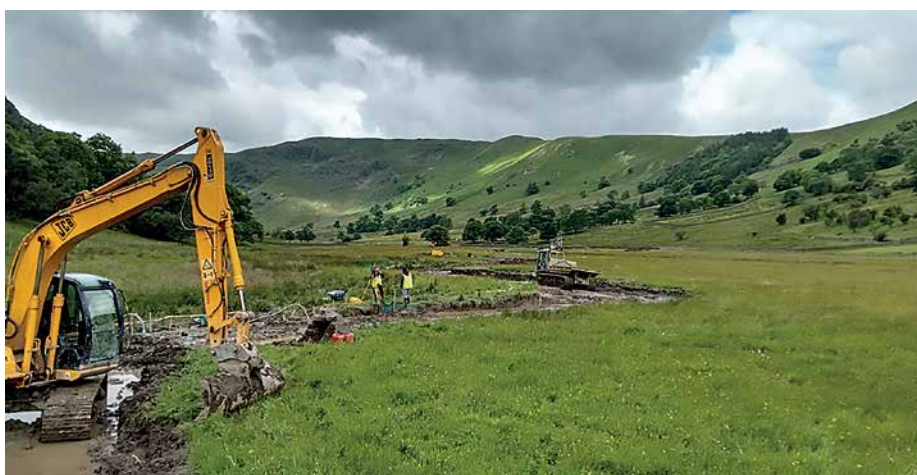
Figure 3. Swindale Beck restoration work in progress. Photo credit RSPB Images.

A specialist environmental contractor, OpenSpace, won the tendering process and started work on site in March 2016 (Figure 3). Weather proved challenging at times, as did the presence of a large number of land drains, which in combination regularly inundated the work area. Insufficient gravel found in some parts of the new route added extra complications and raised concerns that the restored river may be more dynamic than was desirable, which could have negative consequences for surrounding land. To help provide some stability, a number of embryo gravel bars were constructed in locations where these would be most likely to form naturally.

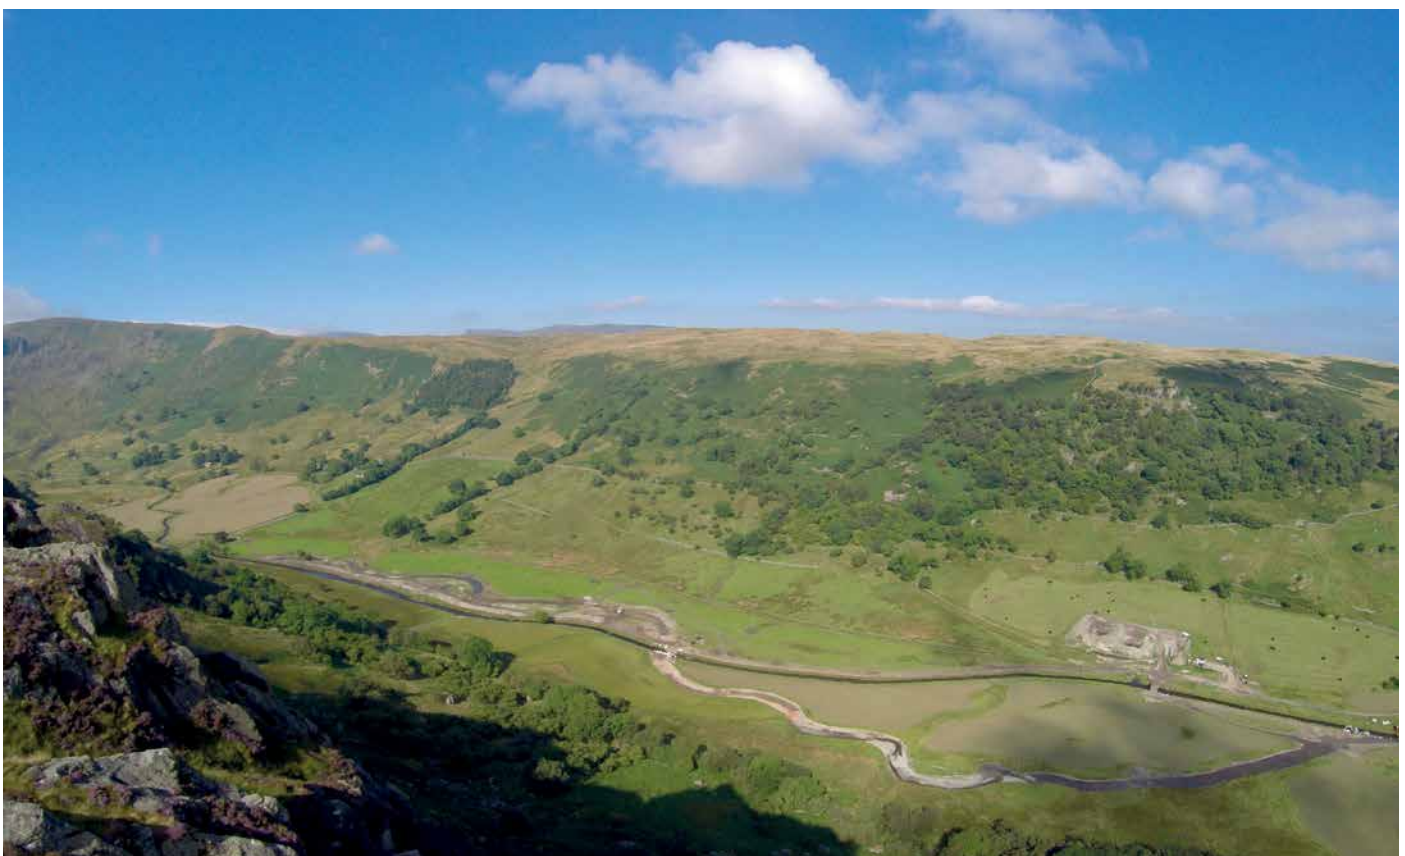
Figure 4. Aerial photo showing the straightened route and the restored route before connection. Photo credit RSPB Images.

After electro-fishing to remove fish from the straightened route, connection into the new sinuous channel took place in August 2016 (Figure 4). A very heavy rainfall event occurred two days later, flooding the whole valley bottom. Concerns about what this might have done to the unconsolidated banks of the new river proved to be

The restored channel at 891 m is 140 m longer and around 2 m wider than the old route and, without the levees, is much better connected to the flood plain. In-channel deposition is visibly occurring in several places, which should reduce the quantity of material ending up at the United Utilities intake, saving on maintenance costs. Gravels are naturally sorted within the channel resulting in areas of fine sediment distinct from larger substrate. As the new river beds in, and aquatic organisms recolonise, this enhanced morphological diversity will almost certainly result in the beck having much more wildlife than it has supported for decades. We will be carrying out a range of different monitoring activities

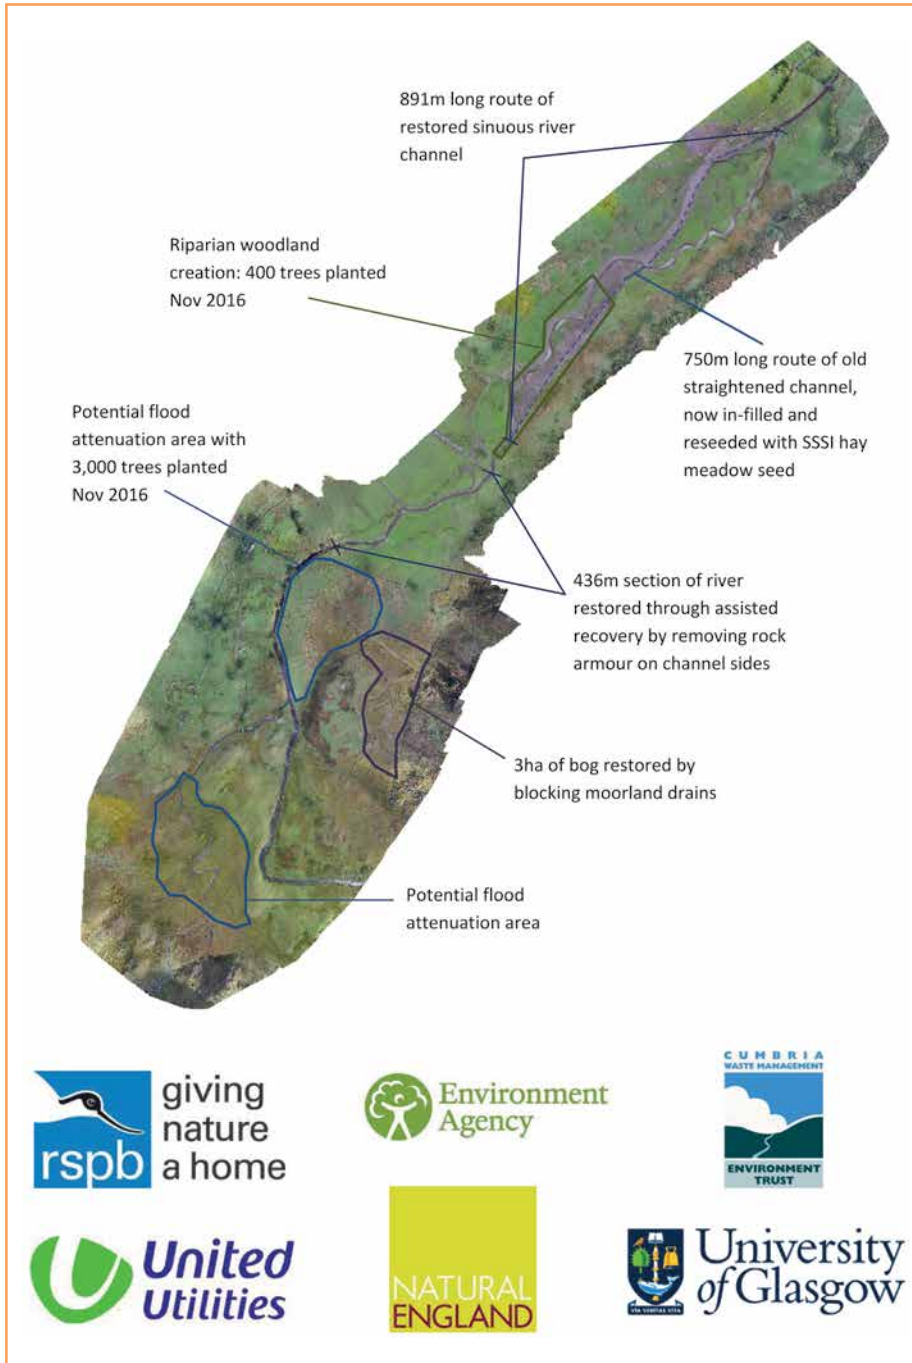
Figure 5. Annotated aerial photo showing river restoration and other Swindale projects. Photo credit Glasgow University.

Swindale Beck restoration is nested within a programme of complementary projects to improve ecosystem services in the Swindale catchment, including 40,000 trees being planted around the valley over the last four years, large-scale moorland restoration, a renewed drinking water intake and fish pass, and plans for two flood attenuation areas. (Figure 5).
