## **River and Wetland Restoration in Japan**

**K. Nakamura and K. Tockner**

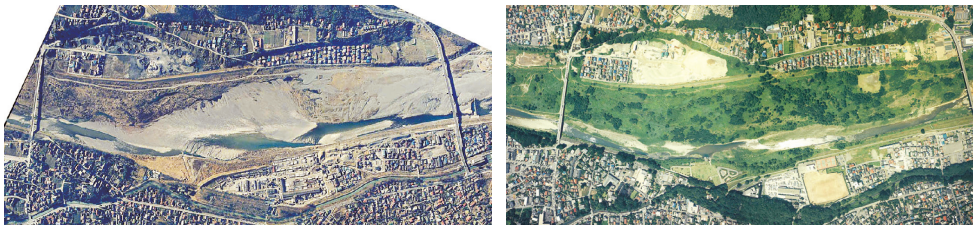
**Figure 1** Tama River (Nagata area) in 1974 (Left; courtesy of GSI ) and in 1994 (Right; photo: PWRI)

The main goal of the project is the transformation of the woody and shrubby river channel back to a gravel bed channel. The sediment-hydraulic calculations and detailed historic analyses of river bed changes revealed the following main results (Shimatani, 2003): (i) River bed degradation is a consequence of a decreased sediment supply from

upstream sections (excavation), an enhanced sediment transport through the narrowed river channel, and the sediment trapping by the Hamura weir. (ii) Natural lateral bank erosion is prevented because the low-flow channel is covered with erosion-proof Neocene or Pleistocene soft rock. (iii) It will take a few hundred years to upgrade the river bed naturally at this area because of the huge sediment trap capacity of the Hamura weir. Therefore, it was concluded that artificial widening and the addition of sediments are necessary for restoring the gravel river bed. The restoration was conducted at two sites within a 1 km reach. At the upstream site the conservation of *Aster kantoensis*, an endangered species typical for ERS, was the main goal. Therefore, *Robinia pseudo-acacia* (an alien species) and fine sediment were removed. At the downstream site, a  $2.4 \times 10^4 \text{ m}^2$  gravel bed was restored. The inundation frequency of the restored gravel bed ranges from several times a year to every five years. To increase the sediment supply from upstream sections, sediment was artificially added at the upstream end (downstream of the Hamura weir). This program has just started, therefore, the success has not yet been evaluated.

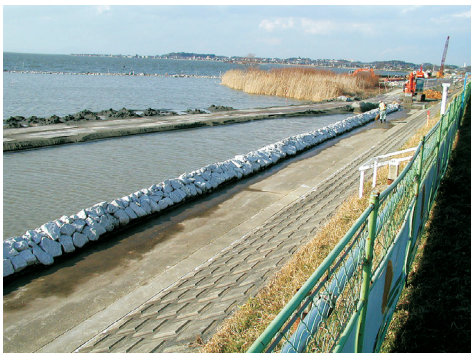
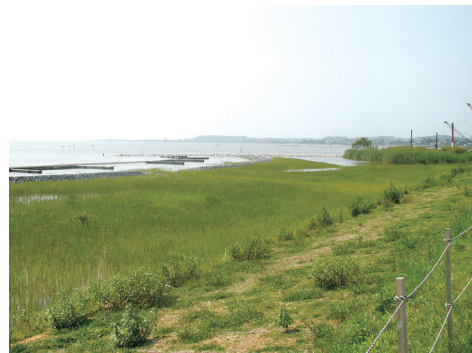
**Figure 3** Lake Kasumigaura: Restoration of the littoral zone. Left: Banks are covered with concrete (during construction). Right: Recovery of natural vegetation (about three months after restoration) (Photos: K. Nakamura)

Lake Kasumigaura (ca 60 km northeast of Tokyo) is the second largest lake in Japan. The area of the lake and its catchment is 220 km<sup>2</sup> and 2,157 km<sup>2</sup>, respectively. Mean water depth is, however, only 4 m. The lake is eutrophic. The lake vegetation has deteriorated since the 1970s because of water pollution, artificial bank construction, and water level control. The banks have been fortified and a barrage was built at the outflow, which artificially controls the water level for both flood defense and for maintaining water resources (industrial, drinking and irrigation water). From the 1970s to the 2000s, the area covered by emergent plants decreased by 50 %, submerged plants completely disappeared (former area: 700 x 10<sup>4</sup> m<sup>2</sup>), and water transparency decreased from 150 to 30 cm. Algae blooms have also damaged the young shoots of emergent plants. The Kasumigaura River Office, MLIT, initiated large-scale lakeshore restoration measures in 2001. The rapid decline of “Asaza”, *Nymphoides peltata*, was the main turning point. This project aims to conserve *Nymphoides peltata* and to restore lake littoral zones. The project is conducted in close cooperation between NPO groups, civil engineers, and ecologists. The alignment and slope (ca 1 to 100) of the lakeshore were designed using old reference maps, photos, and information from natural lakes. Excavated offshore bottom sediment was used for restoration. They were covered with a thin layer (10 cm) of littoral sediment that contained important “seed banks” for vegetation regeneration. Restoration work was completed in spring 2002. Surprisingly, vegetation has partially

recovered in summer 2002 (Figure 3). Many locally extinct plants successfully recovered by natural seed banks (Table 1) (Nakamura, online; Nakamura, 2002; Nishihiro, 2003). Indeed, *Chara* has appeared for the first time since 30 years. The success of this restoration project indicates that even locally extinct species can be restored, which again encourages those people who wish to restore nature in Japan.
