ARGA and ARAGÓN RIVERS

Title		LIFE + MINK TERRITORY (<i>Territorio visión</i>)	
Organization		Gestión Ambiental de Navarra, Navarre Government, TRAGSA, Ministry of Ecological Transition, Ebro Water Agency	
Start	End	October 2010	March 2016
River typology		Meandering gravel river (wandering previously)	
Target species/habitat		European mink, Poplar and willow riparian woodlands, Otter, European, Pond turtle, Meanders	
Q mean		65 m ³ /s	
Contact		Josu Elso (jelsohua@gan-nik.es)

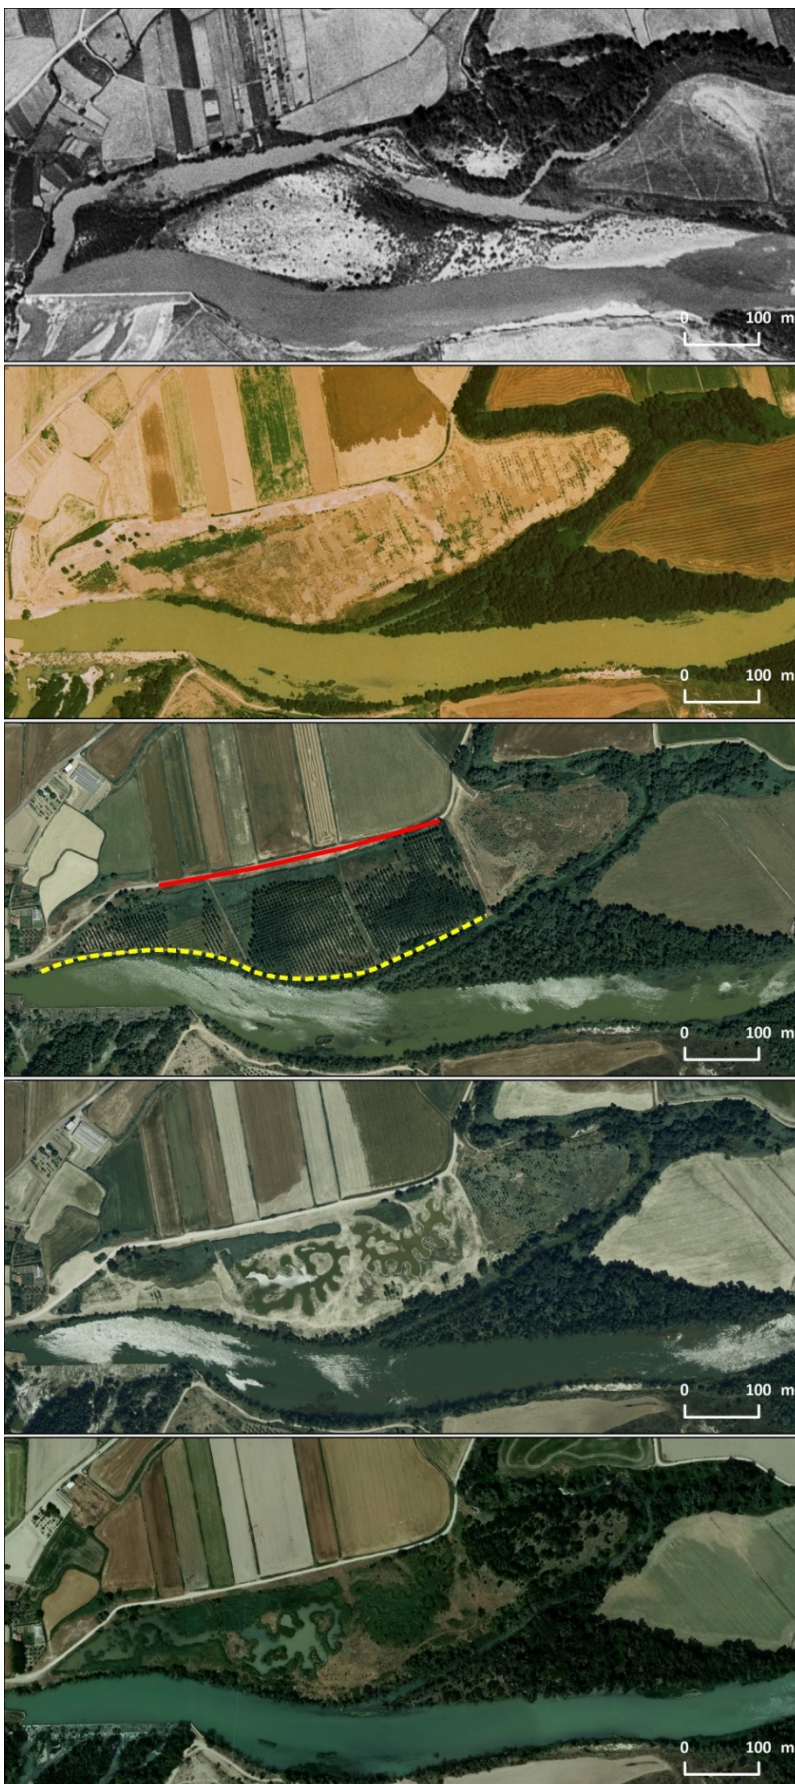
Figure 2. Example of 8.65 ha fluvial territory recovery in Soto Manolo and wetlands creation. From the top to down: 1957; late 90'; before restoration in 2012 (yellow line set back of riprap, red line improvement of a path protection); after restoration (2013) and in 2022.

- In Mérida and Sotocontiendas 582 m and 1425 m of lateral dykes were set back, reconstructing or heightening existing structures and guaranteeing that the same protection degree is kept behind the setback defences.
- In other cases buying the lands for restoration and conservation does not require more protection, facilitating the recovery of functional floodplains and decreasing flood risk areas downstream. This has been implemented in Caparroso (Figure 2), Carcastillo and Soto Montecillo where 800 m, 1450 m and 400 m of dykes and riprap were removed, respectively.
- Finally, old dykes in external areas without any function were removed.

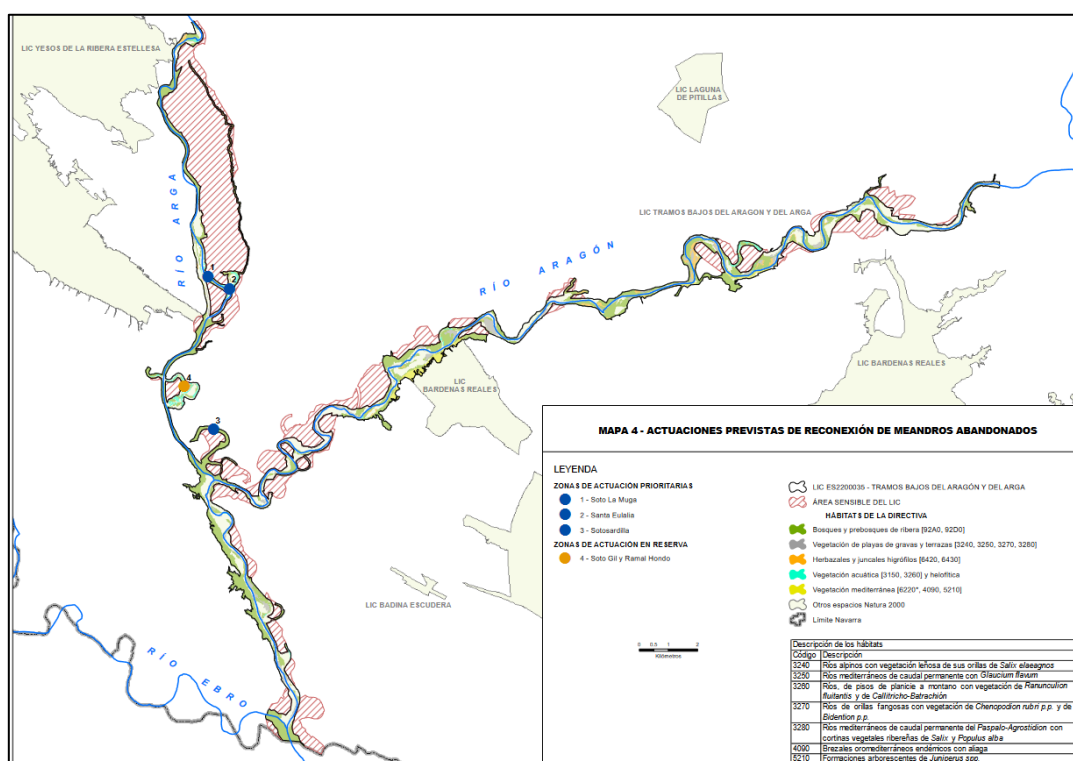
Figure 3. Location of the reconnection meanders actions along the Arga River.

The work has been carried out on the following remnant meanders: Soto de La Muga (Peralta) and Soto de Santa Eulalia (Peralta). A third one initially contemplated was not completed under this project but it has been done in a subsequent project led by the Ministry of Environment.

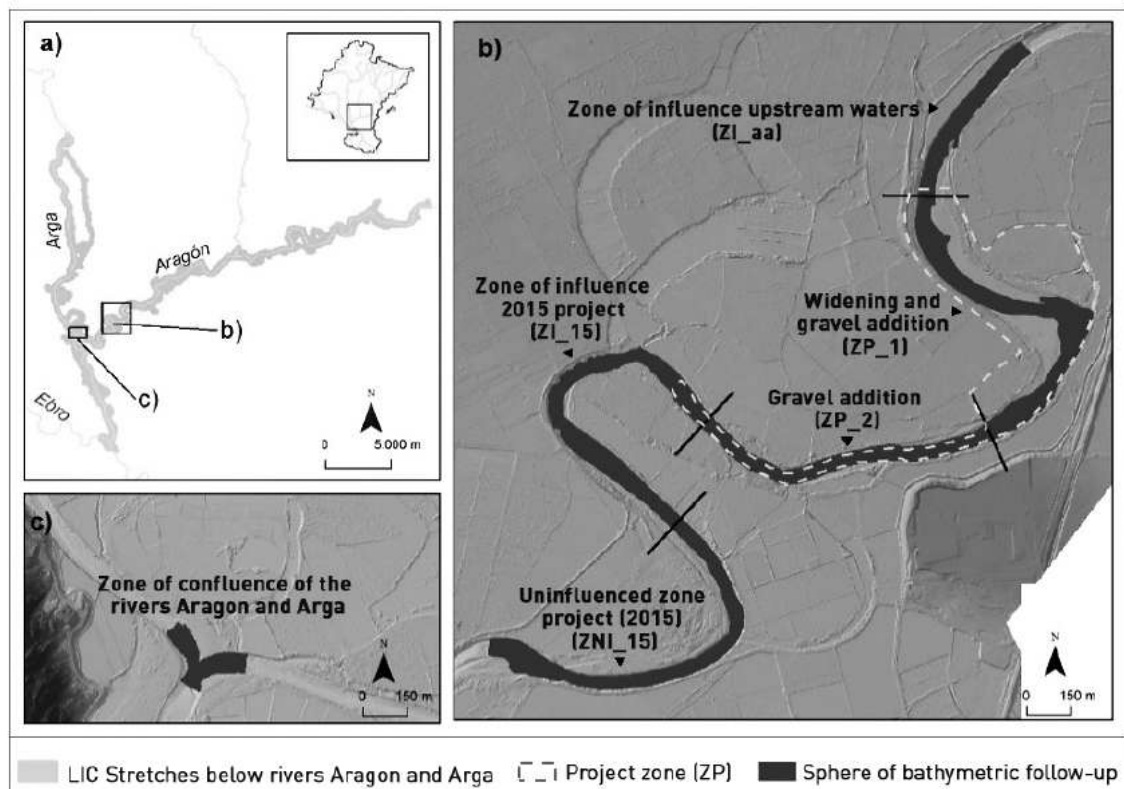
Figure 4. Location of the gravel addition river reach (Pérez et al., 2015)

Gravel addition was done in Sotocontiendas, a meander of Aragón River in Marcilla upstream from the confluence of Arga River. This river reach was selected based on social, legal and political feasibility. A geomorphological, morphometric and granulometrical analysis were previously done, as well as hydraulic and morphodynamic validations that were used to explain people the lack of risk of introducing sediments to the riverbed and reactivating erosive and lateral flooding processes (Pérez et al., 2015).

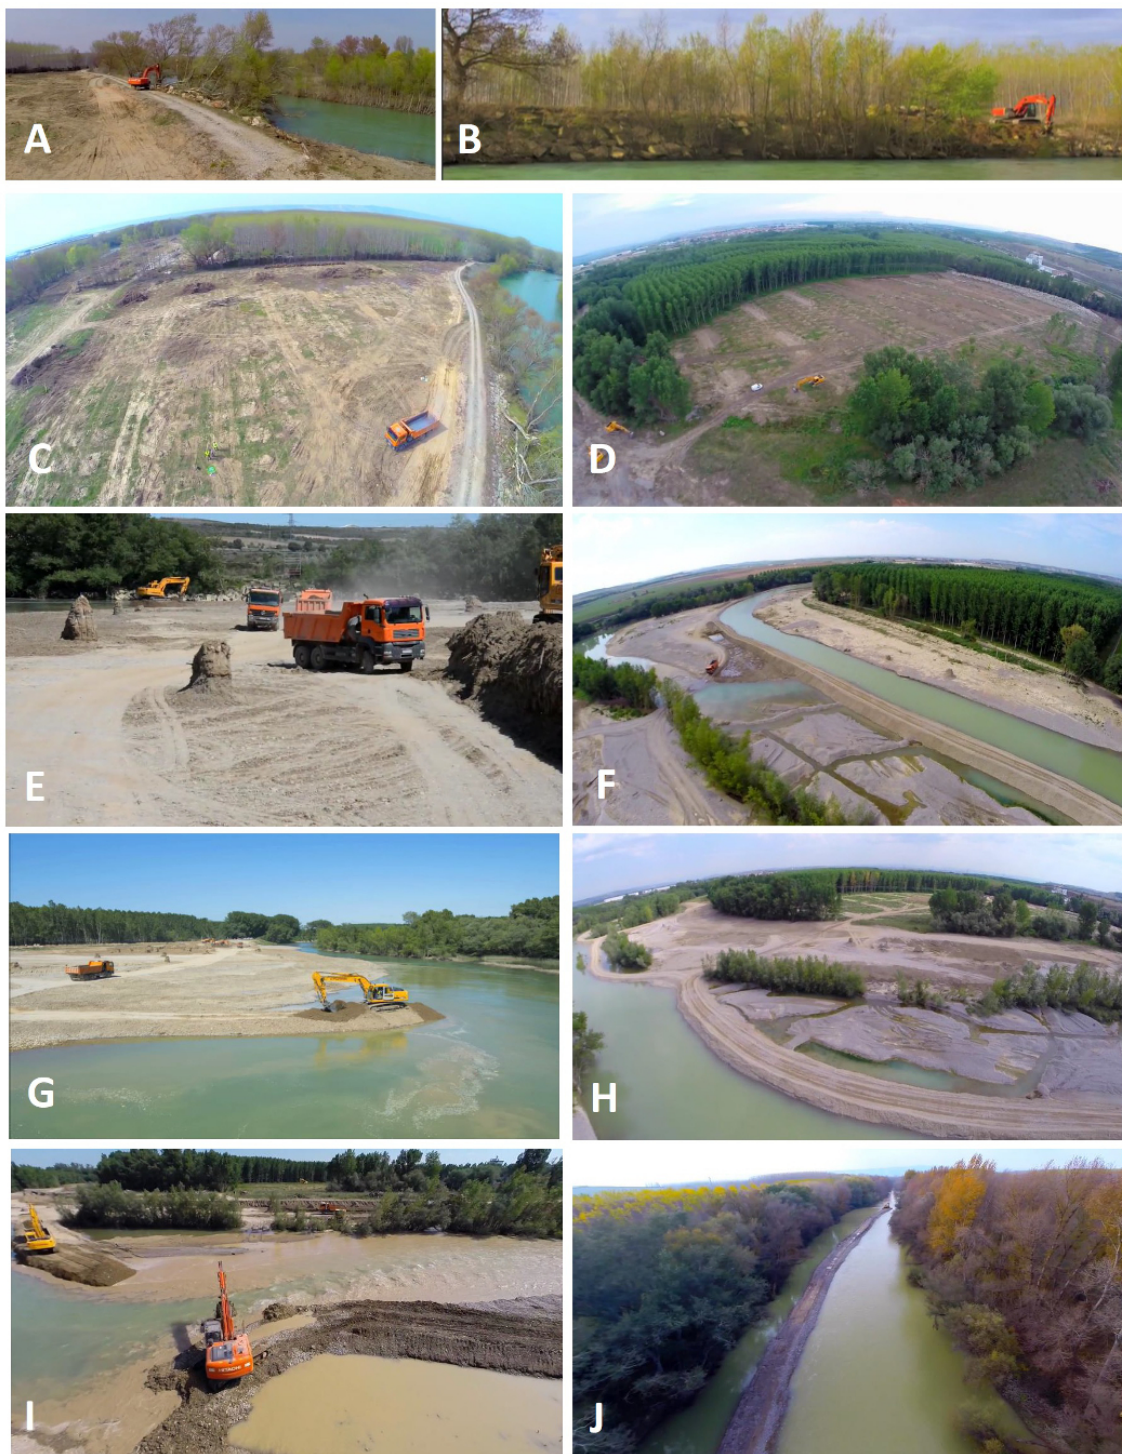
Figure 5. Process of removal of defences and giving sediments back to the river

Restoration process: Removal of dykes (B); suppression of ripraps (A); recovering riparian space (C, D); recovering space for beds and widening the main channel (E, F, G); returning to the river the sediments dredged during the past (H, I, J).

- (I) Recovering the geo-morphodynamic process of lateral adjustment by suppressing 985 linear meters of riprap and similar structures.
- (II) Reactivating overflow processes following the elimination of containing structures, which involved the removal of 1,342 linear meters of dyke.

- (III) Restoring the original reliefs and forms in accordance with the morphometric studies. 4.6 ha were re-sectioned, generating a land excavation volume of 200,000 m³, of which 101,115 m³ was gravel and 98,885 m³ silt.

- (IV) Returning the excavated sediments (mainly dredged material that constituted the borders and constructed the dykes). 90,485 m³ of silt was reintroduced back into the river during episodes of swelling, and gravel was spread evenly along the 2.5 km, creating an average regrowth of 0.65 m.

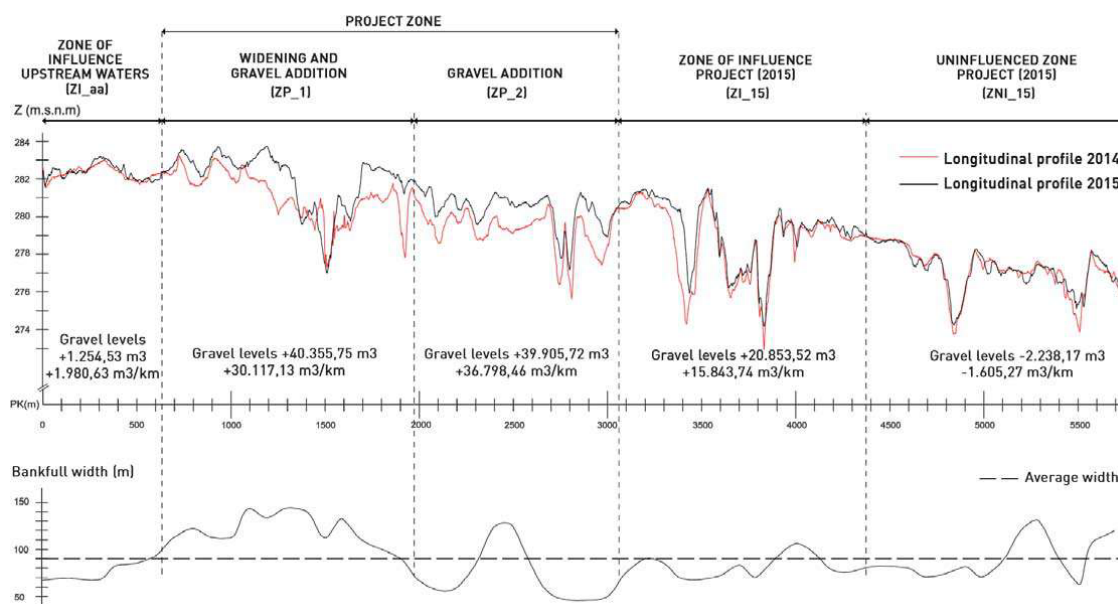
Figure 6. Longitudinal profile before and after sediment addition and changes on bankfull width (Perez et al, 2015)

As Perez et al. (2015) explained the preliminary data available (Figure 6 and 7) indicates that the morpho-functional behaviour of the stretch is extremely similar to that envisaged. The results of the hydro and morphodynamic studies of model validation (prior to the works), concluded that the effect on the likelihood of flooding in the stretch were imperceptible, and that the filling would remain in the widened stretch, whilst in the rest of the stretch the material would not accumulate but circulated to lower waters. Following the envisaged addition, the bed of the river Aragon would balance out after around 100 days, understood as equivalent days of water flow (calculated at approximately 21% del Q2.33). For its part, the river would maintain waters at the lower part of the widened stretch, and the initial slope.

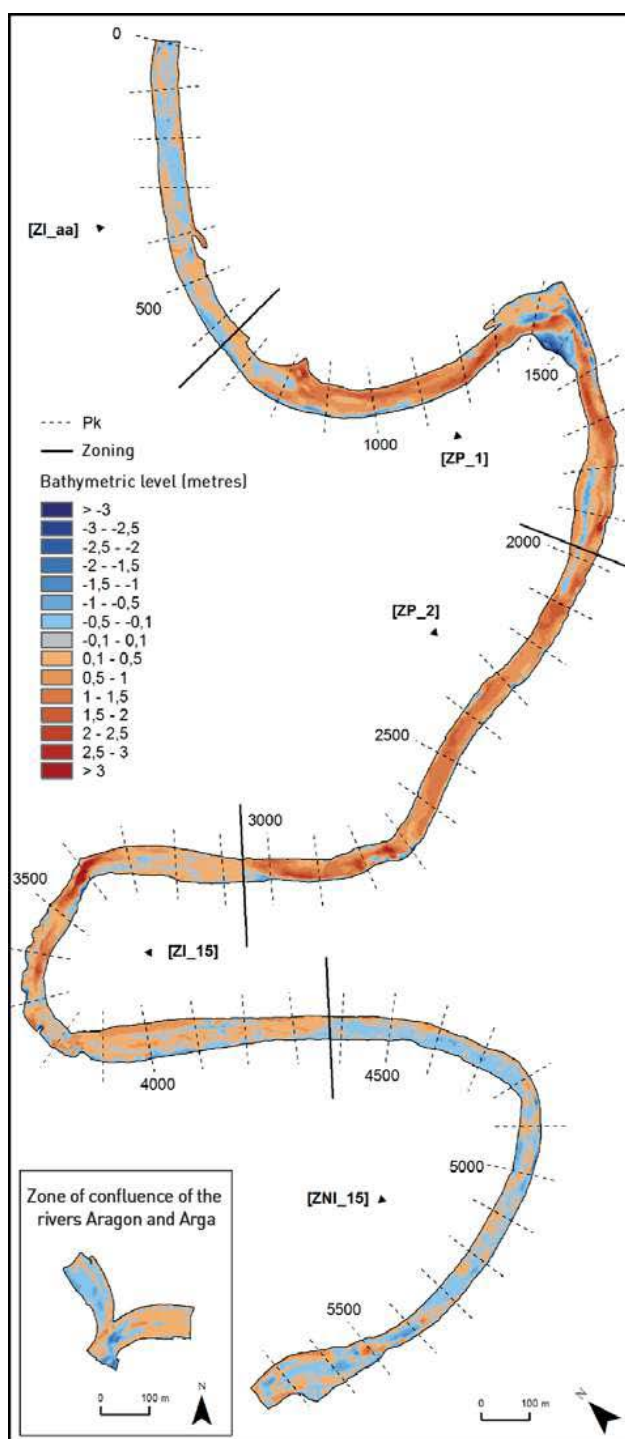
Figure 7. Bathymetric level differences between before (March 2014) restoration and after (March 2015).

The monitoring of dykes and ripraps removal and sediment addition was done through a couple of bathymetrical surveys, one before the works began and another once they were finished, in March 2015, to provide an approximation of the morpho-sedimentary behaviour of the river reach.
