# Remove culverts

**Title:** Tanner's Brook Restoration  
**Location:** Southampton, England  
**Cost of technique:** ££££££  
**Overall cost of scheme:** ££££££  
**Benefits:** ££££££  
**Dates:** 2012 - 2013

Remove Culverts

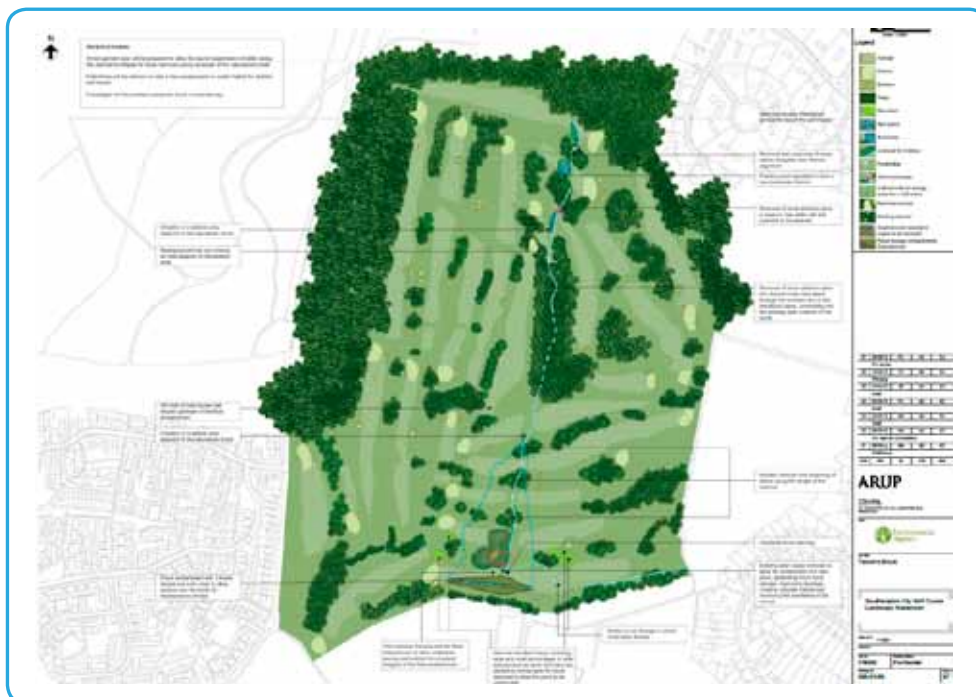
Holly Brook deculverting design

The culvert was excavated and a two-stage channel was profiled to maximise the potential for marginal aquatic habitat to establish. Online ponds and backwaters were also excavated for the same reason. The channel was left to naturally develop, which has resulted in natural riffle formation, immediately increasing the in-channel morphological diversity.

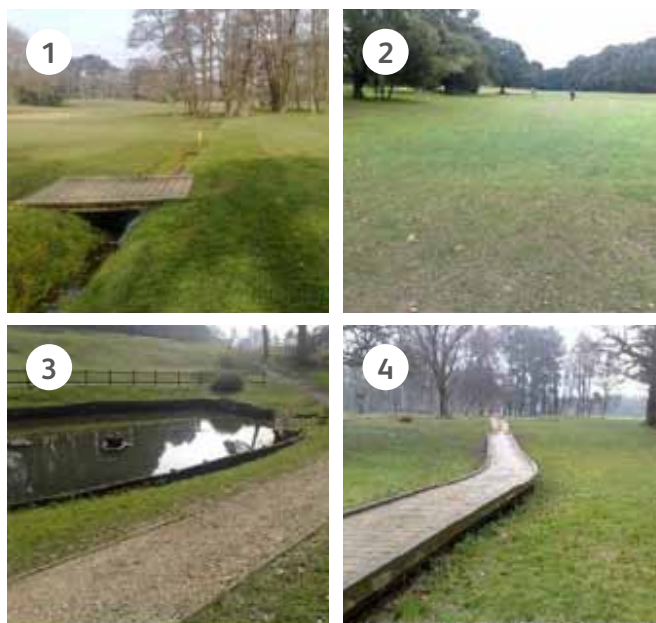
(1) Seasonally waterlogged location of subsequent naturalised channel; (2) Seasonally waterlogged location of subsequent naturalised channel; (3) Vertical edged pond; (4) Raised timber boardwalk over waterlogged ground.

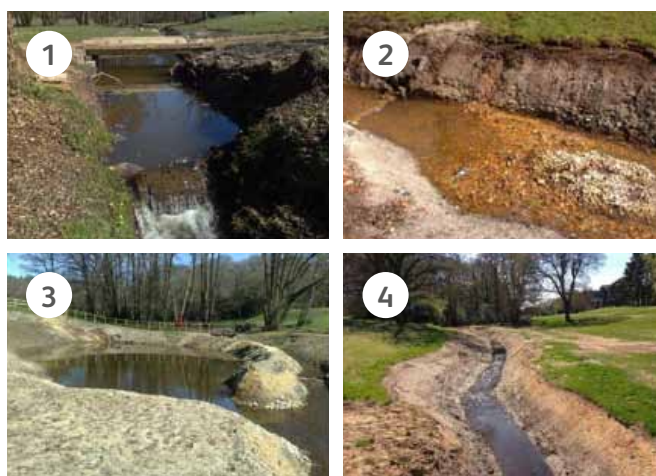
(1) Weirs creates acoustic feature along channel. Increasing in-channel morphological diversity; (2) Natural riffles forming. Increasing in-channel morphological diversity; (3) Online pond/ Backwater. Ecological value of marginal aquatic habitat, banks and riparian zone improved; (4) Two stage channel enhances ecological value of marginal aquatic habitat, banks and riparian zone.
